Television

AUGUST 1976

- 517 Syclops Revisited** *by Barry F. Pamplin*
An investigation of the fault conditions that arise in the Syclops combined line output/switch-mode power supply circuit used in the Thorn 9000 chassis.

- 528 Electrolytic Tester** *by Alan Willcox*
This complementary design to the Capacitance Meter published in May covers capacitors in the range 10–4,000 μ F, checking both leakage and value.

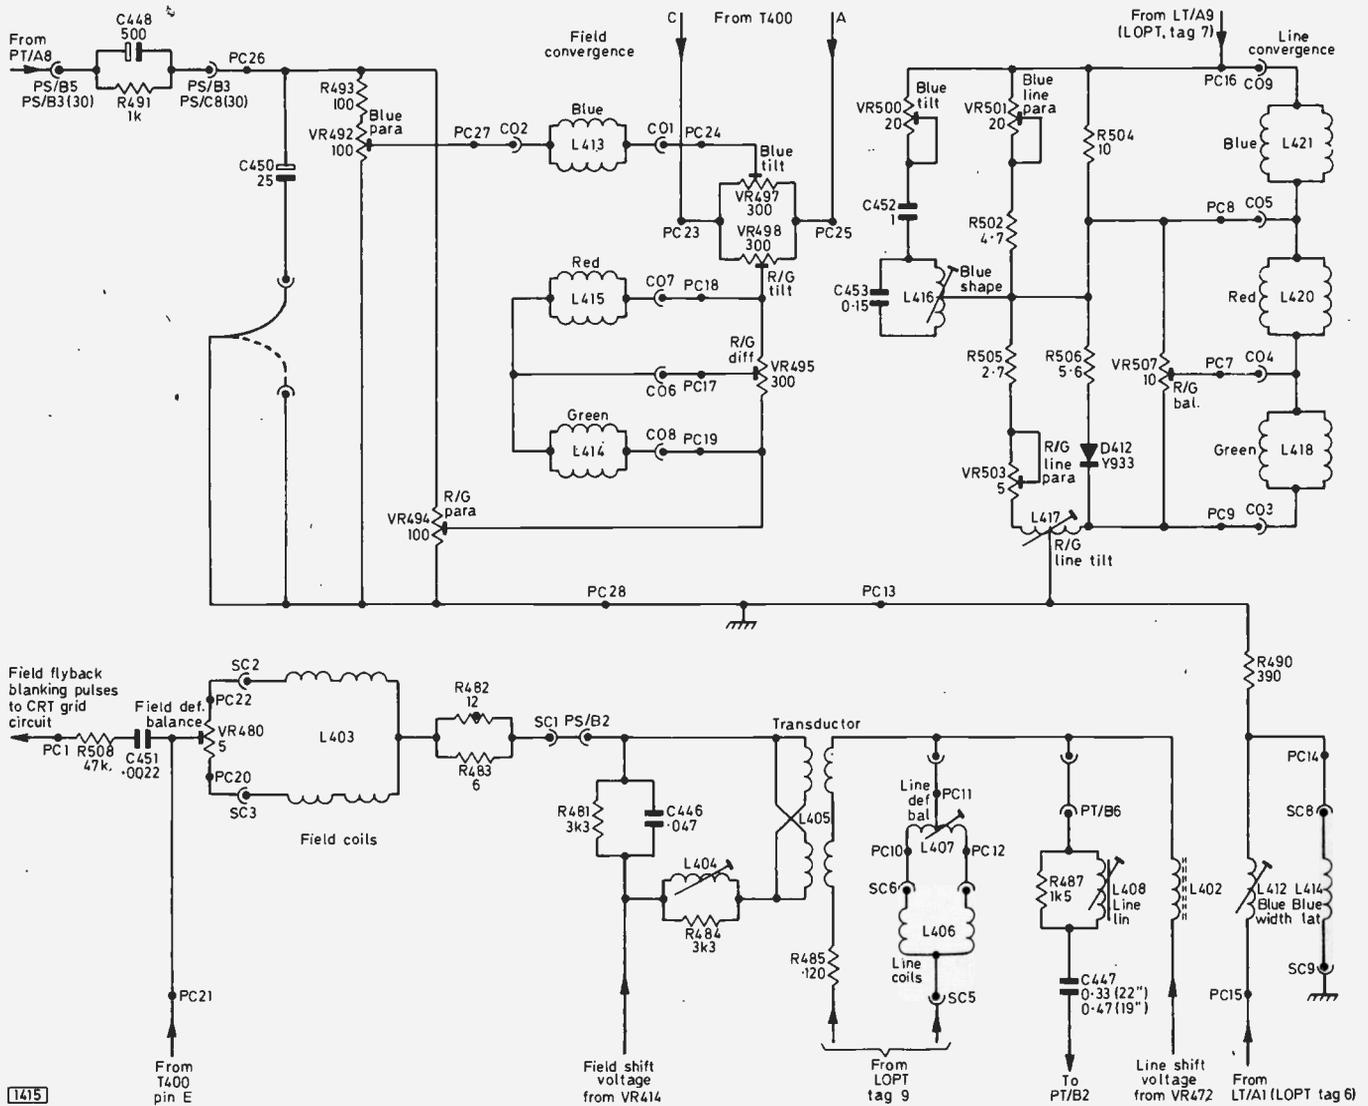
Fig. 4: The convergence circuitry, 10 series chassis. In the 30 series R493 and R508 are omitted, L412 is a tapped coil with the second section replacing R490, R484 is omitted and R481 is changed to 10Ω and is connected across the parallel windings on the transducer. The S-correction capacitor C447 is 1μF in the 17in. model. The small-screen (17, 18 and 19in.) models do not incorporate pincushion distortion correction, transducer L405 and its associated components L404, C446, R481, R484 and R485 being omitted.

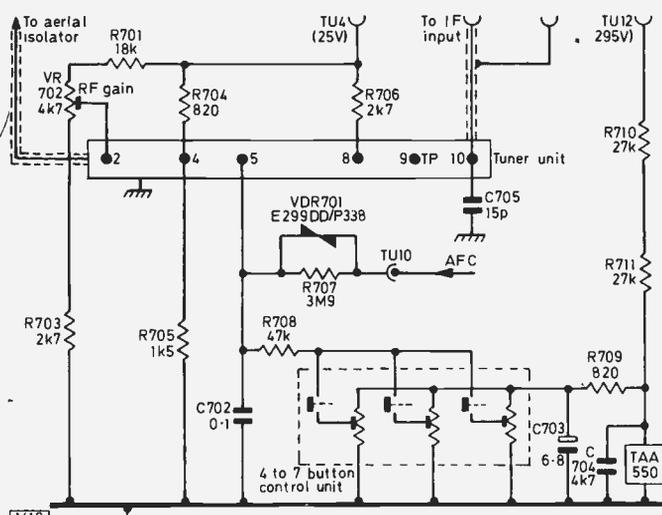
Fig. 5: Circuitry associated with the varicap tuner used in many 30 series models.

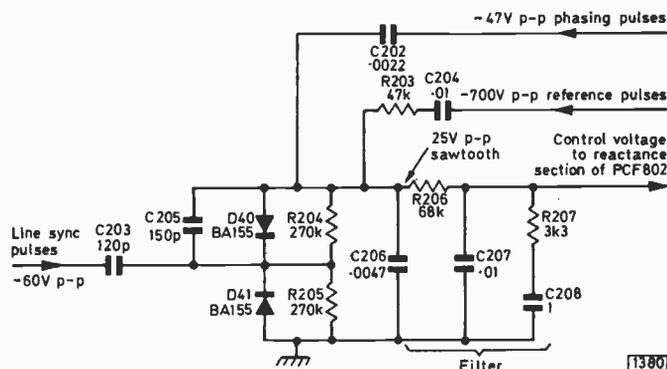
Fig. 1: Flywheel line sync discriminator circuit used in the Pye group hybrid colour chassis (691-7).

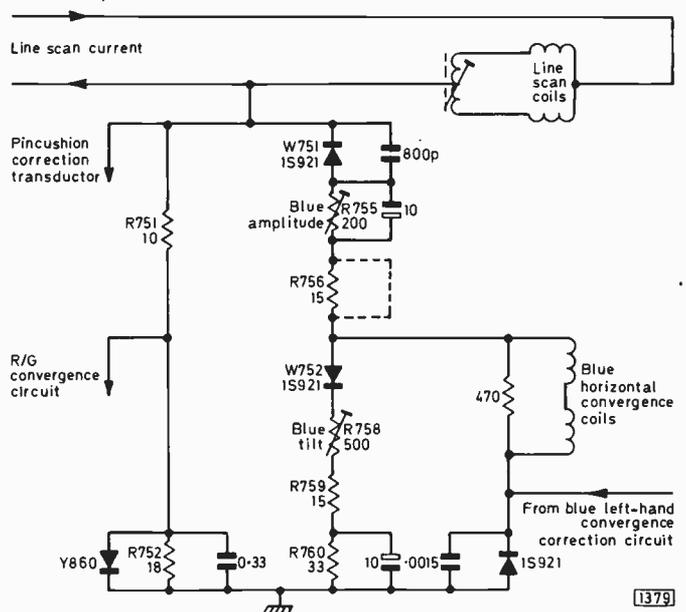
Fig. 2: Part of the blue horizontal convergence circuit in the Thorn 3500 chassis. Where there are parallel resistive paths, open-circuit components can cause burn ups.

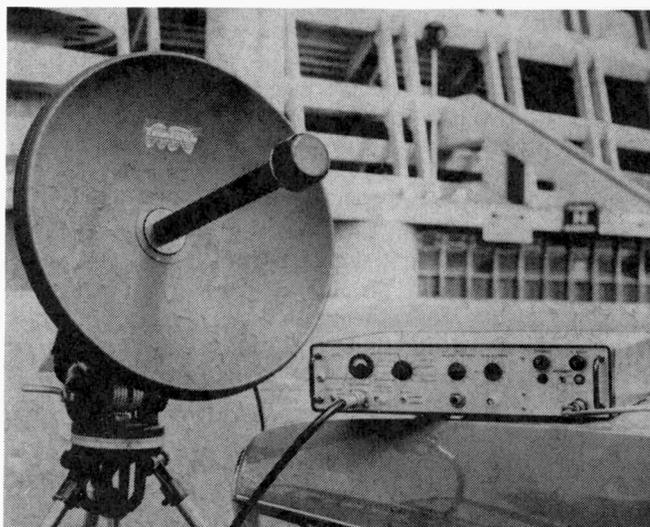
A portable microwave system for ENG manufactured by Terracom.

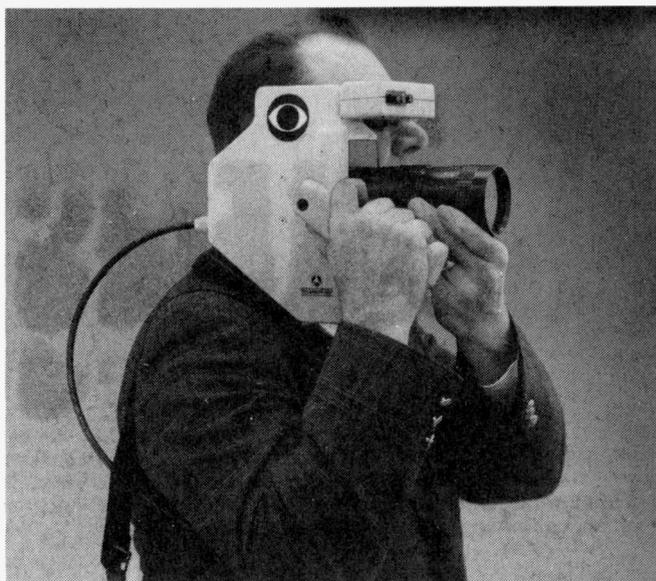
The Thomson-CSF “Microcam” colour camera. With lens and viewfinder, it weighs only 8lbs, and the shoulder-slung electronics pack only 3lbs.
