Television

SEPTEMBER 1976

CONVERTER

A
TV
PROJECT

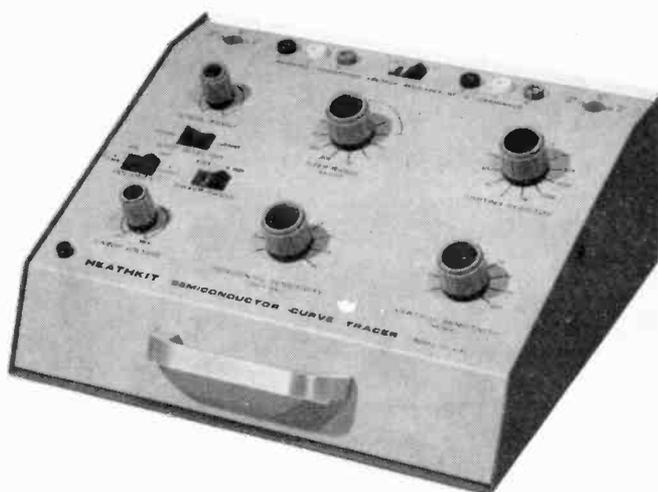
A simplified block diagram of the IT-1121 is shown in Fig. 1. The sweep supply transforms and full-wave rectifies the a.c. mains supply to produce a pulsating d.c. of up to 40V or 200V peak, either positive or negative-going as required. This pulsating d.c. is applied via a sweep limiting resistor to the collector (or drain) of the transistor under test. The voltage at the collector is sampled and applied to the horizontal (X) deflection circuits of the associated oscilloscope.

A step generator, triggered from the mains supply, is used to apply a current (or voltage) staircase of up to nine steps to the base (or gate) of the transistor under test, and the resulting emitter (or source) current is sampled and applied to the vertical (Y) deflection circuits of the oscilloscope. The resulting display shows the transistor's I_C/V_C characteristic curves for various values of base current. When testing diodes, the step generator is not used.
