TELEVISION

SERVICING-VIDEO-CONSTRUCTION-DEVELOPMENTS

SERVICING THE THORN 3000/3500 CHASSIS

September
1978

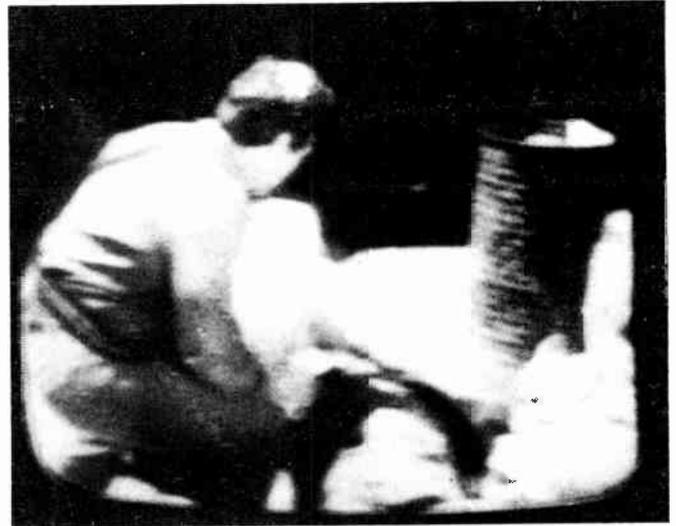
Off-screen photographs showing pulse information from a nearby line terminal/VDU system, taken at the author's home. The exact source of the interference is not known and the equipment manufacturer has refused to comment further. The signals are from Madrid, ch. E4 (48.25MHz), received via Sp.E.
