Volume XXII Issue 2 January 29, 1971

Important Information for your Service Department

Prepared and Distributed by **RCA Sales Corporation, Product Performance** 600 N. Sherman Drive, Indianapolis, Indiana 46201

Hum Bars and/or Degaussing "Interference"—CTC 44, CTC 47

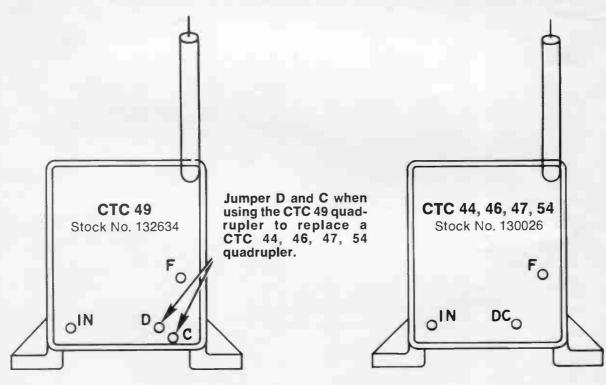
The CTC 49 quadrupler (Stock No. 132634, Drawing No. 1463641-2) can be used as a direct replacement for the CTC 44, 46, 47, 54 quadrupler (Stock No. 130026, Drawing No. 1463641-1) by jumpering quadrupler terminals "D" and "C" together and using that point for the "DC" connection. Stock No. 130026 cannot be used in the CTC 49 chassis.

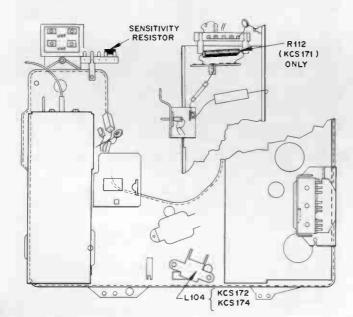
(a) KCS 171, KCS 172, and KCS 174

Step-6 Temporarily connect a short across the component in **Table-2**, and shown in Figure-2(a or b).

Chassis	Short Across	Figure
KCS 171	R112	(a)
KCS 172	L104	(a)
KCS 174	L104	(a)
KCS 179	R112	(b)
KCS 183	L1 04	(b)

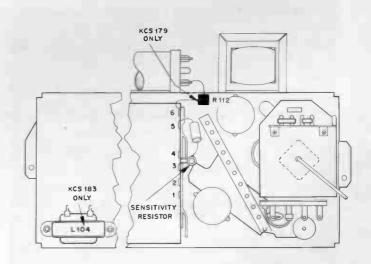
(b) KCS 179 and KCS 183

Figure 2—Disable Circuit Component Locations

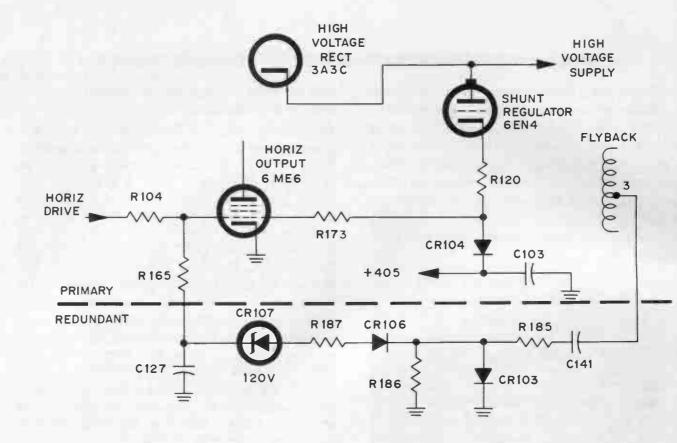
Figure 3—CTC 39 High Voltage Regulator Circuits

In addition to the primary shunt regulator system, the CTC 39 and CTC 50 chassis, after June 1, 1971, have a redundant regulator circuit as shown in Figure-3. This circuit provides grid regulation of the horizontal output in the event of failure of the shunt regulator.

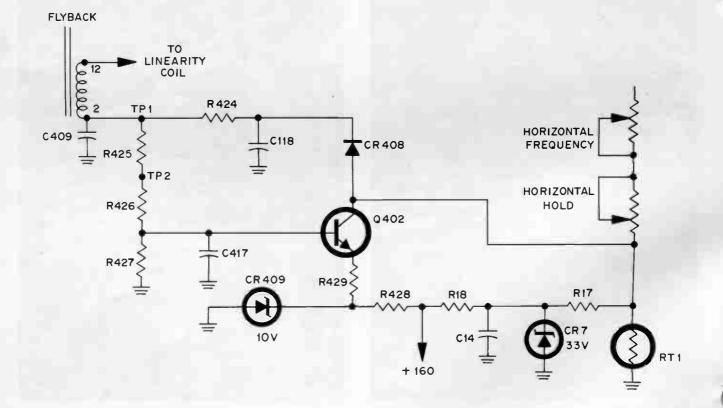
Figure 5—CTC 46 and CTC 54 Oscillator Disable Circuit Schematic Diagram

The CTC 46 and CTC 54 chassis employ the oscillator disable circuit shown in Figure-5. During normal circuit operation, transistor Q402 is non-conducting due to the emitter-base bias provided by zener diode CR 409 and voltage divider resistors R425, R426, and R427. The collector voltage (approximately +32 VDC) is applied to the bottom of **Horizontal-Hold** control during normal operation, supplied by zener diode CR 7 and associated components.

The positive voltage on capacitor C409 is applied to the voltage divider composed of resistors R425, R426, and R427. The voltage across R427 is applied to the base of transistor Q402. It is, under normal circuit conditions (high voltage within specified range), too small to overcome emitter bias provided by CR 409. Therefore, there will be no conduction of transistor Q402, the **Horizontal-Hold** control will have its normal operating potential (DC level), and the picture will remain in synchronization.

Failure of the high-voltage regulator lets more energy be supplied to the flyback, increasing the positive charge on capacitor C409. This action drives the base voltage of Q402 more positive, turning the transistor "on", reducing collector voltage significantly. The new collector voltage **now** applied to the bottom of the **Horizontal-Hold** control (approximately 10 VDC), shifts the horizontal oscillator frequency well beyond the range of the hold control—causing a loss of sync.

- (b) If less than +9V is measured at collector, replace zener diode CR 409 (RCA Stock No. 130044), and Q402.
- (c) If a negative voltage is measured at the collector of Q402, replace CR 401 (trace diode).

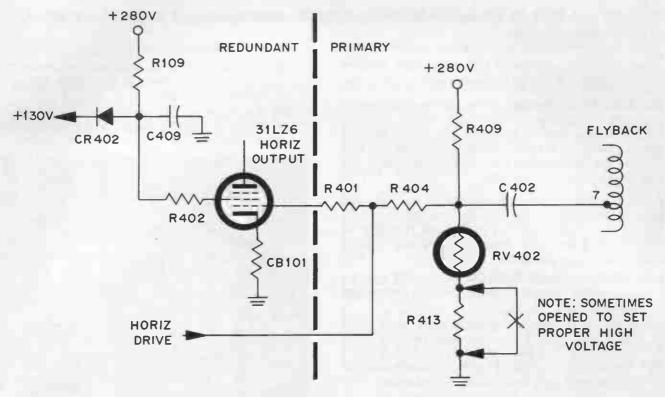
Figure 7-CTC 51 High Voltage Regulator Circuits

The high voltage regulator circuits employed in the CTC 51 are shown in Figure-7. This chassis uses a redundant regulator system that will automatically assume control of the high voltage if any failure occurs in the primary pulse-regulator circuit.

The primary regulator system in these chassis (right side of schematic) is the familiar pulse-regulator system used in many RCA color chassis. The circuit functions to control the grid bias of the horizontal output tube.

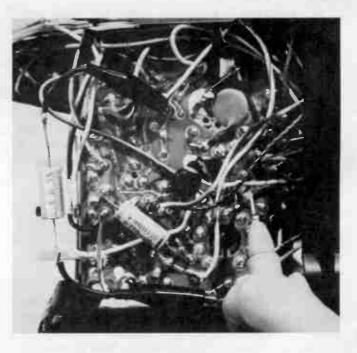
Figure 8—CTC 51, 52, 53, and 55 (PW 400 Board)

Step-2 Turn the receiver "off" and temporarily connect a 6.8K, 5%, 5 W resistor from PW 400-F to ground—test points shown in Figure-8.
