Techni-talk

COMPLETE ELECTRONIC SERVICING INFORMATION
radio • tv • hi-fi

Vol. 15, No. 3

Fall, 1963

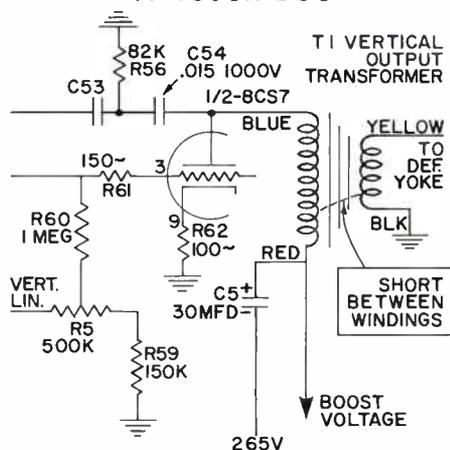
TV TOUGH DOG

We had a Westinghouse model H-P3312 portable come into the shop with a vertical collapse which turned out to be a "tough dog." Generally most vertical troubles are quite easy to find although this case took more time than usual. The voltage on pin 3 of the control grid was only a -1.5 volts and this voltage changed and was intermittent. The correct voltage should be about a -2.5 volts. The plate of the vert oscillator was +15 volts and a low grid voltage of -9 volts.

Generally a person would think that the vertical tube was not oscillating properly but, the boost voltage was down to 250 volts and should be about 520 volts. The white vertical line did not fill out the screen horizontally. After the transformer was on about fifteen minutes the transformer became warm. The transformer resistance checked good or real close to the schematic diagram resistances. Little voltage was measured across the cathode resistor.

The blue lead was cut from the plate of the 8CS7 and the voltage was only about 15 volts. The voltmeter reading of 100 ohms showed practically a short between windings. Since the secondary of the transformer was connected to ground an internal short between primary and secondary caused the defect. The vertical transformer was replaced and the TV returned to normal.
