# PHILCO TV

## SCHEMATIC DIAGRAMS

MODEL 48-700 THRU 53T2750

# 1947-1953

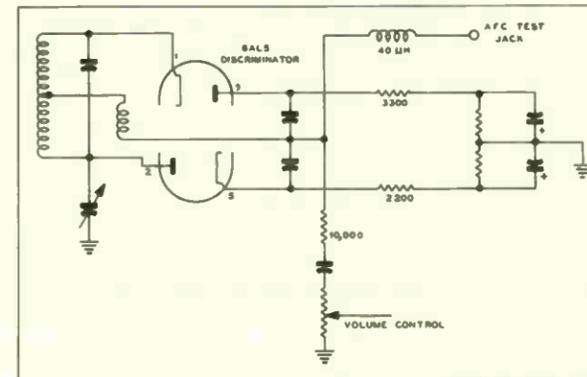
Figure 14. Revised Discriminator Schematic

Beat patterns may appear in the picture when operating on Channel 7; less frequently on Channels 4 and 11. This condition may be corrected by adding compensating and filter resistors to the FM discriminator circuit, as shown in the revised schematic, figure 14, and the layout drawing, figure 15.

It is recommended that the following changes be made when the chassis are serviced, or when Channels 4, 7, or 11 are adjusted for reception.

2. Install a wiring panel, Part No. 12W45661, at the location indicated by TB4 in figure 15. Note how the terminals are numbered, and make sure that the number 3 terminal is used as the mounting foot.
3. Connect the 27,000-ohm resistor R215 between terminals 2 and 4 of TB4, as shown in figure 15.
4. Connect the 27,000-ohm resistor R216 between terminals 1 and 4 of TB4.
5. Connect a bare wire jumper between terminals 3 and 4 of TB4.
6. Connect the 10-mf. condenser C218 between terminals 2 and 4 of TB4 (positive lead to terminal 2).
7. Connect the 10-mf. condenser C219 between terminals 1 and 4 of TB4 (positive lead to terminal 4).
8. Connect a 40-microhenry choke, Part No. 32-4143-1, between terminals 1 and 3 of TB3. (If terminal 3 is already in use, connect to any nearby vacant terminal.)

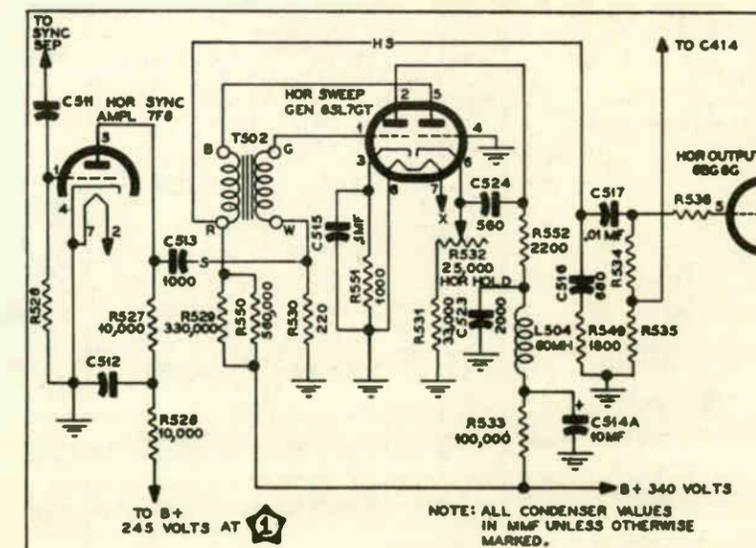
Figure 12. Horizontal-Sweep Changes

A vertical black line, which usually shows up with no signal or a weak signal, may be caused by oscillation in the 6BG6G horizontal output stage.

duits, which increased the horizontal sync stability. The procedure for modifying these circuits in the early runs is given below. Figure 12 shows the modified circuits. The following parts are needed:

19	5-mmf. condenser (C223) added at pin 2 of 2nd a-i-f tube.	18. 27	Run 6 and 7	32-1224-5		To improve a-i-f stability.
20	T503 changed.	19. 27	Run 6 and 7	32-8331	32-8305	To reduce high-voltage breakdown.
21	R528 rewired as in figure 12.	19. 26. 27	Run 6 and 7	No change		To improve horizontal-sync stability.
22	R529 changed to 330,000 ohms.	19. 26. 27	Run 6 and 7	66-4333340*	66-4103340*	To improve horizontal-sync stability.
23	R530 changed to 220 ohms.	19. 26. 27	Run 6 and 7	66-1223340*	66-2223340*	To improve horizontal-sync stability.
24	R531 changed to 33,000 ohms and rewired as in figure 12.	19. 26. 27	Run 6 and 7	66-3333340*	66-4563340*	To improve horizontal-sync stability.
25	R532 changed to 25,000 pot. and rewired as in figure 12.	19. 26. 27	Run 6 and 7	33-5539-28	33-5539-13	To improve horizontal-sync stability.
26	R533 changed to 100,000 ohms and rewired as in figure 12.	19. 26. 27	Run 6 and 7	66-4103340*	66-4393340*	To improve horizontal-sync stability.

ITEM NO.	DESCRIPTION OF CHANGE	FIGURES OF PR-1103 AFFECTED	CHANGE EFFECTIVE	NEW OR ADDED PART NO.	OLD OR REMOVED PART NO.	REASON
28	R550, 560,000 ohms, added as in figure 12.	19. 26. 27	Run 6 and 7	66-4563340*		To improve horizontal-sync stability.
29	R551, 1000 ohms, added as in figure 12.	19. 26. 27	Run 6 and 7	66-2103340*		To improve horizontal-sync stability.
30	R552, 2200 ohms, added as in figure 12.	19. 26. 27	Run 6 and 7	66-2223340*		To improve horizontal-sync stability.
31	C514A rewired as in figure 12.	19. 26. 27	Run 6 and 7	No change		To improve horizontal-sync stability.
32	C515 changed to .1 mf. and rewired as in figure 12.	19. 26. 27	Run 6 and 7	61-0113*	60-10825401*	To improve horizontal-sync stability.
33	C516 changed to 680 mmf. and rewired as in figure 12.	19. 26. 27	Run 6 and 7	60-10685401*	60-10825401*	To improve horizontal-sync stability.
34	C517 rewired as in figure 12.	19. 26. 27	Run 6 and 7	No change		To improve horizontal-sync stability.

35	C523, 2000 mmf., added as in figure 12.	19. 26. 27	Run 6 and 7	60-20205304*		To improve horizontal-sync stability.
36	C524, 560 mmf., added as in figure 12.	19. 26. 27	Run 6 and 7	60-10565314*		To improve horizontal-sync stability.
37	L504, 60 mh., added as in figure 12.	19. 26. 27	Run 6 and 7	32-4256		To improve horizontal-sync stability.
38	Wiring panel, four-point added on bottom of chassis, parallel to sides of chassis, between vertical output (6K6GT) socket and C506.	19. 26. 27	Run 6 and 7	12W45661		To improve horizontal-sync stability.
39	R505 changed to 47,000 ohms.	19. 26. 27	Run 6 and 7	66-3473340*	66-4473340*	To improve horizontal-sync stability.

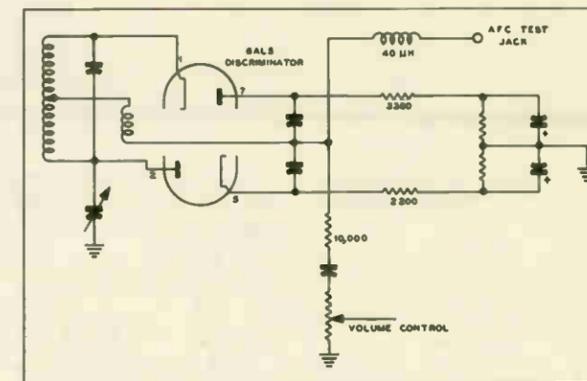
Figure 13. Revised Discriminator Schematic

Beat patterns may appear in the picture when operating on Channel 7; less frequently on Channels 4 and 11. This condition may be corrected by adding compensating and filter resistors to the FM discriminator

It is recommended that the following changes be made when the chassis are serviced, or when Channels 4, 7, or 11 are adjusted for reception.

- Remove the following parts carefully, as they are to be reinstalled.
  - C218, connected between pin 5 of the discriminator tube (6AL5) and ground.
  - C219, connected between pin 7 of the discriminator and ground.
  - R215, connected between pin 5 of the discriminator and ground.
  - R216, connected between pin 7 of the discriminator and terminal 3 of terminal board TB6.
  - Length of wire, connected between terminal 1 of terminal board TB3 and socket J200.

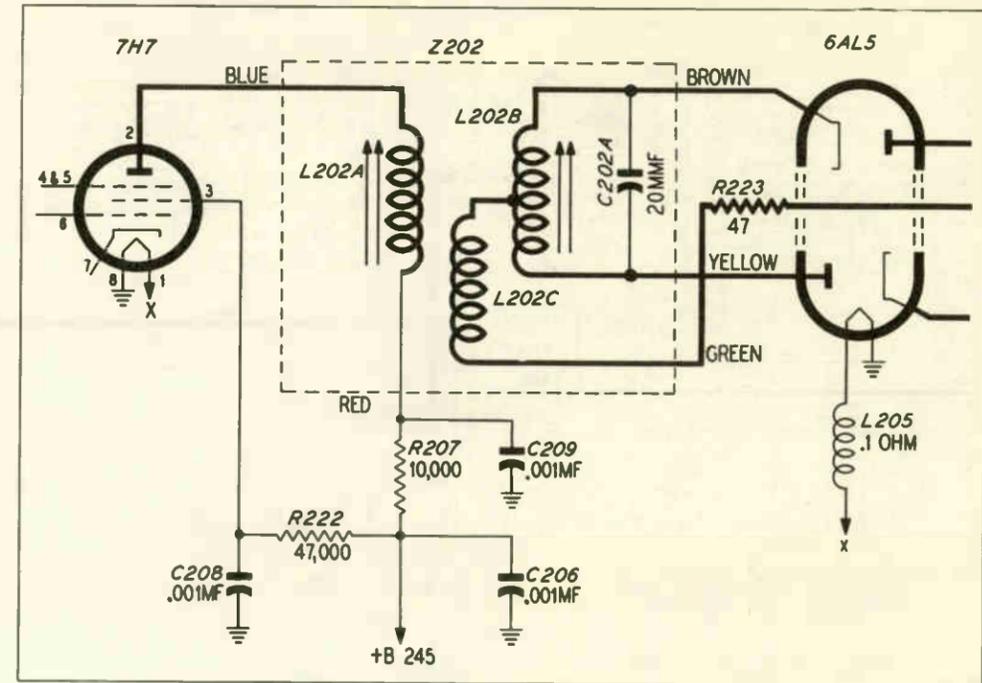
Figure 3. New Discriminator Transformer and Associated Circuit

Z202, discriminator transformer, Part No. 32-4214, was replaced by Part No. 32-4214-3, to reduce frequency drift.

1. Z202 was replaced by a new discriminator transformer, Part No. 32-4317.

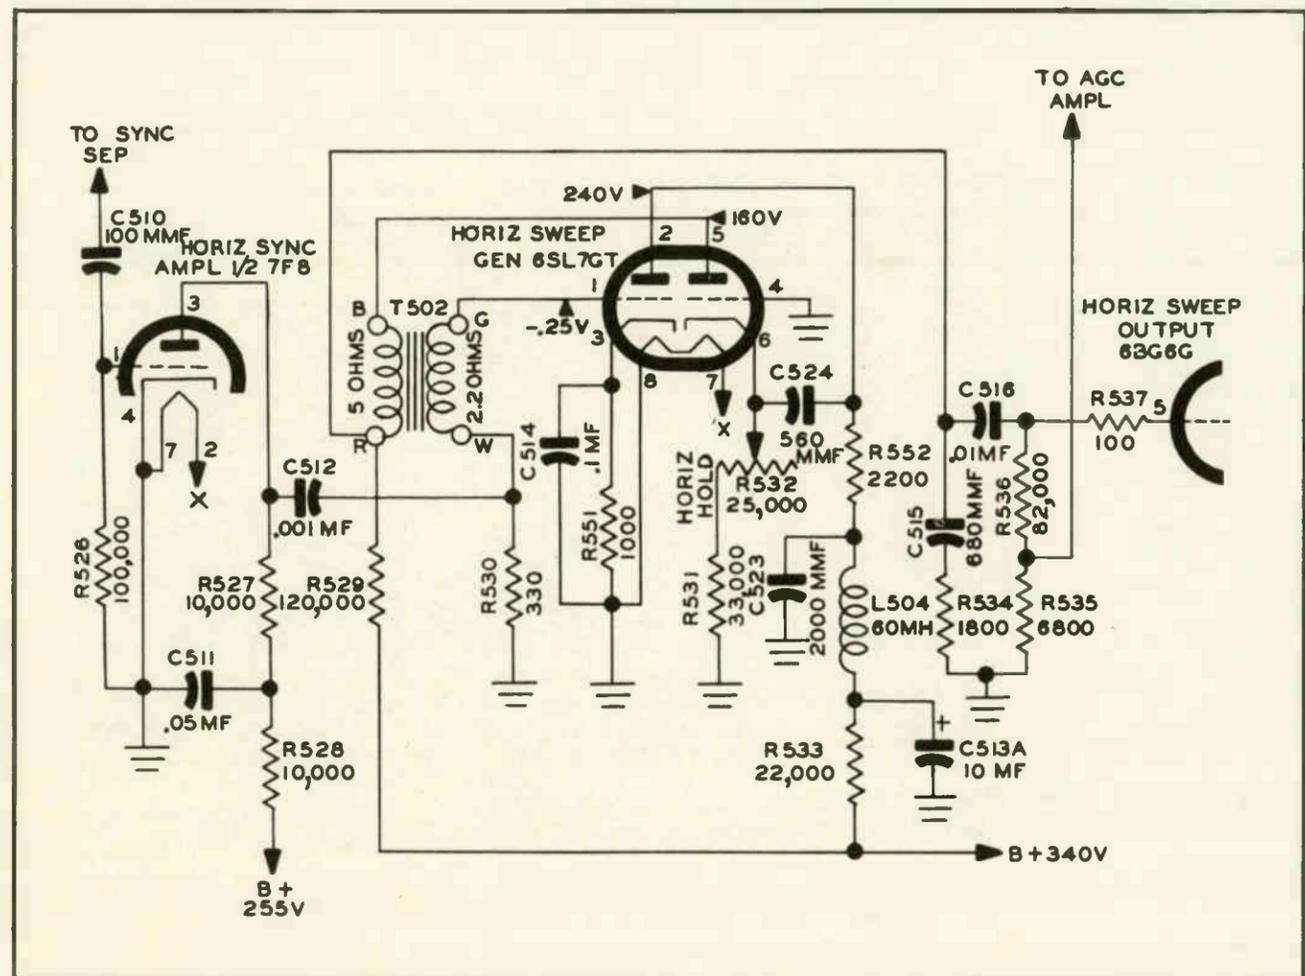
Figure 22. Changes in Horizontal-Sweep-Generator Circuit, Code 121, Run 3

Changes in the horizontal-sweep-generator circuit (to improve sync stability) were incorporated into this run, together with several other changes, as follows:

2. R530, 2200 ohms, Part No. 66-2223340\*, was changed to 330 ohms, Part No. 66-1333340\*.

3. R531, 560,000 ohms, Part No. 66-4564340\*, was changed to 33,000 ohms, Part No. 66-3333340\*, and connected as shown in figure 22.

4. R532, 250,000 ohms, Part No. 33-5539-13, was changed to 25,000 ohms, Part No. 33-5539-28, and connected as shown in figure 22.
5. R533, 220,000 ohms, Part No. 66-4224340\*, was changed to 22,000 ohms, Part No. 66-3223340\*, and connected as shown in figure 22.
