TELEVISION TECHNOTES

MARTIN CLIFFORD

Gernsback Library No. 46

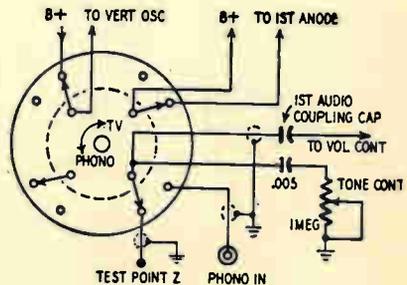
Adding phono to Admiral TV. A 3-pole double-throw switch must be in-

Fig. 5. Adding phono to Admiral TV.

stalled. One section transfers the input of the a.f. amplifier from the low-impedance ratio detector to the high-impedance phonograph pickup. The second section disables the vertical os-

cillator to prevent its radiations from entering the audio circuits when the first a.f. amplifier operates with a high-impedance input. The third section of the change-over switch breaks the B-plus lead to the first anode and prevents a bright horizontal line from appearing on the screen of the picture tube and possibly burning it.

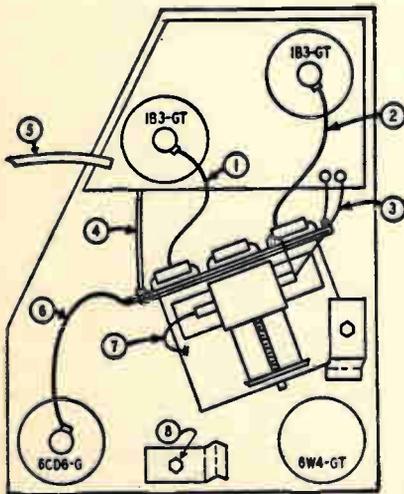
the caps of the tubes from touching any part of the metal compartment or any other parts. Failure to observe this precaution may cause arcing and burning. Although the sketch shows a VL-16 chassis, the information applies to all similar power supplies. Wires 1, 2, 5, 6, and 7 should be kept in free space. Except where properly connected, do not let them rest on other parts or side of compartment. Whenever parts are replaced, make all wires as short and direct as possible without putting a strain on the parts. Do not pull filament wires 3 and 4 too tightly. Do not turn the slug of the width coil (8) too far out, as this will give a lowered impedance, possibly causing the coil to overheat or burn. Be sure to round off soldering connections on any work done.

Fig. 9. Physical layout of parts and critical wiring in the high-voltage cage.

chassis or when a tube has to be removed from this section, be extremely careful to prevent connecting wires to

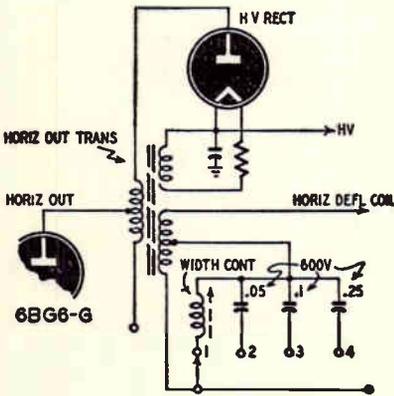
Variable width control. This scheme can be used to increase the width of a

Fig. 57. Technique for variable width.

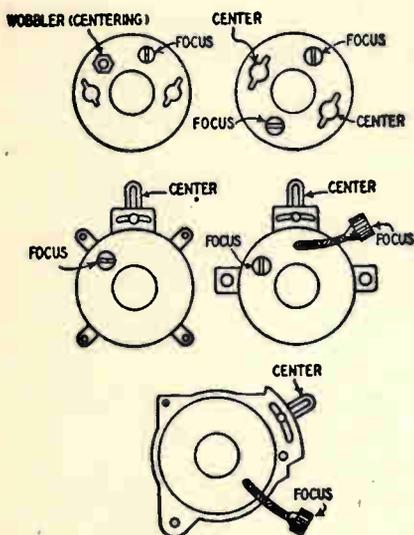
Fig. 58. PM and EM-PM focus assemblies.

metal tool may cause the unit to lose its magnetism and affect its ability to properly focus the electron beam on the screen of the picture tube.
