RADIO SERVICE TRADE KINKS

LEWIS S. SIMON, R.E.

*Manager, Rexall Radio Stores,
Brooklyn, New York*

1939

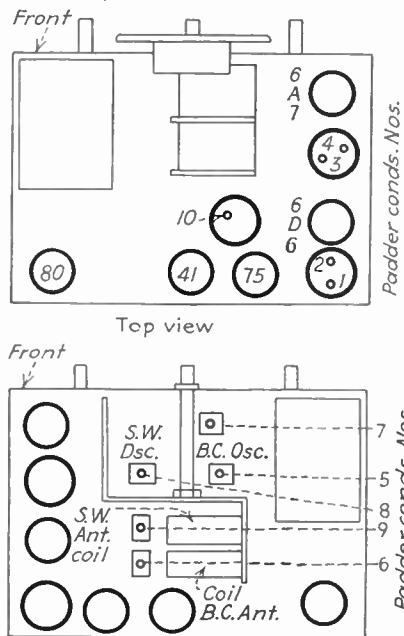
FIG. 1.

Alignment. Set test oscillator to 456 kc. Connect to 6A7 grid cap. Adjust trimmers 1, 2, 3, 4 in the order named.

For the remainder of the adjustments the test oscillator is connected to the antenna and ground wires of the receiver.

Trimmer	Test osc. frequency	Set radio dial to	Set wave switch to
5	1,500 kc.	150	Broadcast 0.55 to 1.75
7	600 kc.	0.60	Broadcast 0.55 to 1.75
8*	15 mc.	15.0	Short wave 18 to 5.5 mc.
9	15 mc.		Short wave 18 to 5.5 mc.
10†	456 kc.	1.0	Broadcast

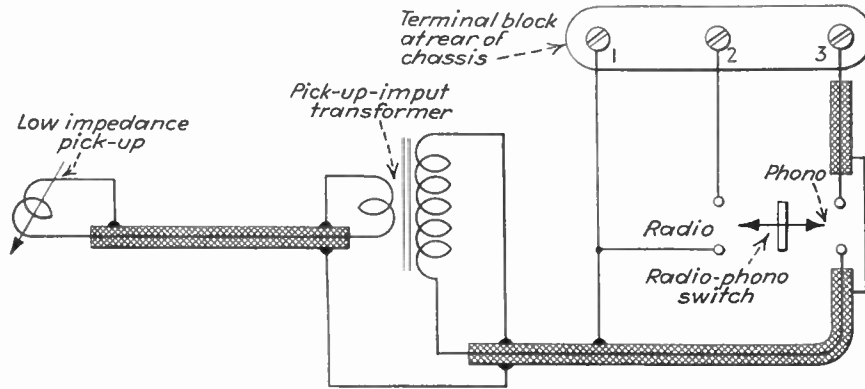
FIG. 2.

Phonograph Models. Certain Atwater Kent models have three terminals at the

R-93, which has a switch connected, as shown in Fig. 2. However, a double-pole double-throw switch can be secured for this purpose when one is not provided

with the phonograph attachment. In using this switch, the two center contacts must be connected together.

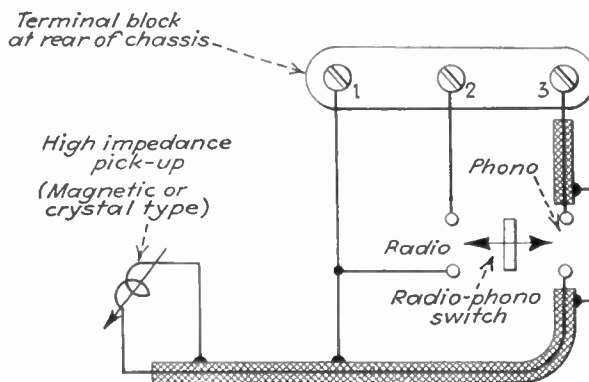
FIG. 4.

If the turntable is to be placed near the receiver, it is advisable to use a high-impedance pickup, but the type mentioned in the previous paragraph will also be satisfactory. Connections for a high-impedance pickup are given in Fig. 4. All leads should be as short as conveniently possible.

When connecting the phonograph, be sure to remove the short jumper wire between contacts 1 and 2 on the terminal strip. This is attached at the factory and is required only in case the radio is

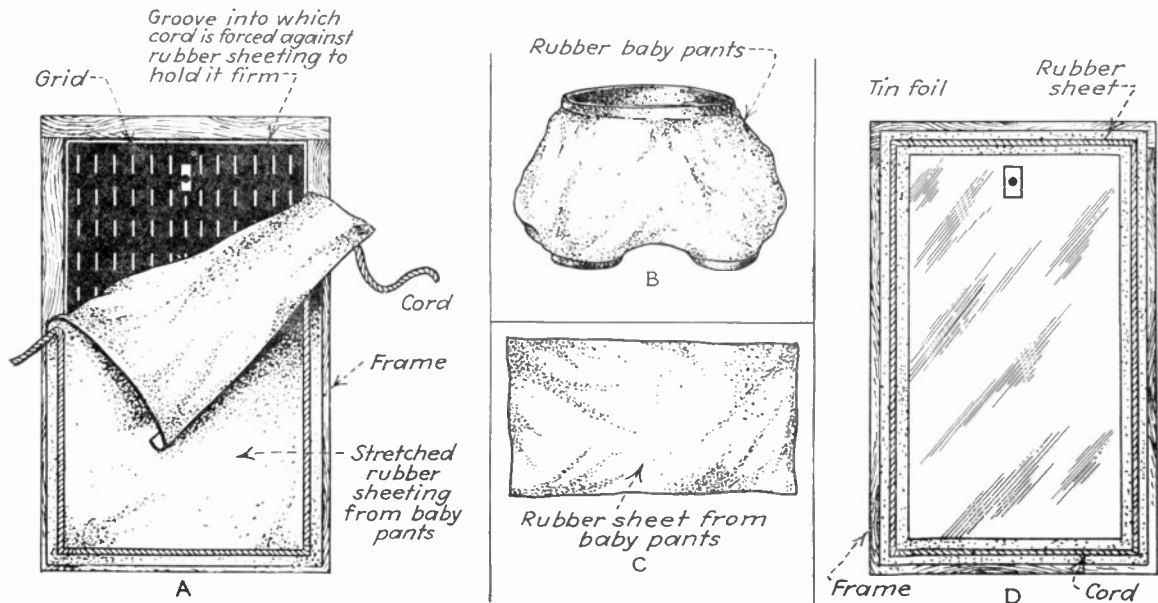
FIG. 6.

Next, procure six rubber baby pants similar to those in Fig. 6B and cut them the size of units, as in Fig. 6C. Then place the rubber sheets on the frames and use the cord to fasten them to the frame, as in Fig. 6D, stretching it at the same time. Make sure that the rubber is stretched evenly all around. If this caution is not heeded, the speaker will rattle considerably.

After the cement dries, the foil will stick like an inner-tube patch, Fig. 6A; it can be smoothed out with the palm of the hand. You are now ready to connect the speaker and make a test. If the volume of the set is too great and the heavy notes produce too much volume, it can be remedied by placing a 1- to 2-megohm resistor across the speaker terminals. This will prevent the speaker from a repeated disaster.

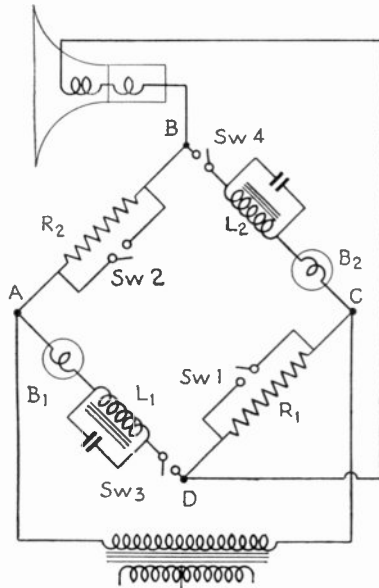
FIG. 8.

When the auto expressionator is not desired, SW_1 and SW_2 are closed and SW_3 and SW_4 are opened. Should any of the parts in the circuit become defective, the set can be operated with the expressionator in the "off" position. The switches are ganged together (see Fig. 8).

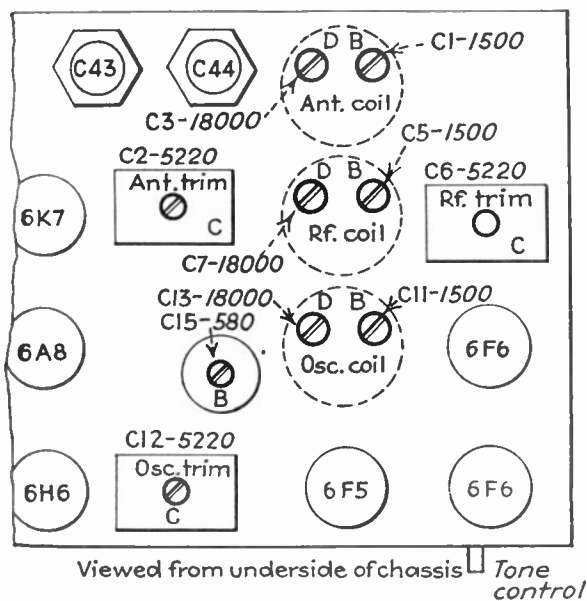
FIG. 11.

Accompanying chassis layout of General Electric's A83 and A85 models shows location of antenna, r.f., and oscillator trimmers. Letters refer to band, condenser numbers refer to trimmers shown in schematic in Fig. 11, and the frequencies shown are those at which trimmers should be aligned.

General Electric recommends alignment in the following order: 465 kc., intermediate frequency—band B, 1,500 kc., (C_{11} , C_5 , C_1); 580 kc., (C_{15})—band C, 5,220 kc., (C_{12} , C_6 , C_2)—band D, 18,000 (C_{13} , C_7 , C_3).

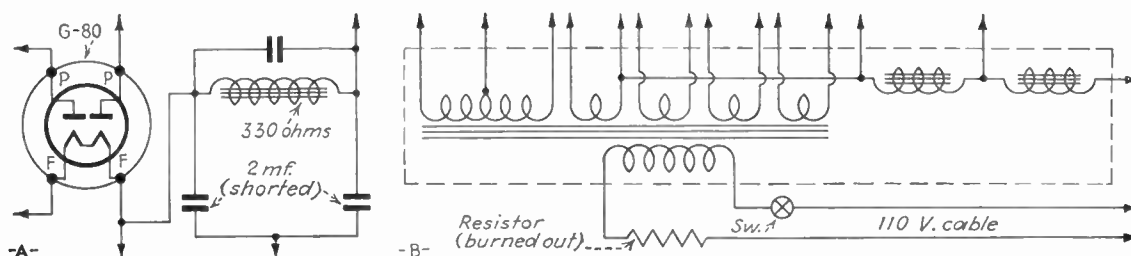
FIG. 13.

the small orange wire leads into the filter pack and connects to a 2-mf. filter condenser (see Fig. 13). This condenser was shorted, causing the 80 filament to burn out. The lead to the condenser should be cut and taped, and a 2-mf., 600-volt condenser mounted on the outside of the can.

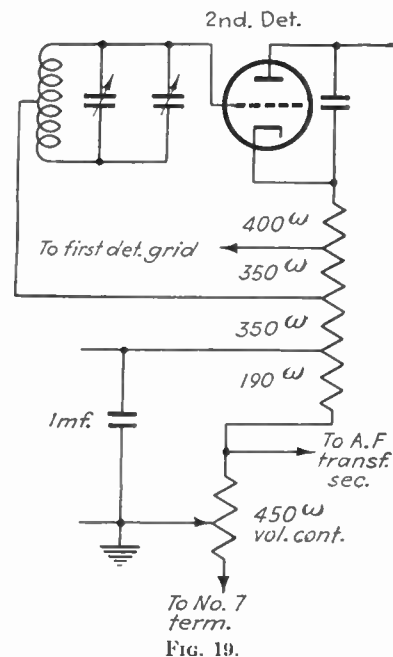
The values of the tapped resistor strip and the volume control of the Radiola 62 were omitted from the manufacturer's schematic. These values are shown in the accompanying illustration. The part No. of the tapped resistor is 5810 and that of the volume control is 5811.

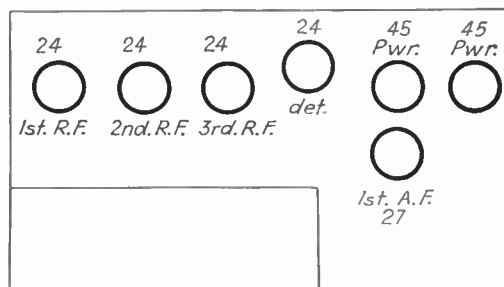
FIG. 26.

The accompanying illustration shows the tube-socket layout of the chassis employed in these a.c. receivers. The schematic will be found on the following pages in Rider's *Manuals*: "Zenith,"
