ACTUAL TROUBLES IN COMMERCIAL RADIO RECEIVERS

1927 — 1934

BERTRAM M. FREED

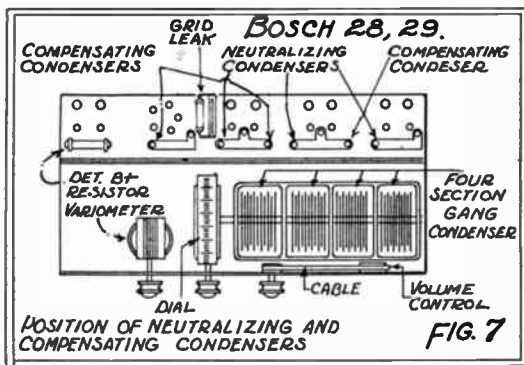
When new tubes or ones with slightly different characteristics are installed in these receivers, it sometimes becomes necessary that the R.F. stages be reneutralized.

Shifting of the condenser gang compensating condensers after the set has been in service over a period of time, may necessitate readjustment. Both the neutralizing and com-

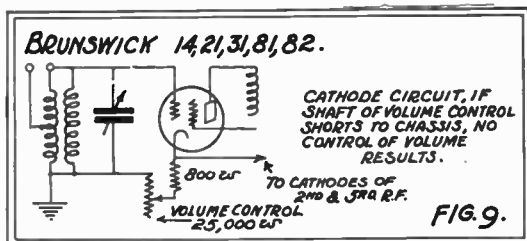
If it is found that the volume level can not be varied and the receiver operates at full volume, the probability

of the volume control shaft being shorted to the chassis is strong. This shaft should be insulated from the

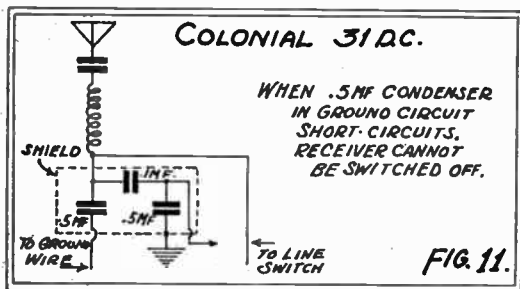
Colonial 31 D.C.

The condition may be encountered where the receiver cannot be switched off with the line switch until the ground wire is disconnected from the ground binding post. The cause for this situation lies with a short circuited .5 mf. condenser in the ground circuit. This condenser is one of three contained in a common block and connected as shown in Figure 11. Although it is good procedure to replace the entire block, a good .5 mf. condenser may be connected in series with the ground post lead, in the event a replacement block cannot be secured easily.

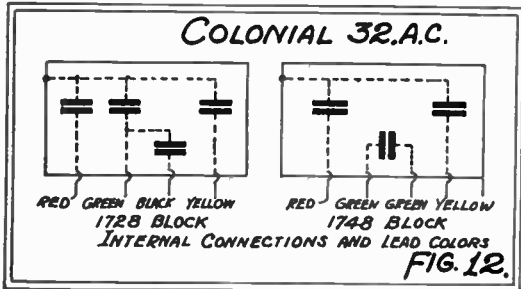
Should the condition of fading still exist after these two condensers have been replaced, or checked and found correct, the most probable and usual cause is open-circuited or leaky sections of the bypass condenser blocks in the 1st, 2nd and 3rd R.F., and detector stages. The blocks in the 2nd and 3rd R.F. stages are each composed of four condensers, bypassing the plate circuit, the cathode circuit, one side of the filament to chassis and the fourth condenser bypassing the screen circuit, connecting from screen to cathode, the latter connection made within the block. The condensers of the block in the 1st R.F. also bypass the cathode, filament and screen circuits in like manner, but

the first condenser bypasses the 750,000 ohm red carbon resistor in the secondary return circuit instead of the plate circuit, as in the case with the blocks in 2nd and 3rd R.F.

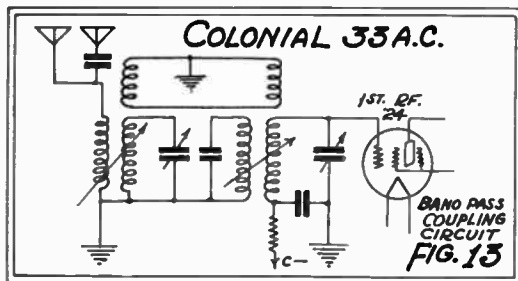
The complaint of weak reception with all voltages and tubes correct, has several times been traced to an open

band-selector coupling coil. Two such coils are used to couple the two portions of the band selector, and as these coils are not part of the electrical circuit of the receiver.

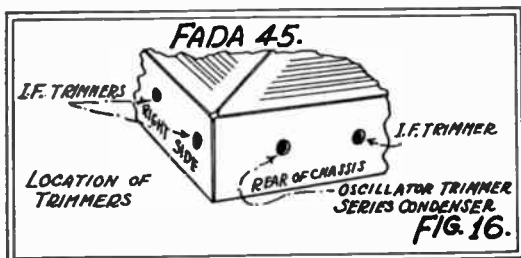
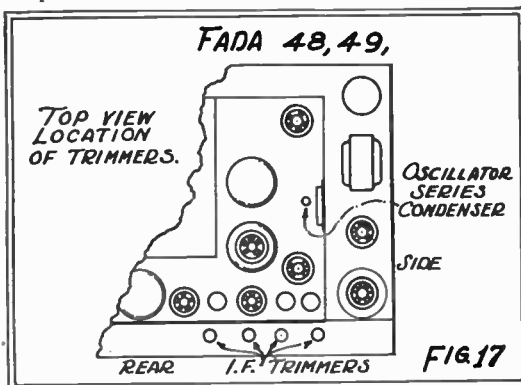
Alignment of these receivers is often confusing because of the different location or position of the alignment condensers. The I.F. trimmers in the model 45 are located in the rear right-hand corner of the chassis as shown in Figure 16. Due to the fact that the primary of the second intermediate transformer is not tuned, there are only three condensers to be adjusted at the intermediate frequency the fourth trimmer being the oscillator series condenser, which is aligned at 600 K.C. The model 48 and 49 receivers have four I.F. compensating condensers lo-

cated at the rear of the chassis as shown in Figure 17. The oscillator series condenser, which is adjusted at 600

K.C. while "rocking" the tuning gang is accessible from the top of the chassis and is located to the right of the

second detector socket. The tuning gang is aligned by adjustment of the compensators on top of each section.

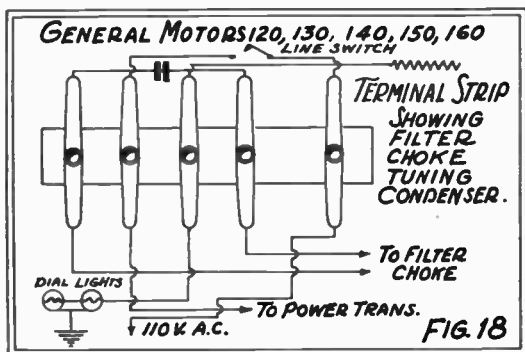
The condition of an abnormal hum has often been found caused by a short-circuited .1 mf. "tuning" con-

denser connected across the filter choke. This condenser is connected across two lugs on the A.C. terminal strip and located beneath the strip as shown in Figure 18.

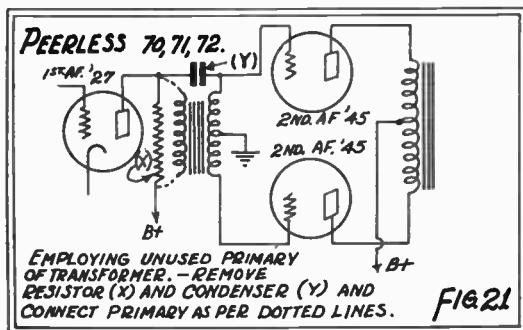
Where an open-circuited or shorted .06 mf. condenser, coupling the first audio stage to the output tubes, is found, the unused primary of the audio transformer whose secondary only is employed, may be utilized. The coupling condenser should be removed and the primary, not shown in the schematic of this receiver, connected in place of the 20,000 ohm carbon plate resistor as shown in Figure 21. This procedure will result in greater volume and slightly lower hum level.

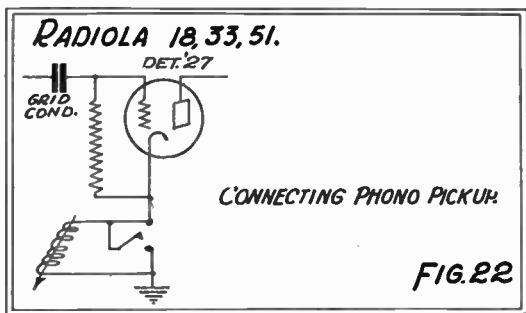
Connecting a phono pickup to these receivers often presents a number of difficulties. If a high impedance pickup is connected from the grid to cathode of the detector tube, the long leads will cause unstable operation and an audio howl. In order to obtain the added ampli-

fication of the detector tube and resulting greater volume, the pickup should be inserted in the cathode circuit of the detector tube as shown in Figure 22.

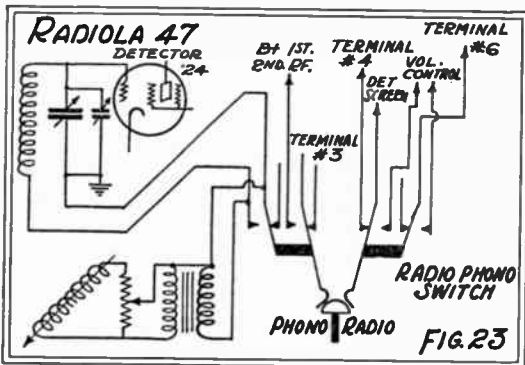
model 47. The condition of intermittent reception on this model, however, with the symptoms of no screen or plate voltages obtained on the R.F. tubes has been traced

to badly corroded contacts of the radio-phonograph transfer switch. These contacts may be easily cleaned by the insertion of a small strip of fine sandpaper or a small magnetite file, after the switch has been removed. The connections to the switch are shown in Figure 23.

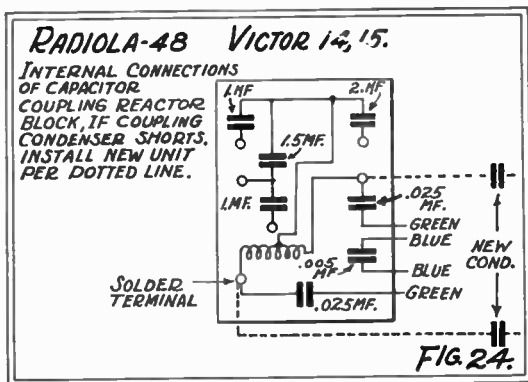
The symptoms of muffled, distorted reproduction, and hum which will clear up when one of the 45 tubes is removed, has invariably been traced to a shorted .025 mf. condenser coupling the detector tube to the power amplifiers. This condition will be made evident by the high plate current and positive grid bias reading obtained on the 45 in whose grid circuit the shorted condenser is connected. Although these condensers are located in the capacitor and coupling reactor block, it is not necessary to replace the entire unit when one of these condensers short-circuits. A new condenser may be installed in series with

the green lead connecting to the grid of the 45, or the green lead may be disconnected and the new unit installed

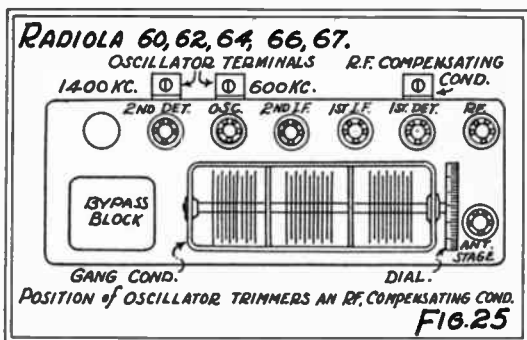
Poor sensitivity at either the high or low frequencies may be due to the oscillator trimmers being out of adjustment. These trimmers are located to the right of the chassis (facing the rear) as shown in Figure 25. The trimmer on the right should be adjusted for maximum response with the receiver tuned to a 1400 K.C. signal generated by an oscillator. The left trimmer is properly adjusted for maximum response with the receiver tuned to a 600 K.C. signal. An insensitive condition may also be caused by the poor adjustment of the R.F. compensator condenser, located at the extreme left as shown in Figure 25, which should be adjusted in the following manner. Tighten the adjusting screw clockwise until the tuning of any station will produce a whistle or oscillation. With the receiver tuned to some station at approximately 1000

K.C. turn the adjusting screw back beyond the point of oscillation. Now tune the set at different points on the dial to observe the presence of oscillation. If this is found, turn the compensating condenser screw back slightly.

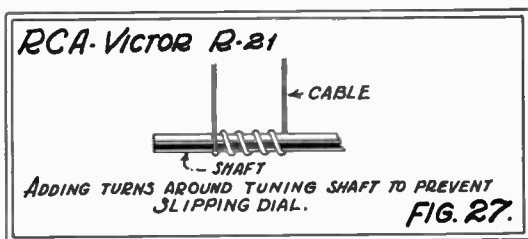
A slipping tuning dial on the Model 21 may be repaired by taking another turn or two around the tuning shaft with the drive cable as shown in Figure 27. To accomplish this, the tension spring must be released so that the turn may be made with the loose cable. When the dial is removed to gain access to the tension spring, its position should be carefully noted so that it may be re-installed without disturbing the dial settings.

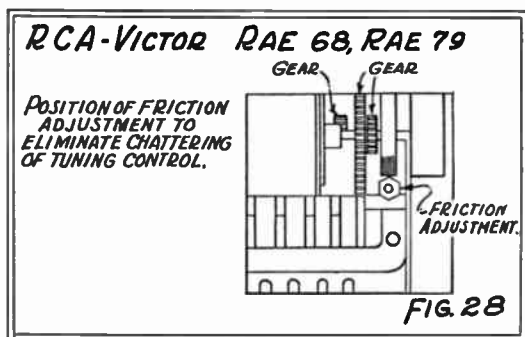
Chattering of the tuning control when one of the sta-

tion selector buttons is pressed, may be eliminated by adjustment of the friction screw whose location is shown in Figure 28. It should not be adjusted too loosely.

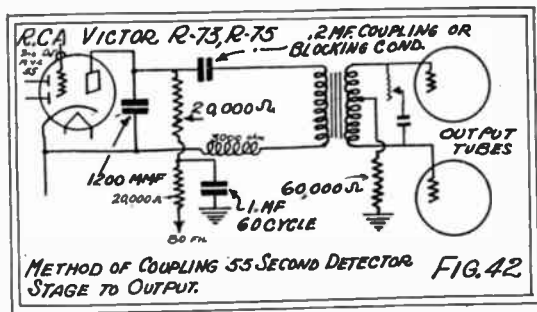
The symptoms of distorted reproduction with an indi-

cation of excessive plate current drawn by the power output tubes as disclosed by a set analyzer, have been traced, in several cases, to an open-circuited 60,000 ohm resistor in the push-pull input secondary return circuit. This unit is also located under the resistor terminal strip.

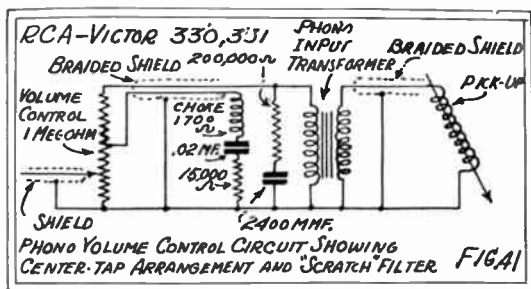
A common complaint with this model is poor control of record volume. A sharp drop in volume is usually obtained when the phono volume control is turned to the middle of its range. This trouble may be remedied by disconnecting the lead to the center-tap on the volume control resistance element. This center-tap on the volume control is employed in conjunction with a choke-condenser-resistor combination as shown in Figure 41, to reduce the high frequency response so as to reduce "needle

scratch." In all cases, however, where the center-tap has been disconnected, the increase in "needle scratch" has been negligible, not interfering with the quality of record reproduction. In the event such condition results, the tone control of the receiver may be used to lower the high frequency response.

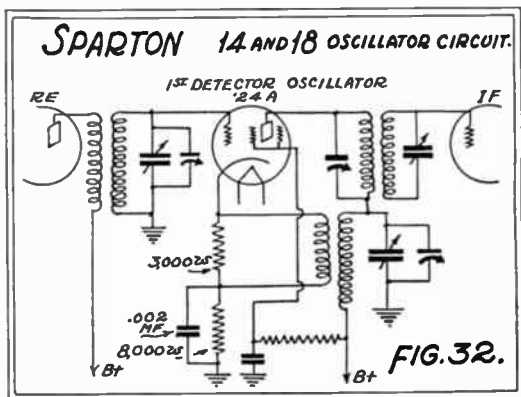
Sparton 18

The complaint of intermittent reception, where volume will decrease abruptly to a lower level, has invariably been traced to shorting components mounted upon the terminal strip located under the A.V.C. tube socket. In most

cases however, the trouble will be found to lie with unsoldered or poorly soldered connections to the wire-wound resistors on this strip.

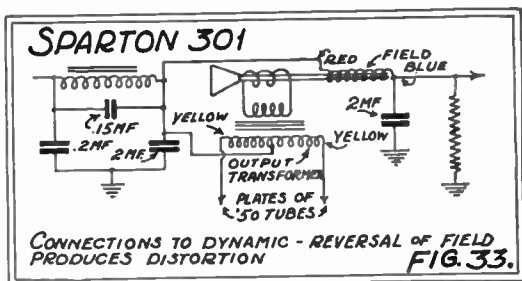
Sparton 301

The symptoms of low volume and distorted reproduction are sometimes due to reversed connections to the dynamic speaker field coil. This condition will be disclosed with a set analyzer by low plate voltages obtained on the output tubes. Since the center-tap of the output transformer primary is tied to one side of the field coil, as shown in Figure 33, reversal will cause this trouble.

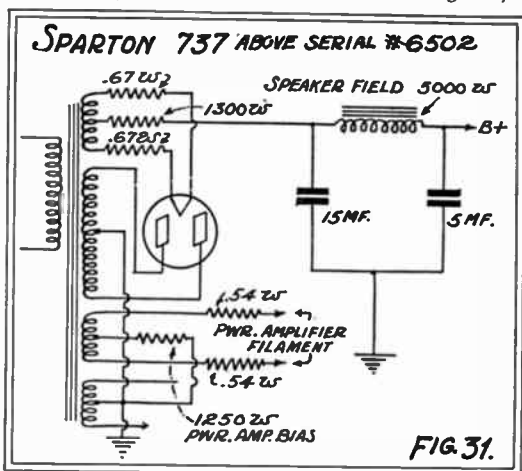
Sparton 737 (Above Serial No. 6502)

An inoperative receiver is often caused by an open 1300 ohm wire-wound resistor located alongside the 80 rectifier socket. This unit serves to reduce the voltage output of the larger power transformer which was originally in-

tended and designed for use in the Model 301 receiver. It is connected as shown in Figure 31.

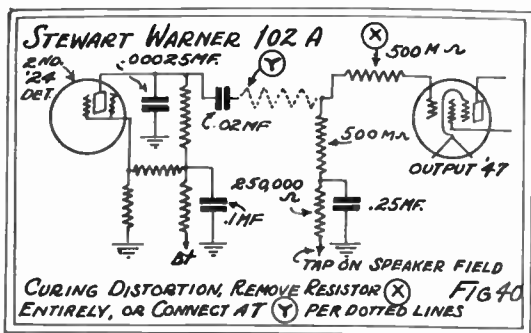
Stewart Warner 102A

The complaint of distorted reproduction, regardless of the volume control setting, may be eliminated as well as materially increasing the volume, by connecting a 500,000 ohm resistor from detector screen to chassis. This data applies to chassis bearing a serial number above 34,000. Where the same complaint is encountered on receivers be-

low this serial number, check for an open-circuited 2 megohm resistor in the screen circuit. Lack of screen voltage on the detector tube will evidence this defect.

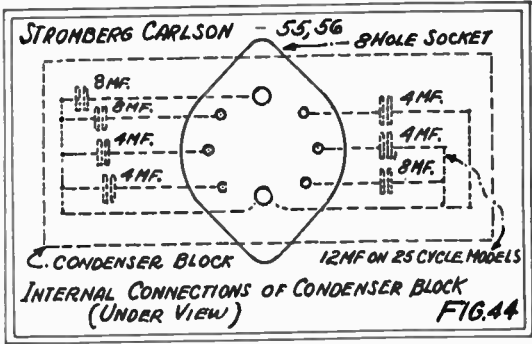
tion has been traced to leakage of and *between* sections of the filter condenser block. This block, whose internal connections are shown in Figure 44, is fastened to the chassis by four screws and is equipped with an 8 prong plug which fits into an 8 hole socket on the chassis. At

times, the leakage will show up only during operation of the receiver, and for this reason is difficult to check with an ordinary ohmmeter of limited range. If a voltmeter is employed in conjunction with a source of high voltage, locating the leaky section is made easier. Another method commonly employed by most service men is that of disconnecting each condenser, in turn, and substituting a unit of similar characteristics. Replacement of the entire block is unnecessary once the path of leakage is found. Those sections causing the trouble may be disconnected from the circuit and new condensers installed beneath the chassis.

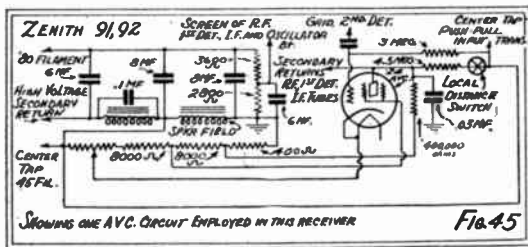
The symptoms of distorted reproduction upon resonance, which can be cleared by detuning slightly, has been traced to the A.V.C. screen-cathode voltage divider resistor changing in value. In some models the screen section of this resistor has a value of 15,000 ohms and the cathode section a value of 3,000 ohms, while in others

the values are 10,000 and 2,500 ohms respectively.

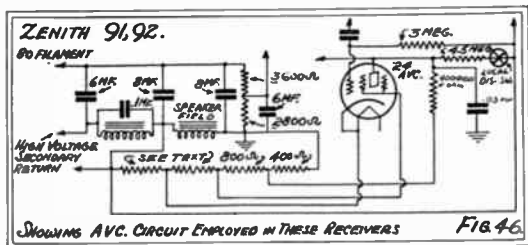
A great many of the troubles associated with these receivers originate in some portion of the A.V.C. circuit and are due to the failure of some component therein. The fact that these models appeared with three different versions of the A.V.C. circuit makes trouble-shooting more difficult and involves procedure. In the first, the volume control was placed in the voltage divider system of the A.V.C. 24 tube which varied the cathode bias on this tube, as shown in Figure 45. A local-distance switch was also employed which shunted a resistor from the plate to the cathode of the A.V.C. tube when the switch was in the local position, thus impressing a constant bias on the R.F. first detector and I.F. stages. This serves to retard the A.V.C. action and reduce inter-station noise. A second revised circuit soon appeared as shown in Figure 46, with the manual volume control in

the grid circuit of the first A.F. stage. A tapped resistor was substituted in place of the volume control in the A.V.C. circuit shown in Fig. 45. This revision permitted the reading of the tuning meter to remain constant regardless of the position of the volume control because the A.V.C. tube operated at full efficiency. A further change was made, wherein the local-distance switch and the $4\frac{1}{2}$ megohm resistor in series with it,

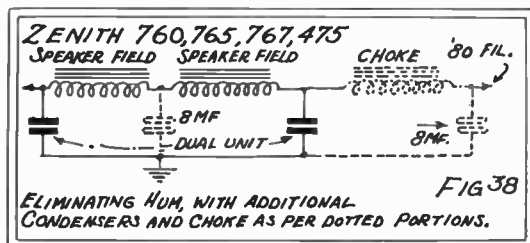
The complaint of hum may be eliminated in most instances by the addition of an 8 mf. electrolytic filter condenser connected after the first speaker field (both speaker fields used as chokes) to chassis, as shown in Figure 38. If this procedure proves ineffectual, then another

filter choke must be provided, as described with the models 715, 755 etc., between the 80 filament and the first speaker field. Further reduction in the hum level may be accomplished by connecting an 8 mf. filter condenser from the filament to chassis.
