# TV and radio TUBE TROUBLES

SOL HELLER

GERNSBACK LIBRARY NO. 68

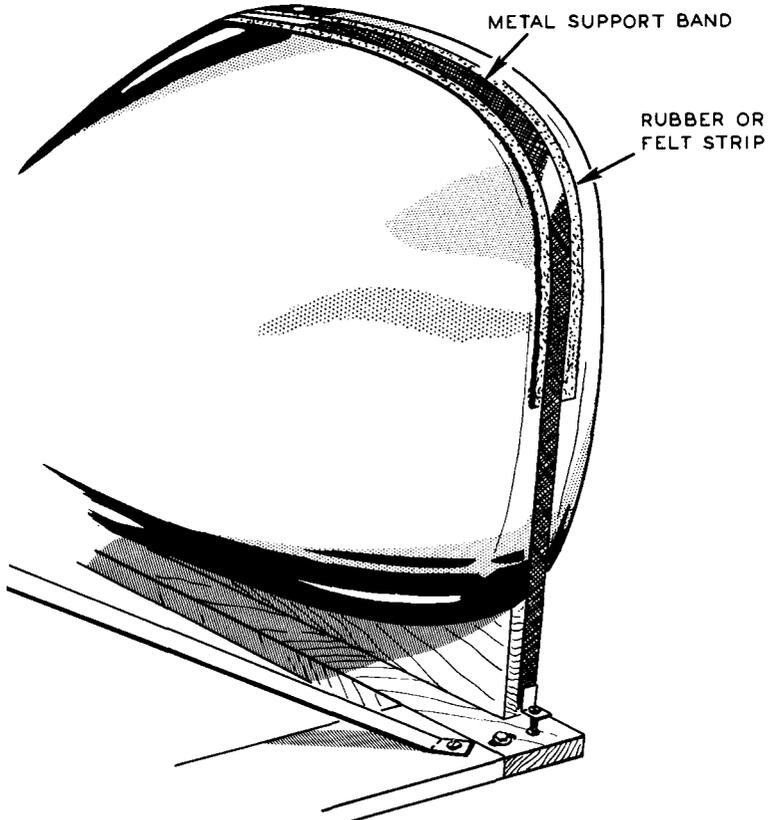
Fig. 101. Position of rubber or felt strip under metal band holding cathode-ray tube in place.

Make sure that protective rubber or felt strips (see Fig. 101) are reinserted between the metal support band and the tube when the support band is replaced after having been disassembled. These protective strips prevent possible breakage of the tube due to excessive tightening of the band. When they are out of position, put them back into place.

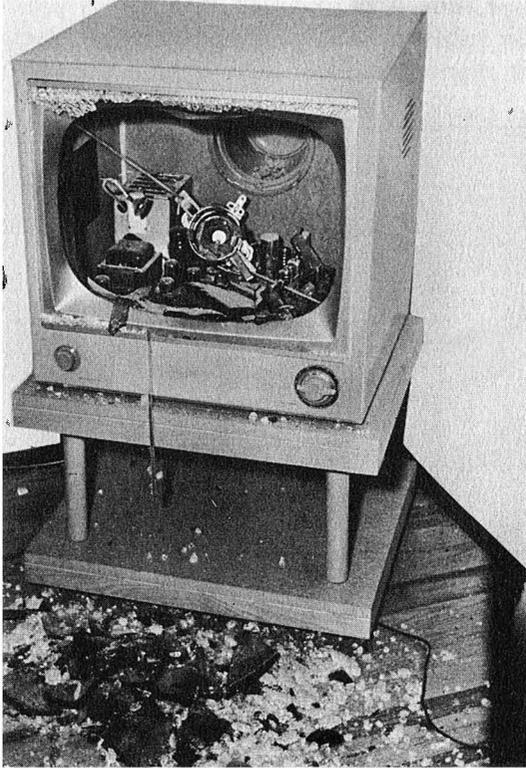
*Fig. 102. Result of a cathode-ray implosion due to inadequate safety precautions.*

hand between the tool and the tube to prevent the tube from being struck if the tool should slip. (The result of an implosion is shown in Fig. 102.)

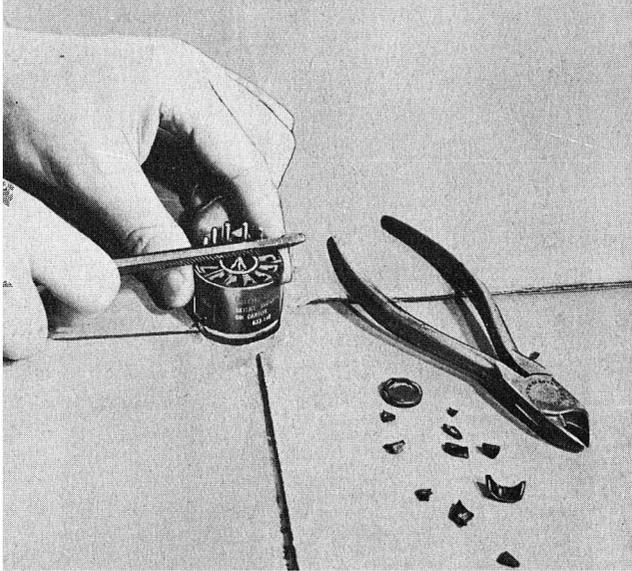
Fig. 103. Deactivating a picture tube. Drilling a hole in the keyway of the tube exposes the exhaust tip, which can then be broken.

1. Put the tube you want to dispose of into a carton designed to hold a unit of its size. Enough soft cloth should be placed under the face of the tube to make its base stick out at the top, outside the fold-over flaps of the carton (Fig. 103).

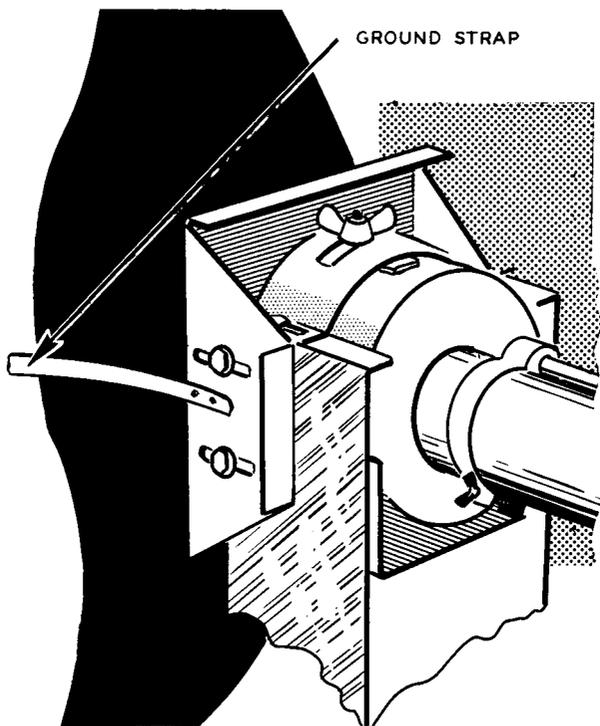
Fig. 104. Sketch showing ground strap on picture tube. Hairpin type clips are also used to place the glass envelope at ground potential.

The first precaution to take when a C-R tube is to be substituted in a TV set is to check whether the grounding clip or strap (if the tube is a glass type) is making contact with the Aquadag coating (Fig. 104). If it isn't, the proper adjustment should be made to remedy the condition and insure that no residual charge is left on the tube when the power is turned off and tubes are interchanged. The receptacle or cup of a disconnected glass C-R tube should be discharged to ground before the tube is handled.

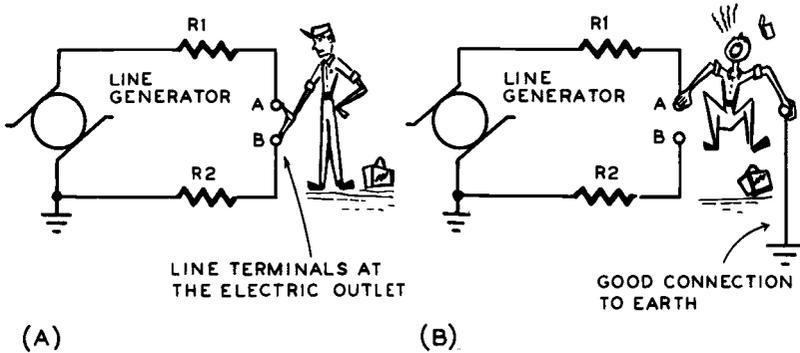
Fig. 105. When a technician (drawing A) puts two fingers of one hand across the line terminals, current flows through the fingers and hand only and does not pass through vital organs. Also, the current is limited by the resistance of the wiring in each branch of the line ( $R_1$  and  $R_2$  represent this resistance). When the technician (drawing B) puts one hand between the "hot" side of the line and a good external ground, current flows from one hand to the other through his body. The current will be greater than in A because  $R_2$  is short-circuited.

Novices who see old-timers testing for line "juice" by putting their fingers across the ac line terminals should not confuse this with getting their body between one side of the line and a good ground. (See Fig. 105-a, b. R1 and R2 represent the resistance of the line.) The current-delivering capacity of a line generator is somewhat less in the first case than it is in the second, making an electric shock less dangerous; more important, putting two fingers (of the same hand) across the line limits the path of current to the hand, leaving vital organs unaffected. Actually, the current going through the fingers is greater than that going through the body, but is not as dangerous.

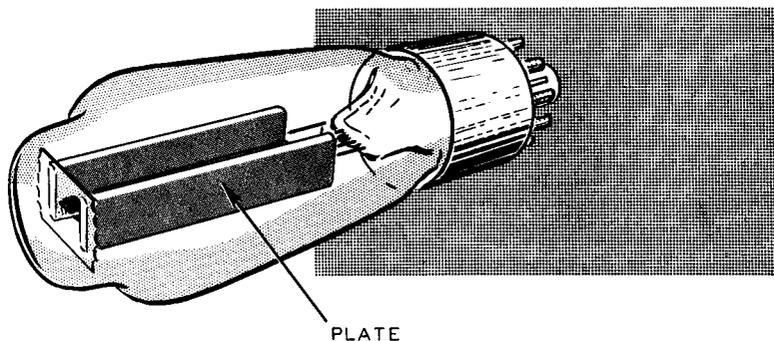
Fig. 201. *When a 5U4-G is horizontally positioned, the long sides of the plates should be vertical.*

in Fig. 201. The filaments are correctly positioned in this case, minimizing the possibility of filament sag. Sag of this kind can result in the development of a filament-to-plate short, which may damage the power transformer and filter capacitors as well as the rectifier tube.

a 5U4-GB that is horizontally mounted, to obtain a tube with a structure identical to the one in the set, one whose plate and base-pin orientation correspond to that of Fig. 201. Otherwise, damage to components may occur. It is desirable to avoid horizontal positioning of the 5U4-GB when servicing a set for any considerable length of time if the positioning of the plates with respect to the pins differs from the one illustrated in Fig. 201.

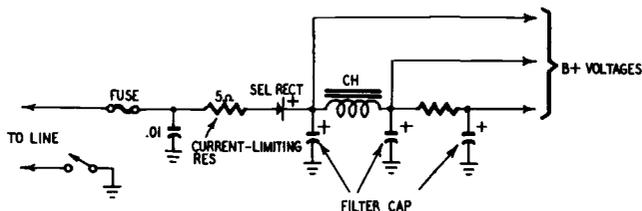
Fig. 202. Representative selenium rectifier power supply, showing one way in which a current-limiting resistor is inserted into the circuit.

Small current-limiting resistors (Fig. 202) are used in series

at this time can be excessive, particularly when the line voltage is high. With a current-limiting resistor present, the peak current is reduced to a safe value.

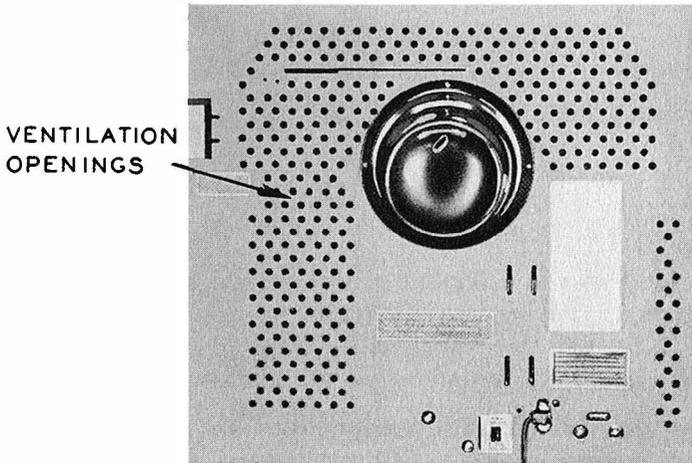
*Fig. 203. Ventilation openings in the back of a TV set. Keeping the receiver some distance away from the wall will prevent obstruction of the openings.*

Excessive heat is generated in a tube, impairing its performance and life, if ventilation is improper. An adequate supply of air must flow past the receiver's tubes, particularly its rectifier and power output tubes. If the set owner keeps the receiver flush against the wall or covers its ventilation openings (Fig. 203) in

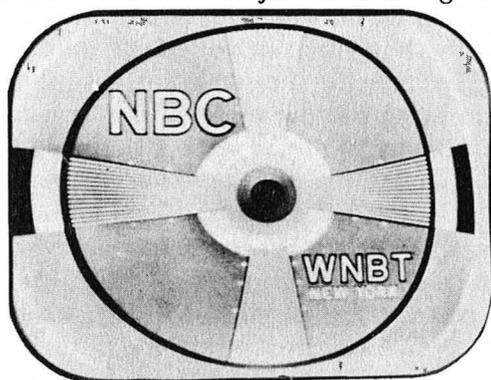
*Fig. 205. Effect of horizontal nonlinearity on test pattern. Note greater width of horizontal wedge at left, compared to the corresponding wedge at the right.*

Higher-than-normal line voltages may be responsible for premature horizontal output tube failures. Excessive width and/or horizontal nonlinearity are associated symptoms in such a case (Fig. 205). A line-voltage check will verify whether this voltage is above normal.

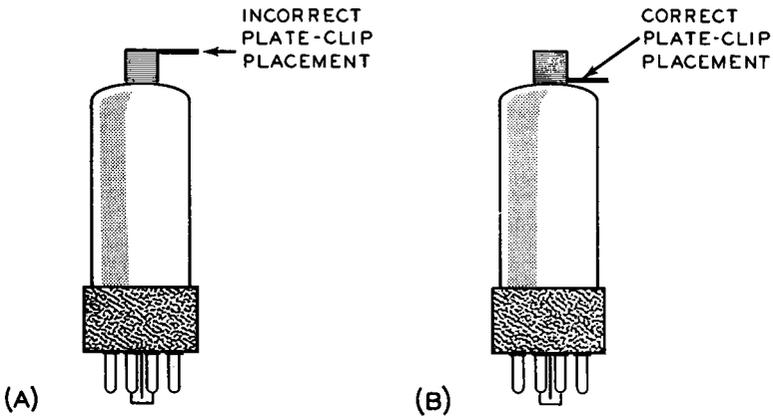
Fig. 206. In receivers where the top of the high-voltage cage is close to the plate clip of the 1B3-GT rectifier, improper placement of the plate clip may be the cause of corona or arcing.

In cases where the top of the high-voltage cage is very close to the plate cap of the rectifier tube, it is possible to introduce arcing and corona by improper placement of the high-voltage anode clip (Fig. 206). In such "low-bridge" cases, make sure the placement of the clip puts the maximum distance between the grounded cage top and the wire leading to the clip.

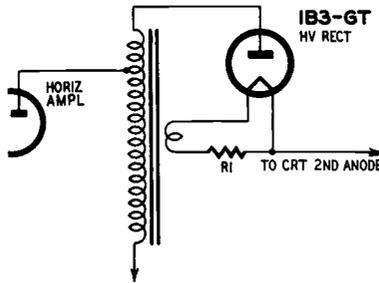
Fig. 207. Portion of high-voltage rectifier circuit, showing location of the filament-dropping resistor (R1).

Excessive filament voltage of the high-voltage rectifier is rather difficult to detect since it cannot be measured directly. The voltage across the filament is usually 1.25, but the voltage between either filament pin and chassis is measured in kilovolts. Check the value of the resistor in series with the filament (see R1 in Fig. 207) when frequent rectifier burnout is the complaint. If the resistor has decreased as much as 1 ohm in value (compared to the value specified in the set schematic) replace it with a unit of the correct resistance.

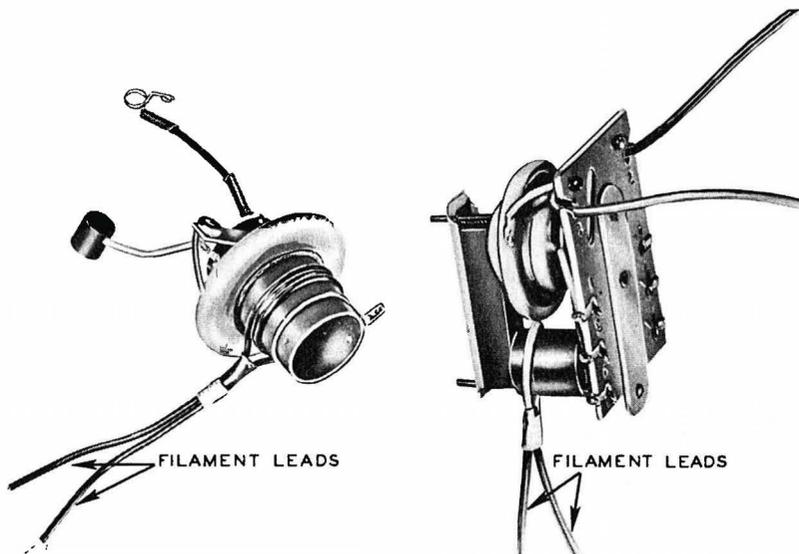
Fig. 208. Photos of flyback units, showing number and position of filament windings. One or two turns may be used, depending on the filament voltage requirements and the construction of the flyback transformer.

A shift in the coupling of the high-voltage rectifier filament winding on the flyback transformer may be the source of frequent tube burnouts (Fig. 208). If a similar flyback is present in another receiver, a comparison can be made to verify whether such a shift has occurred. If it has, the filament winding may be moved a short distance—perhaps  $\frac{3}{16}$  inch or thereabouts—away from the high-voltage winding on the transformer. If set performance remains satisfactory, the winding may be left in this position.

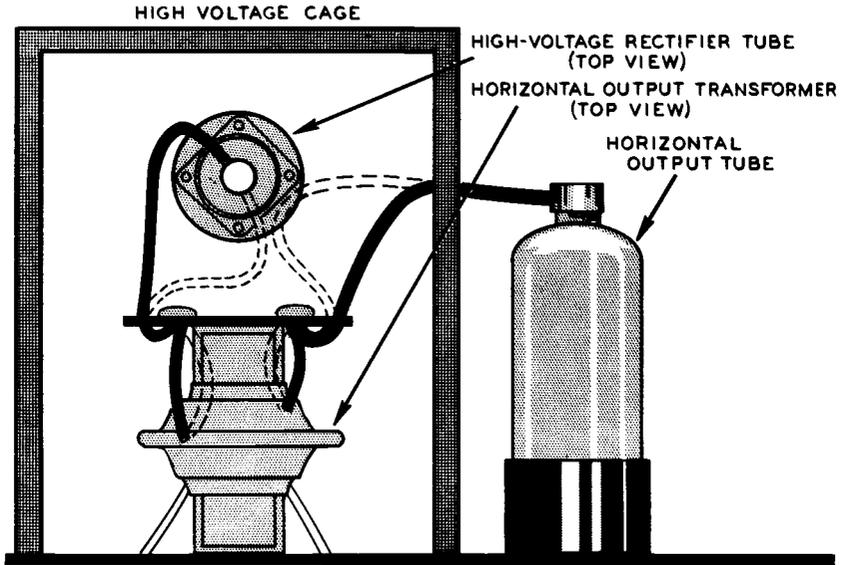
Fig. 209. Proper and improper lead dress in the high-voltage cage. Dotted lines indicate incorrect positioning of leads; high-voltage wires are too close to each other.

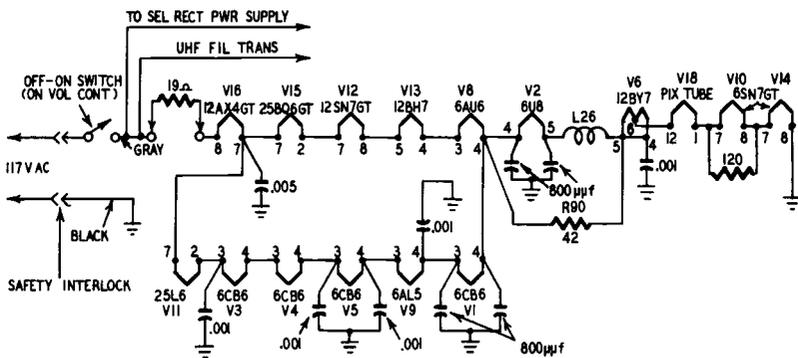
Fig. 211. Series-filament circuit in which two strings of tubes are in parallel. The two parallel strings are in series with a third group of filaments.

There are a number of facts about series-filament circuits (Figs. 210, 211) that the technician should know to minimize the possibility of damage in servicing tubes connected in this way.

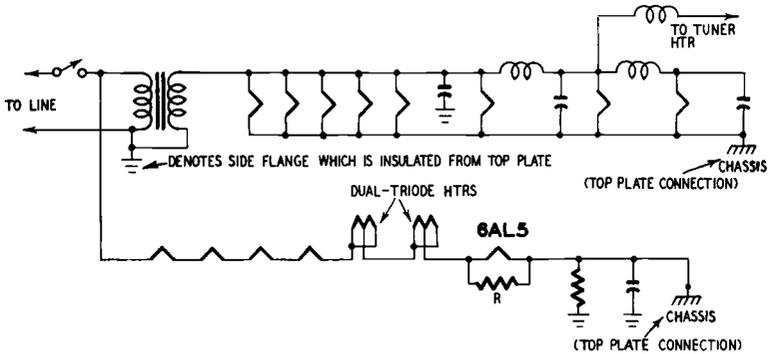
Fig. 212. Series-filament circuit in which a shunt resistor  $R$  is used across one of the tube filaments (6AL5).

possibility of failure of tubes for other reasons is increased as well. If a resistor (R) is in shunt with the tube that has been removed (Fig. 212), the resistor will overheat since an excessive voltage will now be present across it; in a few seconds, it may be permanently damaged.

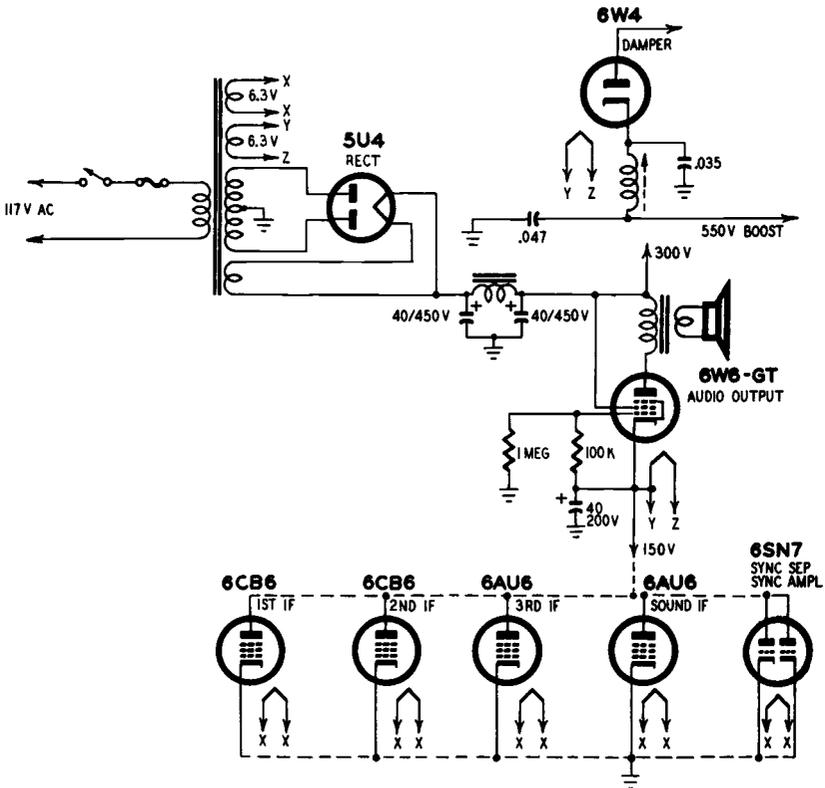
Fig. 302. Part of stacked-tube circuitry.

is probably shorted and a new one should be tried in its place. Sometimes two tubes rather than one are shorted. Double trouble of this kind will generally require bench tests to locate. In the case of a stacked tube circuit, such as the one shown in Fig. 302, a cathode-to-heater short in the damper will eliminate

both raster and sound. Such a short reduces the B boost voltage to the level of the 150-volt supply, causing the damper cathode and plate to be at the same potential. By thus eliminating conduction in this tube, the damper is effectively open-circuited. The plate of the 6W6-GT audio output tube, normally fed from the B boost voltage, receives a supply voltage of only 150 as a result of the cathode-to-heater short in the damper. This brings the plate and cathode voltages of the 6W6-GT to the same level and thus stops conduction in this tube as well.

may affect the sound as well as the synchronization. The bias of the audio output tube in a circuit like the one shown in Fig. 302 will be affected by a change of current in the tubes in series with it. If sound and sync symptoms are both present, then substitution of sync as well as sound tubes should be tried. Study the set schematic to determine which tube substitutions are most logical.

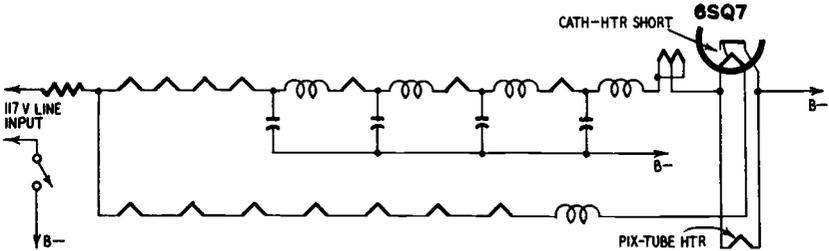
Fig. 303. Filament circuit of a typical TV chassis. A filament-cathode short in the 6SQ7 can shunt the filament current to ground before it passes through the picture tube, causing the cathode-ray tube to remain unlit.

When filament voltage is absent, a short in some tube other than the cathode-ray tube may be responsible (Fig. 303). In certain TV sets, the filament of the picture tube is in parallel with that of the damper. A short in either tube may eliminate filament voltage in both. Try a new damper, in sets of this kind, when the picture-tube filament does not light. In the case of series-filament receivers, trouble in any tube filament in series with that of the picture tube can eliminate its filament lighting; check for the presence of such a defect when receivers of this kind are being worked on.

In some receivers using a filament circuit setup such as the one shown in Fig. 303, a cathode-to-heater short in the first audio tube will eliminate filament voltage from the picture tube and kill the raster. The short will also eliminate the sound signal, leaving only a hum audible. If, in sets of this type, raster and desired sound are missing, hum is audible and the picture tube is unlit, try another first audio tube.

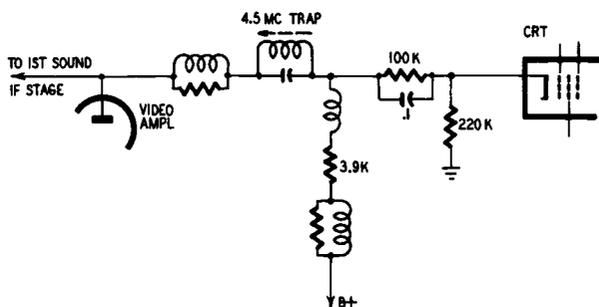
Fig. 304. Direct coupling between video amplifier and cathode-ray tube. Loss of emission in the video amplifier will increase the cathode voltage of the tube, possibly increasing its bias to cutoff in some cases.

If the grid-to-cathode voltage cannot be reduced to zero or to a few volts negative by manipulation of the brightness control, but remains excessively negative at all times, a defective tube may be the cause of the trouble in some cases. In a receiver in which direct coupling between the video amplifier and picture tube is used (Fig. 304), a defective video amplifier may cause an excessive picture-tube bias to be developed, blanking out the raster. Try replacing the video amplifier to check on this source of trouble.

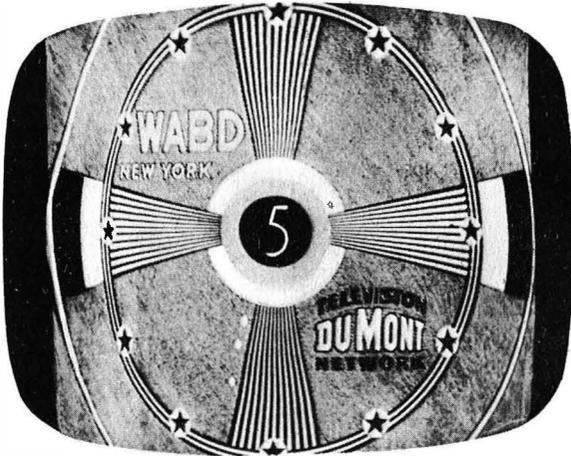
Fig. 305. Photo of test pattern indicates insufficient width.

Insufficient width (Fig. 305) may be due to a weak damper, horizontal output tube or low-voltage rectifier. When the rectifier is weak, other symptoms will generally (but not always) be mani-

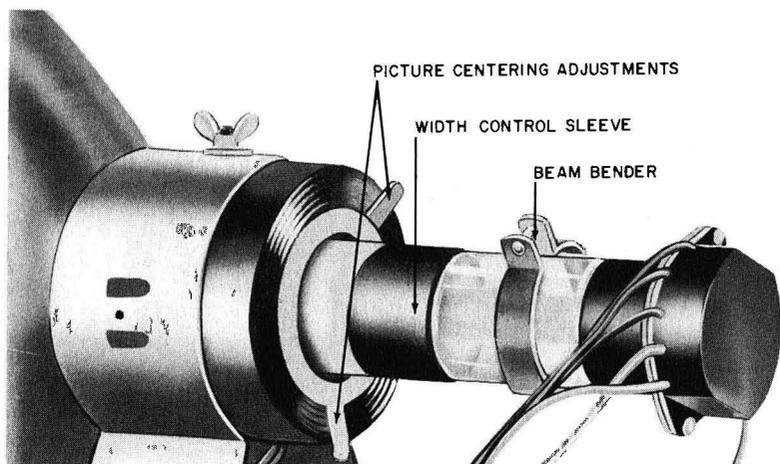
Fig. 306. Sleeve made of brass or aluminum can be used as a width control.

In some receivers a brass or aluminum sleeve is used on the picture-tube neck for adjusting width (Fig. 306). Improper setting of this sleeve may be responsible for a slight loss in width.

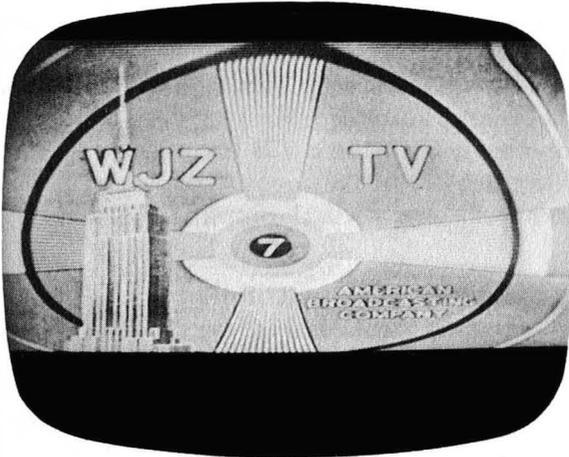
Fig. 307. Photo shows insufficient height.

When insufficient height is the complaint (Fig. 307) either the vertical oscillator or vertical amplifier tube may be responsible. If height and vertical linearity adjustments do not restore the height to normal, replace these tubes. If replacement one at a time does not eliminate symptoms, try replacing both tubes simul-

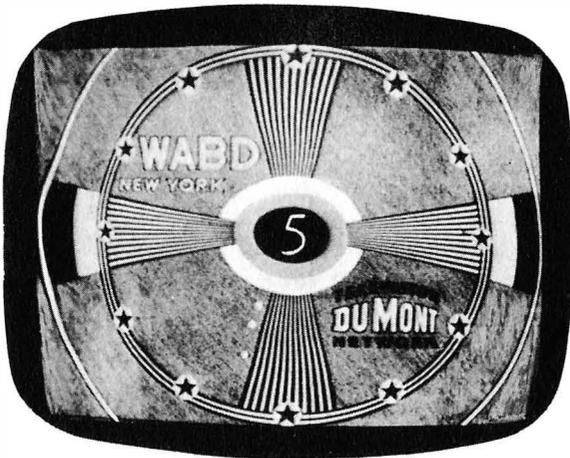
Fig. 308. The test pattern is pulled in. The photo shows inadequate width and height.

When both height and width are inadequate (Fig. 308) and height and width adjustments do not restore raster size to normal, try a new low-voltage rectifier. Such a substitution is particularly indicated if there is an accompanying reduction in sound volume or insufficient contrast or if the focus control achieves or approaches proper focus only at one end of its range.

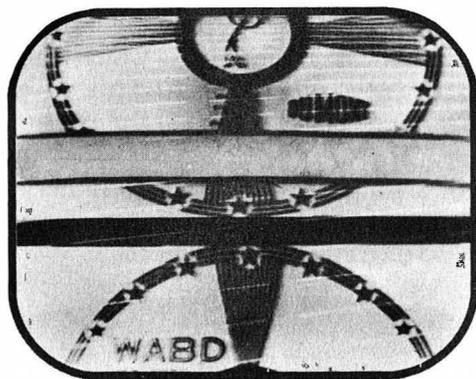
Fig. 309. The vertical blanking bar can be examined by adjustment of the vertical-hold control.

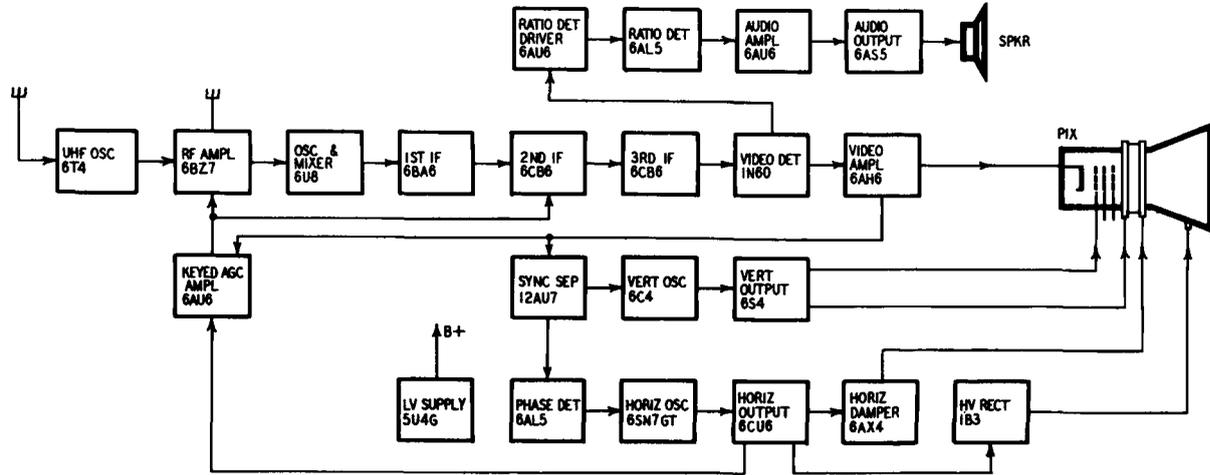
Fig. 401. Block diagram of a typical intercarrier receiver. A brief study of a receiver's block diagram (when the latter is available) is a valuable preliminary step to the localization of tube troubles in the receiver.

When the picture is absent but sound and raster are normal, the source of trouble usually lies in a stage through which the picture—but not the sound signal—passes (Fig. 401). An important

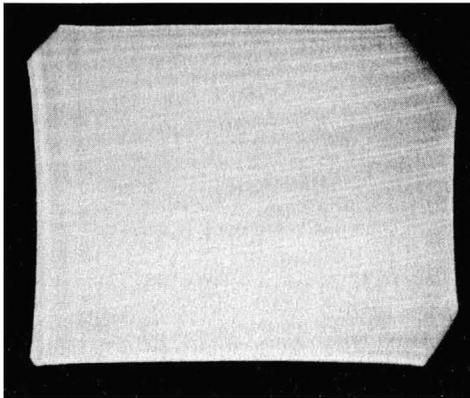
*Fig. 402. How raster will look when sync pulses are not reaching the vertical oscillator. The vertical retrace lines will drift up and down, indicating that the vertical oscillator is free-running or uncontrolled.*

If no noise pattern is seen on the screen, examine the vertical retrace lines on the raster. If these diagonal white lines jump up and down and will not remain stationary (Fig. 402), trouble in some stage preceding the sync takeoff point is indicated. Sync pulses are evidently not reaching the vertical oscillator and the retrace lines are unsynchronized.

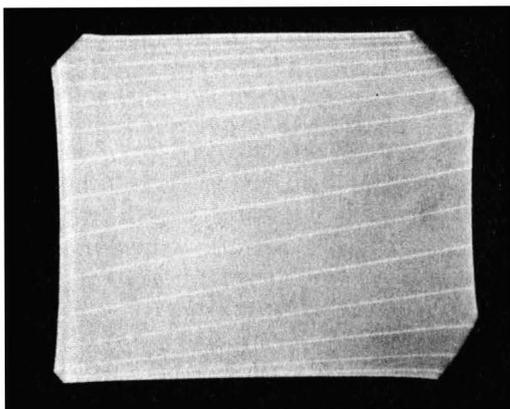
Fig. 403. *What the raster will look like when sync pulses reach the vertical oscillator. The vertical retrace lines will be steady, provided the vertical hold control has been properly adjusted.*

If, on the other hand, the retrace lines *are* steady (Fig. 403), vertical sync pulses are generally getting through to the vertical oscillator. (Retrace lines can be steady due to residual hum.) The video signal must, in consequence, be reaching the sync takeoff point and trouble *after* this point is indicated. When a two-stage video amplifier is present in which the sync pulses are picked off

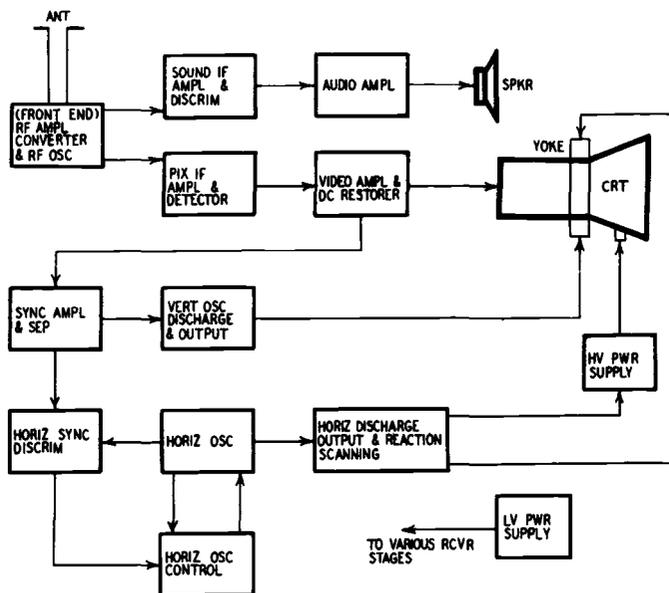
Fig. 404. Block diagram of the older type split-carrier receiver. The sound signal is taken off at the converter.

In older receivers using split-carrier systems, the sound signal is taken off at the mixer or in one of the video if stages (Fig. 404). Substitute tubes (and crystals, if present) in stages common to pix and sound signals to localize the trouble to the unit at fault.

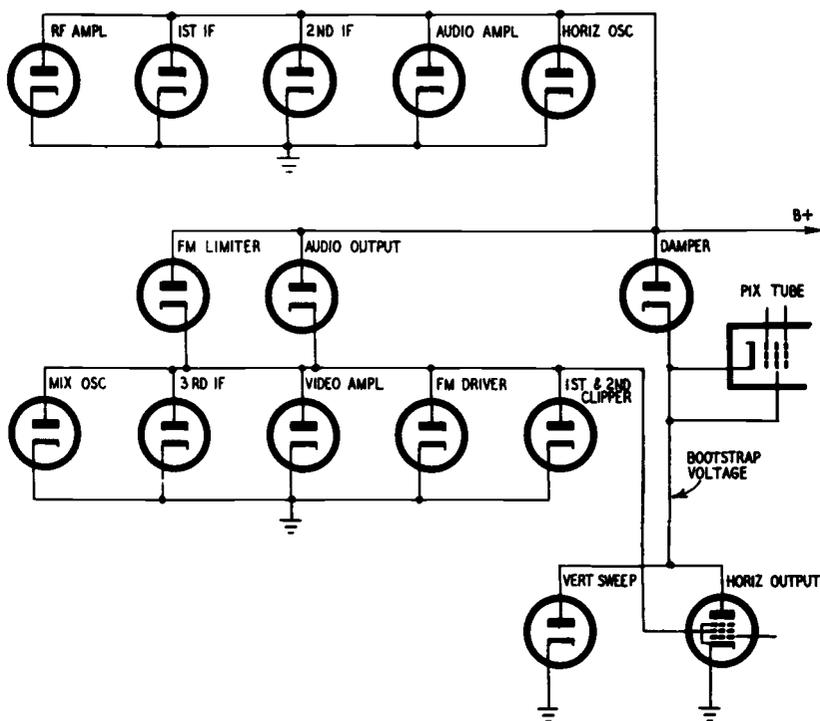
Fig. 405. Block diagram showing a tube-stacking arrangement. Failure of the audio output tube can decrease the B-plus voltages on the video signal carrying tubes with which the audio output tube is in series. Picture as well as sound can be lost.

In sets with stacked tubes a defective audio output tube may be the cause of no pix and sound (Fig. 405) if the video if and

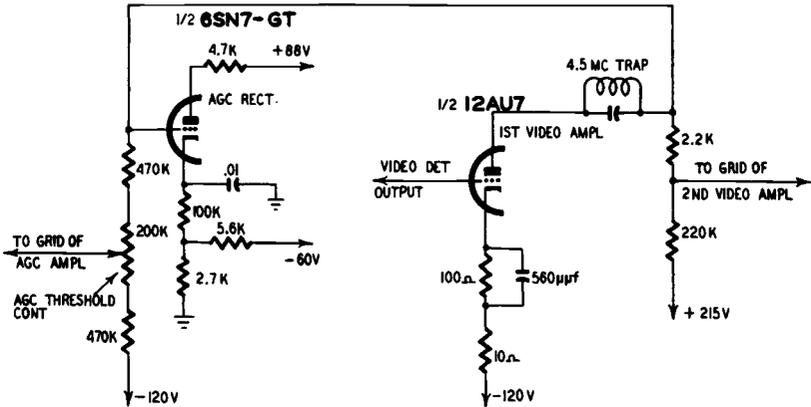
Fig. 406. Video amplifier and associated circuits. Excessive agc bias can result from a video amplifier defect.

In a circuit such as that shown in Fig. 406, a defective video amplifier may cause an excessive agc bias to be developed, elim-

inating picture and sound. Since the video amplifier is not common to the sound and video signals in this split-carrier set, the technician would not ordinarily look in the video amplifier for a fault affecting both sound and pix.

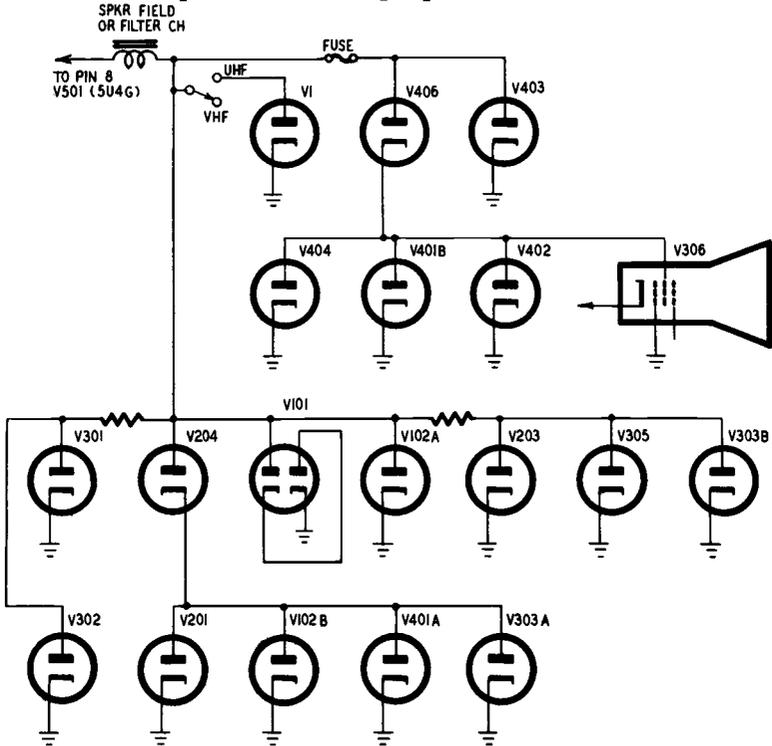
Fig. 407. Block diagram showing tube stacking. V204 is the sound output tube. Its heavy current will be reduced when it loses emission, causing the plate voltages on V101, V102A, V203, V305 and V303B to rise. The tubes are shown as diodes for the sake of simplicity

receiver's sound volume is above normal), a defect in an agc tube may be present. In a circuit such as the one shown in Fig. 407, a loss in agc bias will cause an excessive signal input to the video amplifier. The video amplifier may be driven into cutoff, thus killing the picture. The sound signal, on the other hand, will be

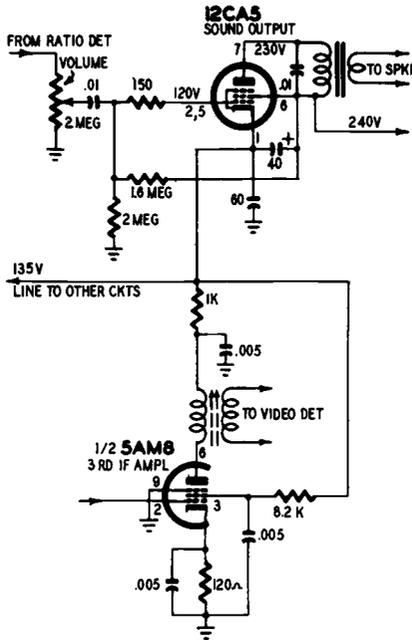
Fig. 408. The audio output and the third if amplifier tubes are in series and act as a voltage divider. A defect in the sound tube can cause loss of picture and sound.

Another example of circuitry in which a defective sound tube may affect both picture and sound is shown in Fig. 408. B-plus voltage to the tuner, video amplifier and agc circuits, as well as the sync separator and clipper, are affected when a fault develops in the audio output tube.

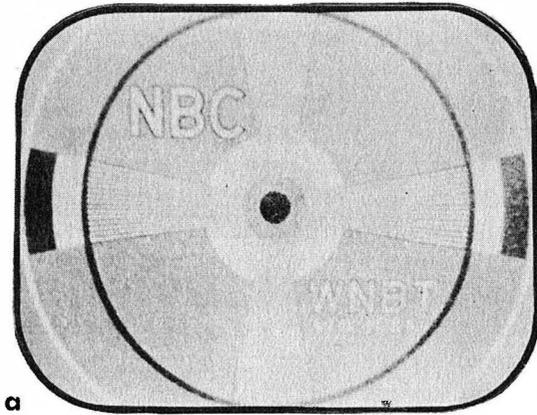
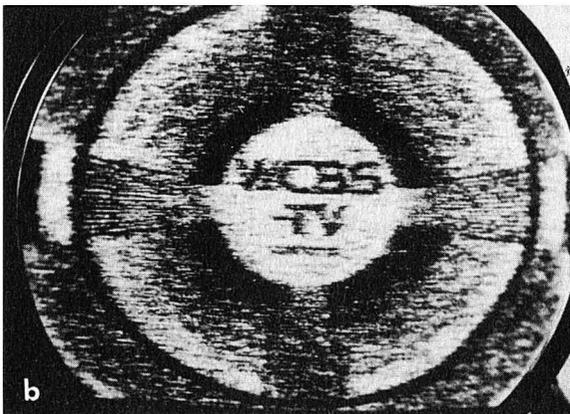
Fig. 409. (a). Weak picture with snow present. (b) Effect of advancing the contrast control setting with a snowy picture.

When insufficient contrast is accompanied by snow in the picture (Fig. 409), try substituting new front-end tubes. If no snow is present, substitute tubes—or crystal—in video signal stages.

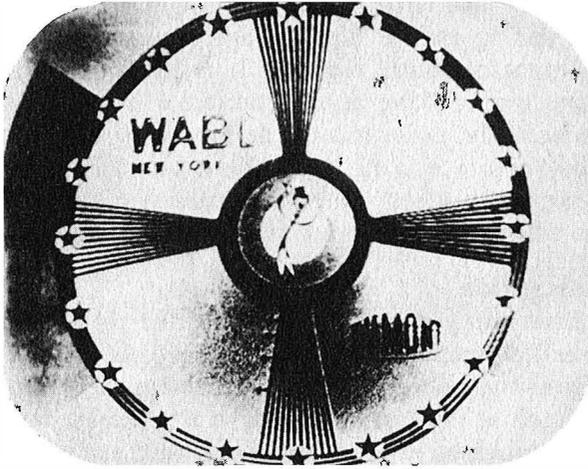
Fig. 410. Photo of test pattern showing excessive picture contrast. Note smearing.

The presence of excessive picture contrast (Fig. 410) is fre-

quently due to agc trouble (loss of agc bias). The existence of such trouble is especially likely when a strong signal produces too much contrast or a blackout ( a black-and-white raster) whereas insufficient contrast, possibly associated with snow, is evident when weak signals are being received.

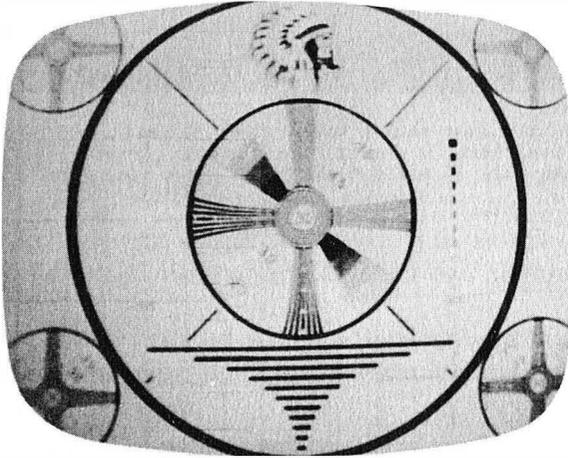
*Fig. 411. Test-pattern photo illustrating white compression due to overloading in the if amplifier. Note washed-out appearance of the picture, poor rendition of whites. No snow is present, however. The condition is most likely to be noted on strong signals.*

Overload characterized by white compression (loss of grays in the picture, causing the pix to look flat and washed out) is often due to a faulty rf amplifier (Fig. 411). Defects in either the rf

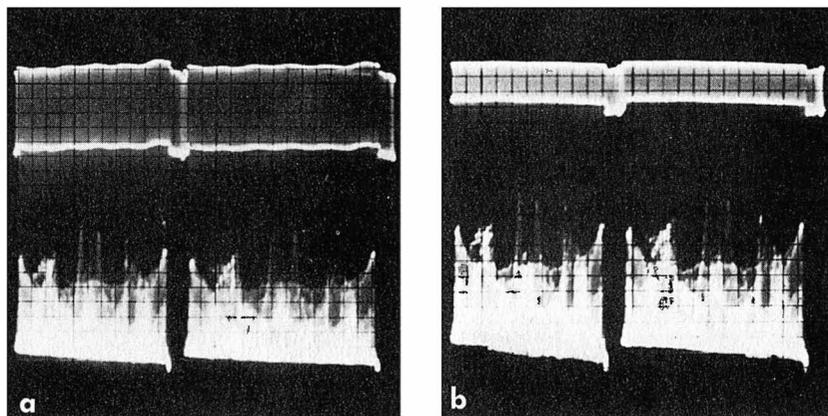
Fig. 412. (a) Normal video detector output waveform. (b) Video detector waveform when black compression is present. Signals in the gray-black region are compressed, causing grays to fall into the black region. Sync pulses are also compressed and reduced in amplitude.

amplifier, agc or video if tubes can be the cause of the trouble. The presence of white or black compression can be verified by making a scale waveform check at the output of the video detector (Fig. 412).

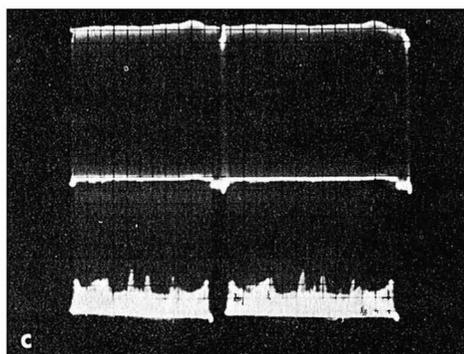
Fig. 412. (c) Video detector output waveform when white compression is present. Note smaller range of variation at bottom of waveform where the white signals are, compared to the normal variation in this region shown in Fig. 412-a.

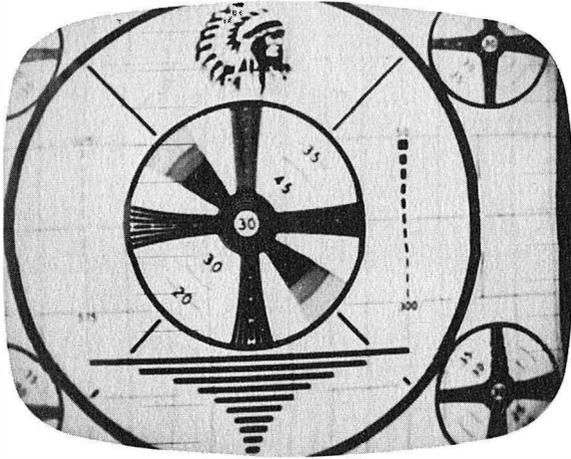
Fig. 413. Test pattern illustrating black compression. Grays are rendered as black, causing the picture to look dark and excessively contrasty.

Sync and black compression (Fig. 413) frequently indicates overload in the video if stages due to insufficient agc bias. Such compression may readily be detected by advancing the brightness control and adjusting the vertical hold control until the picture hovers with the horizontal blanking bar positioned somewhere around the middle of the tube. If the sync pulse hammer is not much darker than the blanking bar proper, sync and black compression is indicated (Fig. 414). The picture will be dark and excessively contrasty when this kind of trouble is present; sync will tend to be lost if the condition is severe.

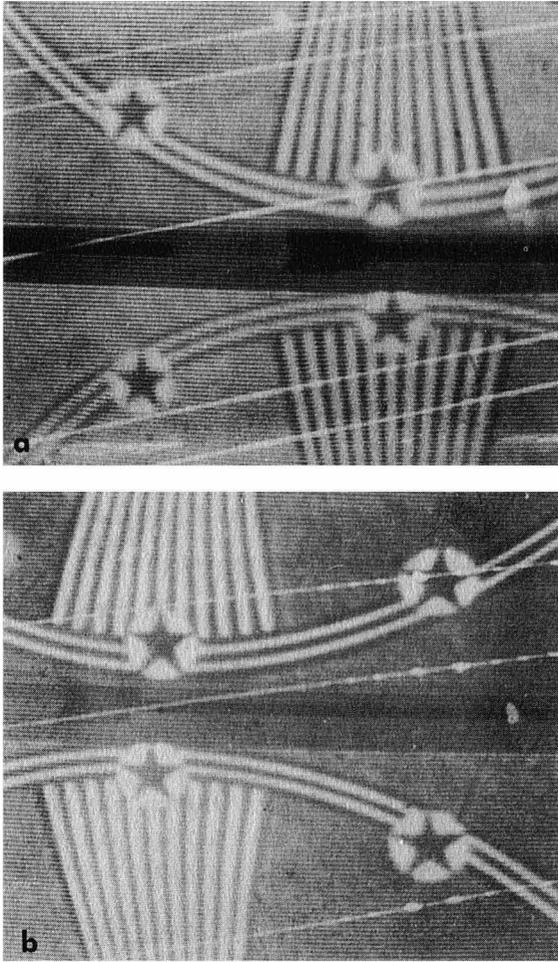
*Fig. 414. The photo at the top shows the normal appearance of vertical blanking bar. Note that the sync hammer is black, while the blanking bar proper is gray. The lower photo illustrates the effect of sync compression on the sync pulse and blanking bar. The reduction in sync-pulse amplitude causes the height of the sync pulse to fall closer to the blanking signal level. As a result the shading of both becomes similar.*

A good preliminary check to make is an inspection of the sync pulse in the vertical and/or horizontal blanking bar (see Figs. 414 and 501). The brightness control should be turned up somewhat to permit the shading of the sync and blanking pulses to become visible. If there isn't much difference in contrast between the sync pulse and the blanking bar, as shown on the screen of the picture tube, sync compression is indicated.

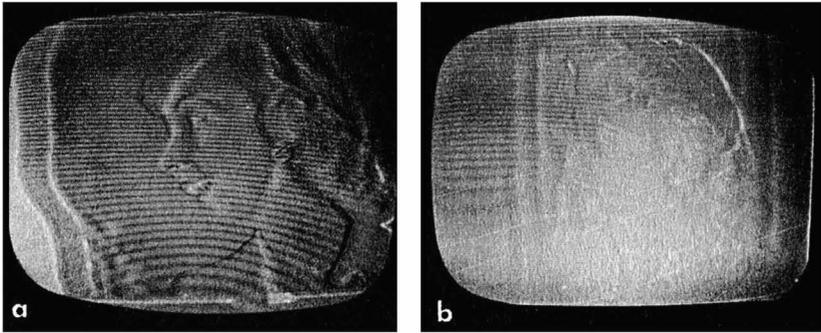
Fig. 415. (a) Negative picture caused by overloading. An inoperative agc tube can cause such overloading by removing the bias from agc-controlled stages. Erratic horizontal and vertical synchronization are often associated with the negative picture. (b) Another example of a negative picture caused by agc trouble. In this case, synchronization has not been impaired. The symptoms illustrated were seen when a medium-strength signal was coming in. With a weak signal and the contrast control setting advanced, the picture may look normal in some cases.

The technician not infrequently encounters a set in which negative pictures are received—one in which normally black areas are white and normally white areas are black (Fig. 415). Overloading is frequently the cause of such phase reversals, particularly when vertical and/or horizontal synchronization is continuously or intermittently affected. An excessive signal in the video if tube grid circuit can produce a negative picture.

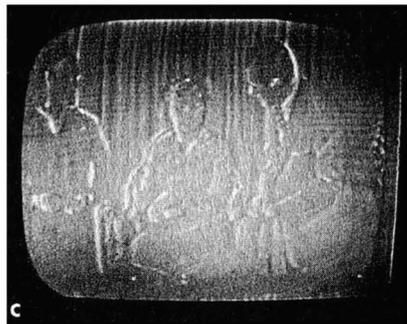
Fig. 415. (c) Negative picture caused by low emission in a 5U4-G rectifier. The 5U4-G in question provided high B plus for the horizontal amplifier tube. Reduction of the rectifier tube's output resulted in the feeding of a smaller pulse from the horizontal amplifier to the plate of the keyed agc tube, decreasing the agc voltage and causing overloading of the agc-controlled stages.

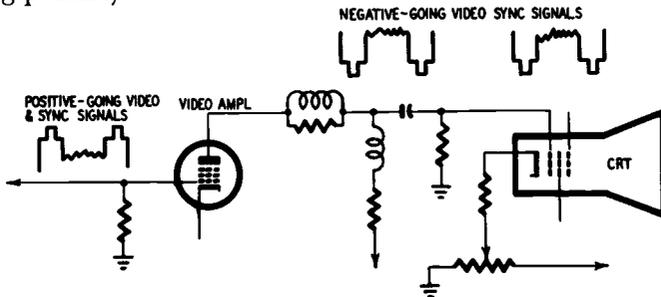
Fig. 416. The sync pulses should be negative-going on a scope waveform test when the video amplifier output signal goes to the grid of the cathode-ray tube. It is assumed that the scope does not invert the signal. When the video amplifier feeds to the cathode of the picture tube, the sync pulses should be positive-going.

Trouble in a picture tube itself can produce a negative picture. Before making a laborious substitution to test for such a source of trouble, simply check the scope waveform at the point where the video signal is fed to the tube. If the signal is applied to the grid, the polarity of the sync pulses should be *negative*; they should be *positive* if the video is fed to the cathode (Fig. 416). If the signal polarity is correct but a negative picture is obtained anyway, trouble in the C-R tube is indicated and another tube should be substituted. (It is assumed that voltage and resistance tests between picture-tube elements and ground have eliminated the possibility of circuit trouble.)

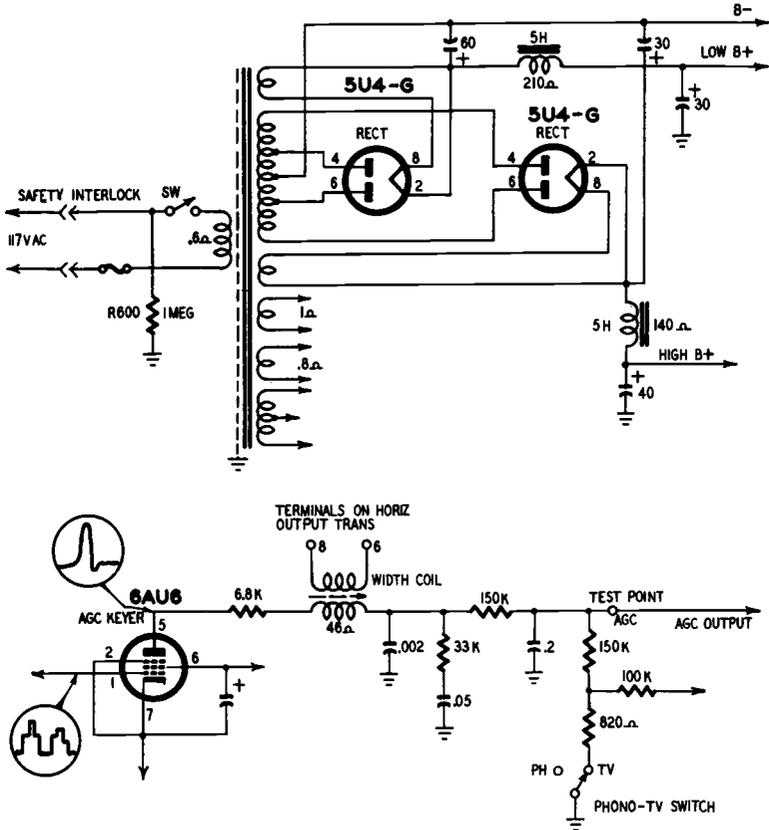
Fig. 417. Typical power supply and agc picture circuits. The 5U4-G at the right (upper drawing) provides high B plus for the horizontal output tube which feeds pulses to the plate of the keyed agc tube (lower drawing). A defect in this rectifier tube can affect agc operation without producing visible symptoms of malfunctioning in other circuits.

Loss of emission in a low-voltage rectifier, in the type of circuit shown in Fig. 417, may result in negative picture. Knowing what to look for in such instances can save the technician considerable troubleshooting time.

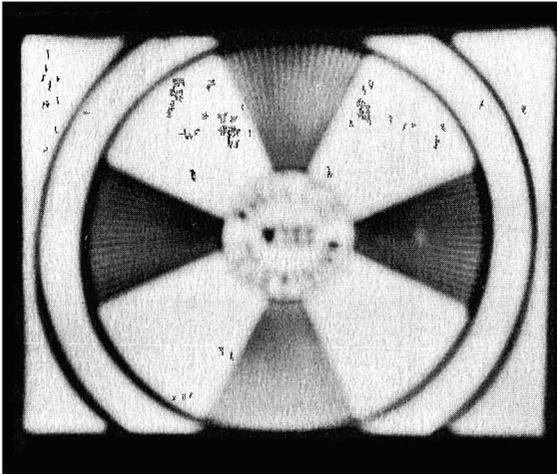
Fig. 418. Effect of improper focus on the test pattern.

A blurring of the entire picture is generally produced by improper focus. The vertical and horizontal wedges in the test pattern will not be sharply defined when this condition is present

(Fig. 418) and neither will the scanning lines of the raster. (Reduce the contrast setting to zero, eliminating the picture, to examine these lines.) When adjustment of the focus control and/or focus magnet proves ineffective in clearing up the condition, one of the following troubles may be present:

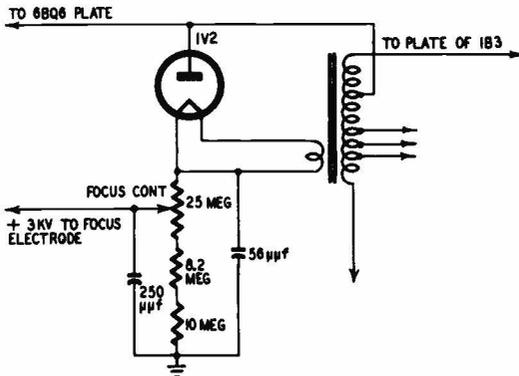
Fig. 419. Focus tube and associated circuit used with picture tubes employing high-voltage electrostatic focus.

a 1V2) to provide the focus voltage needed, reduced emission or some other defect in this tube may make it impossible to achieve proper picture focusing (Fig. 419). The same is true of magneti-

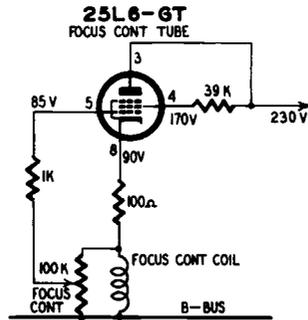
Fig. 420. Focus control tube and associated circuit used in some receivers.

cally focused sets that use a separate focus control tube. (Fig. 420).

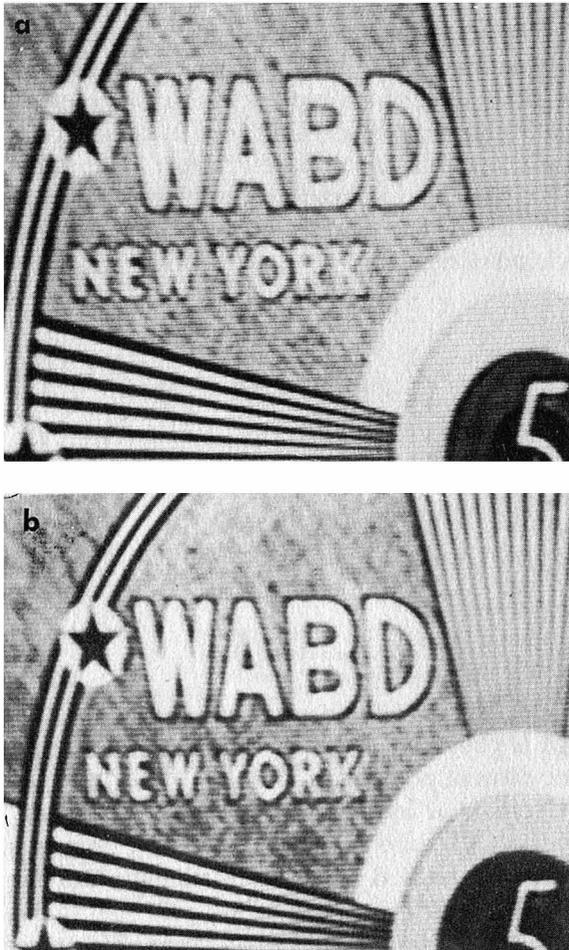
Fig. 421. (a) Appearance of section of test pattern when scanning-spot size is correct. Appearance of same portion of test pattern (b) when scanning-spot size is larger than normal. Note that the dark spaces between scanning lines are no longer clearly visible.

A condition similar to a slight impairment of focus may be noted (Fig. 421) when the size of the scanning spot has increased for some reason. Possible causes for such an increase include: improper positioning of the ion magnet; gassy C-R tube; loss of emission in a tube in the horizontal or high-voltage section (leading to a reduction in the high voltage) and, of course, an improper focus-control setting.

To check the spot size, observe the white scanning lines in the picture or test pattern. In Fig. 421-a illustrating a normal condition, the scanning lines are narrow and the black horizontal spaces between them are clearly visible. In Fig. 421-b illustrating the

effect of an enlarged spot, the increase in the width of the scanning lines has caused the dark in-between spaces to become narrower, poorly defined and almost invisible.

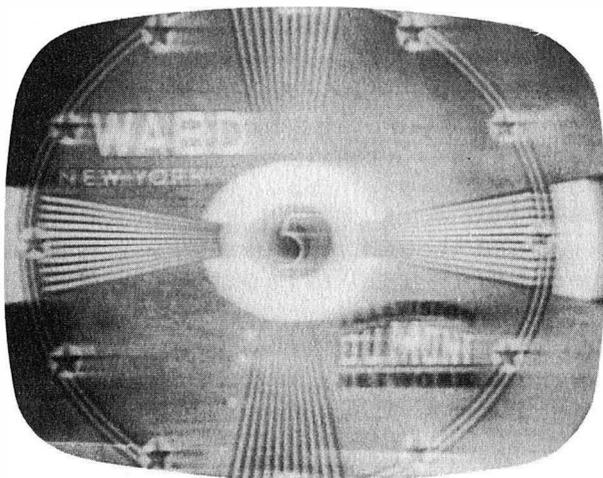
Fig. 422. *Effect of smearing on the test pattern. Symptoms vary somewhat from case to case.*

When response is impaired at low frequencies, smearing may be introduced into the picture. Smearing most noticeably affects large

objects (Fig. 422). White or black edges in the picture, instead of being sharply defined, are smeared generally in the direction of the right side of the screen. Trailing shades ranging from black to white may be seen after large black objects; these shadings go from white to black after large white objects. The picture as a whole will look fuzzy. Smearing is usually due to poor reproduction of low video frequencies.
