# TV and radio TUBE TROUBLES

SOL HELLER

GERNSBACK LIBRARY NO. 68

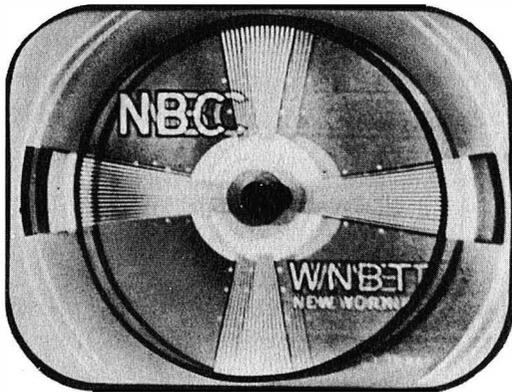
Fig. 423. Ghosts in test pattern.

It is not too well known that a defective tube may cause ghosts or multiple images (Fig. 423) to be seen in the picture. The condition may be explained as follows:

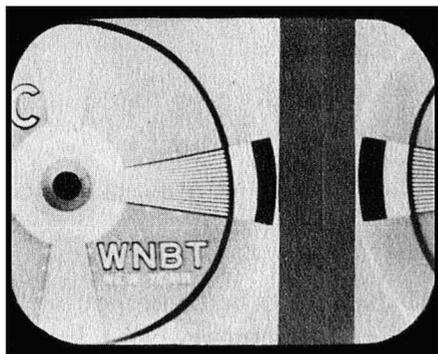
Fig. 501. *Horizontal blanking bar is black when brightness and contrast control settings are normal and no defect is present. The horizontal sync pulses are not visible.*

A good preliminary check to make is an inspection of the sync pulse in the vertical and/or horizontal blanking bar (see Figs. 414 and 501). The brightness control should be turned up somewhat to permit the shading of the sync and blanking pulses to become visible. If there isn't much difference in contrast between the sync pulse and the blanking bar, as shown on the screen of the picture tube, sync compression is indicated.

A horizontally out-of-phase picture (Fig. 501) that cannot be made normal by suitable manipulation of the horizontal hold or afc control points to a defective afc section. Substitute tubes in this section to check on this possibility.

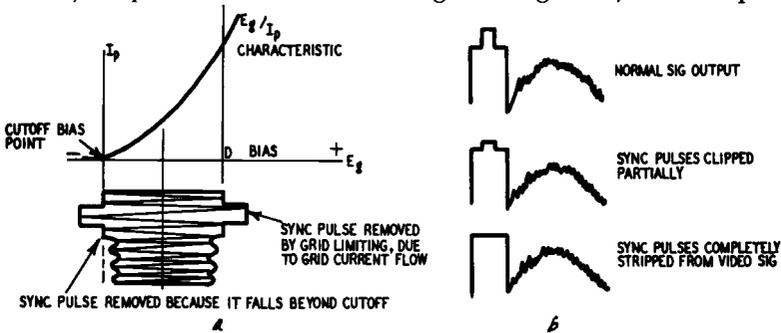
Fig. 502-a, b. Clipping of sync pulses due to overloading of a video if tube. The condition is most likely to occur in the last video if amplifier where the if input signal is highest.

slowly, possibly causing it to be smaller than it should be in the first few seconds after the station switch. As a result, the bias of agc-controlled stages is too low and clipping of the sync pulses tends to occur. See Fig. 502.

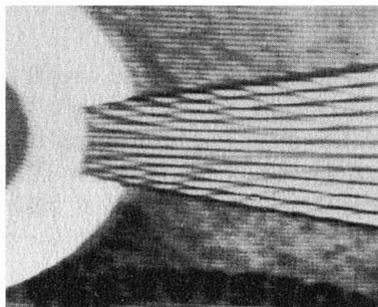
Fig. 503. *Mottling of the horizontal wedges (moire effect) due to poor interlace.*

A loss in interlace can be readily detected when a test pattern is present by inspecting the horizontal wedges. When a moire (see Fig. 503) is noticeable—i.e., circular movement in the horizontal wedges—interlace is being lost.

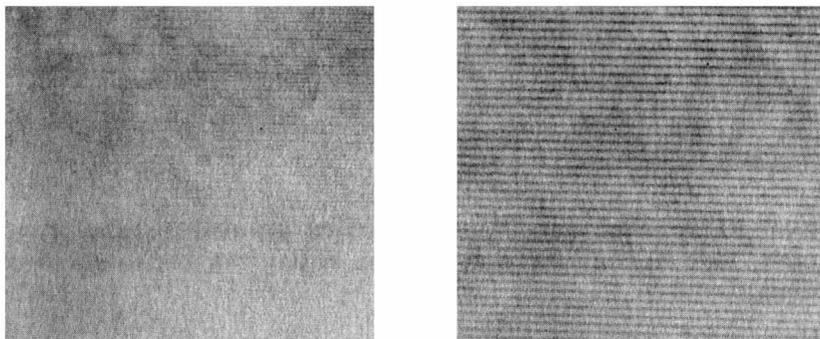
Fig. 504. Good interlace is shown in the photo at the left, but in the photo at the right the scanning lines of one field fall over those of the second field. The dark spaces between lines become wider, more visible.

In the absence of a test pattern, a loss in interlace may be detected by inspecting the scanning lines of the picture or raster. If the dark spaces between scanning lines are nonuniform in width (most obvious when two successive spaces are compared) or the spaces are too wide, interlace is imperfect. See Fig. 504-a,b. The condition will also affect the vertical retrace lines, causing these to pair off. Advancement of the brightness control to the point where the retrace lines become visible will permit their inspection.

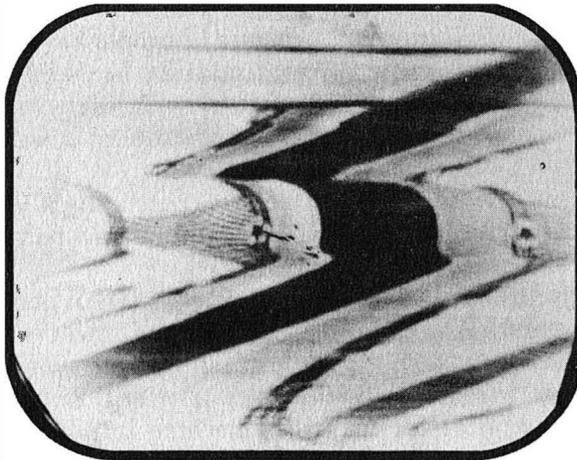
Fig. 506. Complete loss of horizontal synchronization.

When horizontal synchronization is completely absent and cannot be brought in by manipulation of the horizontal hold control (see Fig. 506), trouble in the afc or horizontal oscillator section is indicated. A defect in one of the sync stages through which both

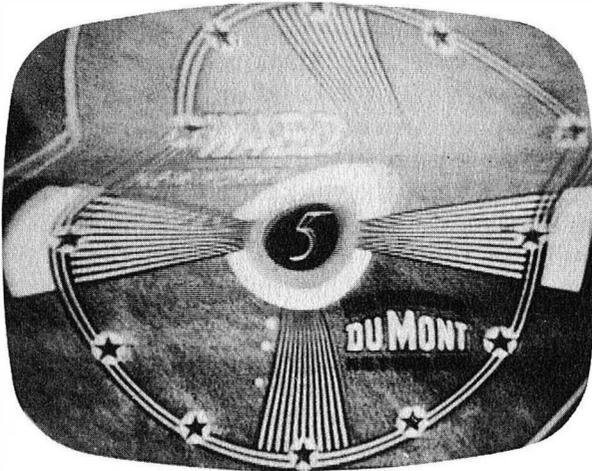
*Fig. 507. A case of severe picture "hook" in the test pattern.*

A certain type of horizontal movement in the picture (see Fig. 507) is referred to as pulling, snaking, bending, hooking or S distortion. Straight vertical sides of objects in the picture are bent when such a defect is present. This should not be confused with tearing, wobble or jitter.

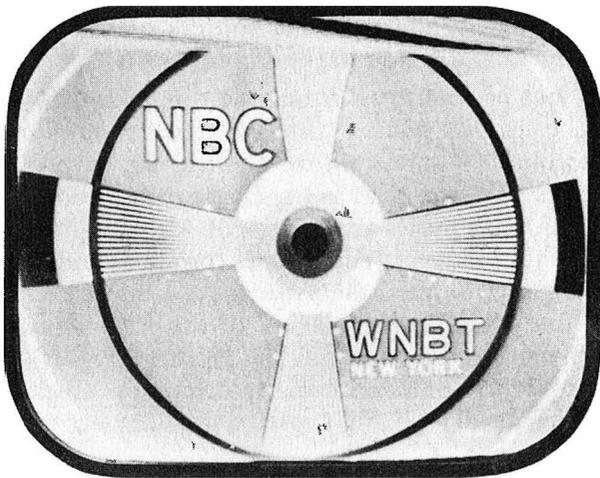
Fig. 508. Tearing out of lines at the top of the picture. The condition may be intermittent or practically continuous.

Tearing out of lines at the top of the picture (Fig. 508) is due to insufficient agc voltage. If the contrast and agc control settings are correct, substitute a new agc tube or tubes.

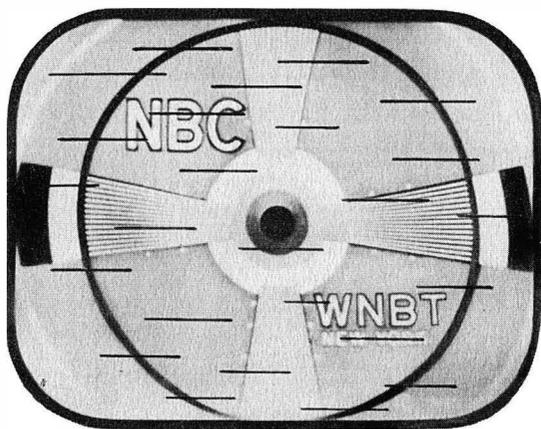
*Fig. 509. Lines in picture due to auto-ignition interference. The picture has been retouched to emphasize the effect. Similar lines may be caused by corona trouble at the high-voltage rectifier socket.*

Corona due to improper spacing of the high-voltage rectifier's socket lugs may produce lines in the picture (Fig. 509) similar to those produced by auto ignition interference. Inspect the tube socket terminals of the high-voltage rectifier to check on this source of trouble.

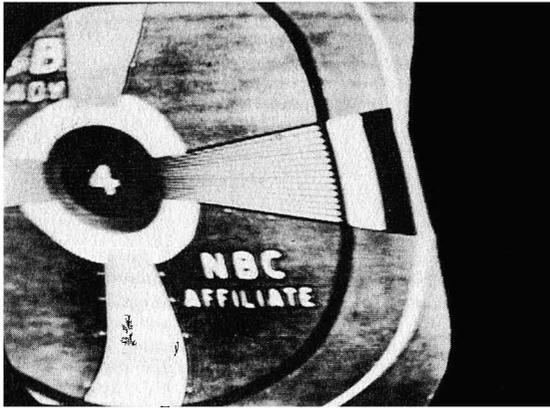
*Fig. 510. Horizontal jitter or weaving. The trouble in this case was due to a short between cathode and heater of a sync clipper-amplifier tube.*

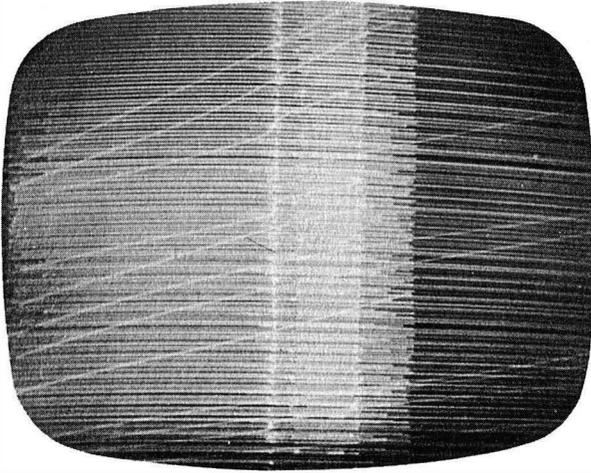
Fig. 511. "Christmas-tree" effect.

In the presence of certain defects, the picture and raster may break up into several sections of varying width. Their faint resemblance to a Christmas tree has led to the symptoms being labeled “Christmas tree” effect. When the breakup is more severe, the raster may disintegrate into a series of bright horizontal lines that cover the central portion of the raster (Fig. 511) and occupy about 50% of the normal raster area. A loud singing or frying noise coming from the horizontal output transformer often accompanies the symptoms just described. These symptoms, incidentally, are most often seen (in certain cases of trouble) when the station selector is set at an unoccupied channel or when channels are switched.

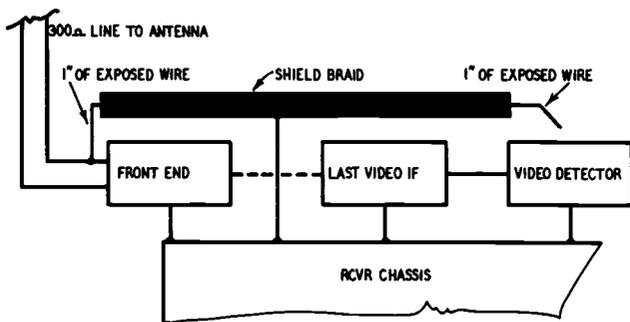
Fig. 601. *Technique for checking the source of radiation interference.*

To check on whether interference is due to radiation from an unshielded last video if or video detector, connect one end of a short length of shielded wire (Fig. 601) to one of the antenna input

terminals. Hold the other end close to the last video if or detector tube. Approximately 1 inch of wire should protrude from the shield at each end and the shield itself should be firmly attached to the receiver chassis. If the interference is intensified by the increased coupling, radiation from the last video if or video detector is indicated. When the source of interference is a sound or video

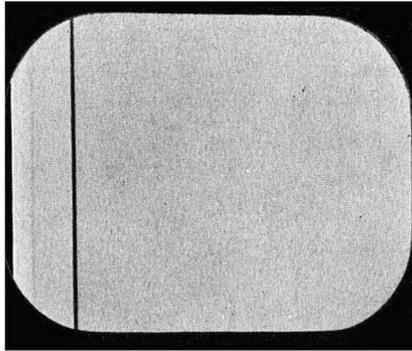
Fig. 602. *Appearance of Barkhausen oscillation in the raster.*

by the front end or video if section and amplified in succeeding stages. The condition generally manifests itself as one or more vertical black lines on the left-hand side of the screen (see Fig. 602). The lines may appear white if the oscillation is relatively weak.

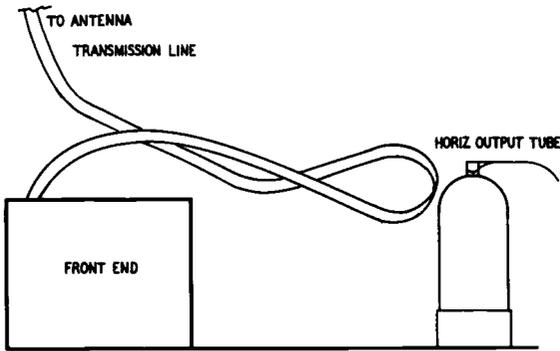
Fig. 603. Bringing the loop near the horizontal-output tube will increase the intensity of Barkhausen lines.

One way to determine whether Barkhausen oscillation is present is to loop a section of the lead-in (see Fig. 603) and hold it near the horizontal output tube. If the intensity of the lines increases or if they change from white to black, Barkhausen oscillation is causing them. Another test consists of putting a magnet (ion magnet or a pm speaker core) near the horizontal amplifier tube. If symptoms are diminished or disappear, they are due to Barkhausen oscillation.

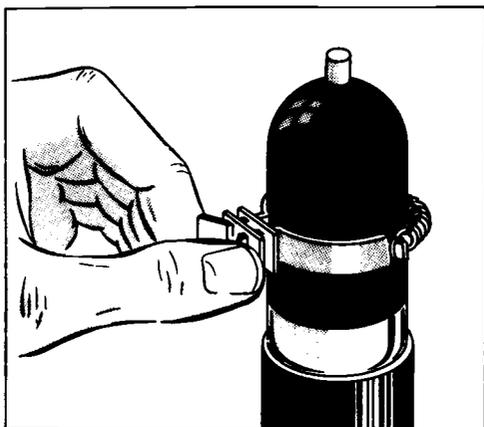
Fig. 604. *Barkhausen oscillation eliminator. The magnet is placed over the horizontal-output tube.*

anti-Barkhausen magnet (Fig. 604), may be placed around the horizontal output tube in such a position that the symptoms are eliminated. The output tube can also be replaced to cure the condition. Don't discard the original tube—it will probably function normally in some other set.

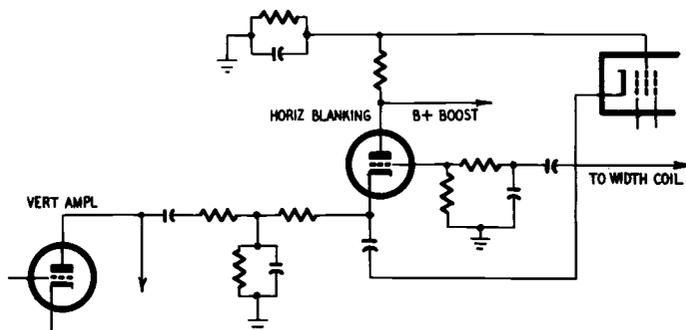
Fig. 605. Horizontal retrace blanking circuit. A sample of the fly-back pulse is fed to the grid of the horizontal-blanking tube. A positive voltage is sent to the picture tube cathode through a capacitor and cuts off the picture tube during horizontal blanking time.

In some TV receivers a horizontal retrace blanking circuit (Fig. 605) is employed. A circuit of this type eliminates the effects of *sync overshoot* at the transmitter. Sync overshoot refers to a narrow spike that is created at the transmitter by the sync pulse and directly follows it. The spike is opposite in polarity to the sync pulse and extends into the white region. Since it effectively un-blanks the picture tube during the blanking interval, it becomes visible as a vertical white line at the left-hand side of the picture. The line generally has a jagged or irregular appearance due to the fact that noise is associated with the sync pulse. It may become readily visible if the horizontal retrace blanking tube becomes defective.

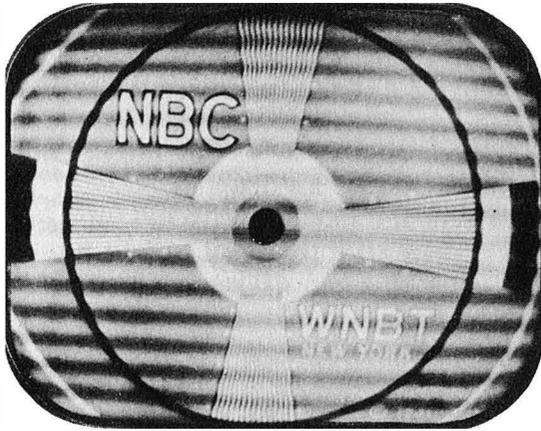
Fig. 606. Sound bars in the picture.

Possible causes of sound bars in the picture (Fig. 606) other than microphonic tubes are few if we exclude circuit troubles. A defective video detector crystal may be one such source—the correct tuning point may no longer coincide with the point where sound ripple is absent. The crystal used as video detector should be checked by substitution if sound appears in the picture when the fine-tuning control is adjusted for optimum resolution and like-lier sources of trouble have been eliminated.

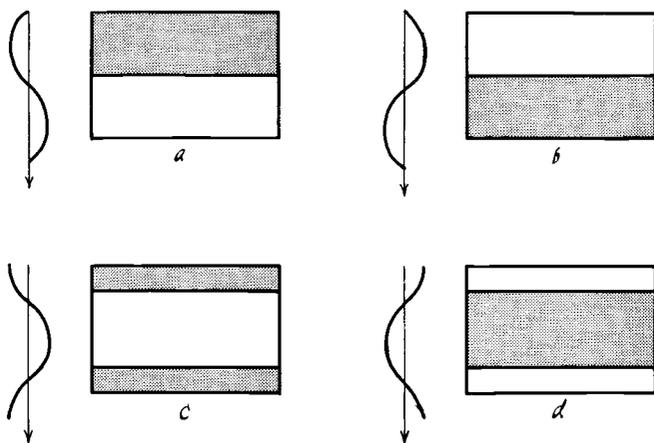
Fig. 607. Bar patterns that may be seen when a 60-cycle hum signal reaches the picture tube. Which pattern will be seen depends on the phase of the hum with respect to the line voltage. Drawings a and c show a 90° phase difference. The drawings in b and d show the effects of reversing the line plug.

Horizontal bars due to 60-cycle hum may cause the picture to have a dark bar over approximately half of its vertical area and a light bar over the other half. See Fig. 607. Or else a single prominent hum bar—either light or dark, depending on the polarity with which the line plug is inserted into the outlet—will be visible. Closer inspection will reveal that the shading of the picture sections not covered by the bar is improper (too light when the bar is dark; too dark when the bar is light).

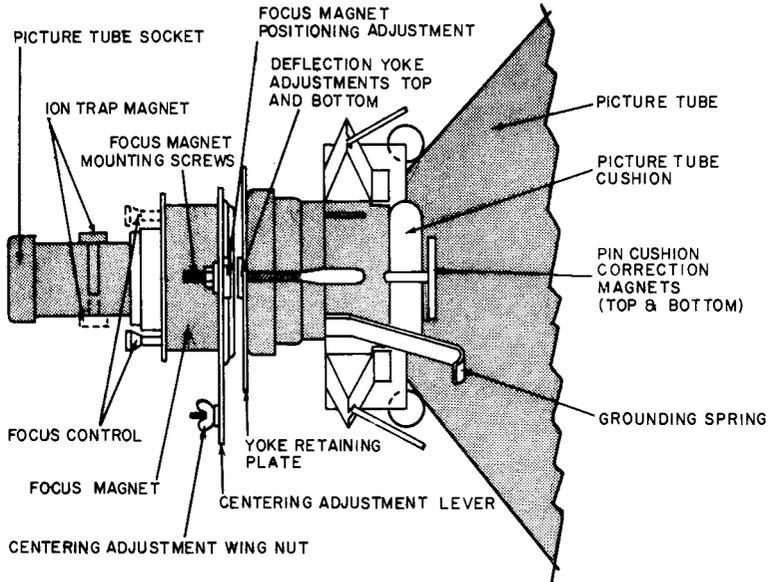
Fig. 701. Components mounted on the neck of the picture tube. The grounding spring connects the outer Aquadag coating to the chassis.

When an external Aquadag coating is used to form a capacitor with the internal coating, some means of grounding the external coating must be employed to make the capacitance effective in the circuit. Metal clips, bands or spring type wires are used for this purpose (see Fig. 701).

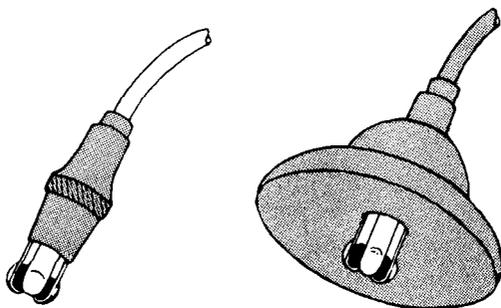
Fig. 702. *Picture-tube anode lead and rubber cap. The drawing at the left shows the appearance of the anode lead after the flange portion of the rubber cap has been trimmed.*

Either replace the cap with a new one or trim it off as shown in Fig. 702.

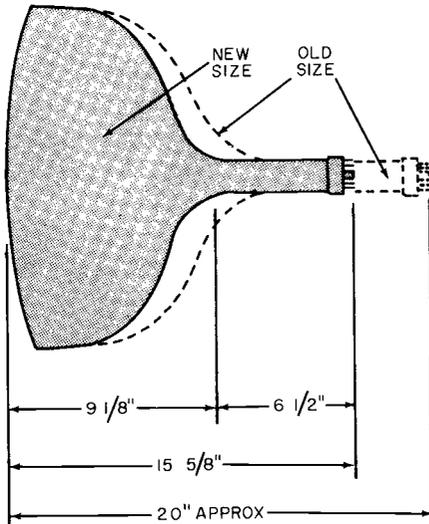
Fig. 704. Picture tubes can be made shorter as the deflection angle is increased. A picture tube with a deflection angle of  $110^\circ$  is less than 16 inches in length. This drawing shows the difference in length between two tubes having different deflection angles.

to match the higher deflection angles of large-screen tubes as these were developed. (Higher picture-tube deflection angles mean shorter tubes, as indicated in Fig. 704.)<sup>3</sup>

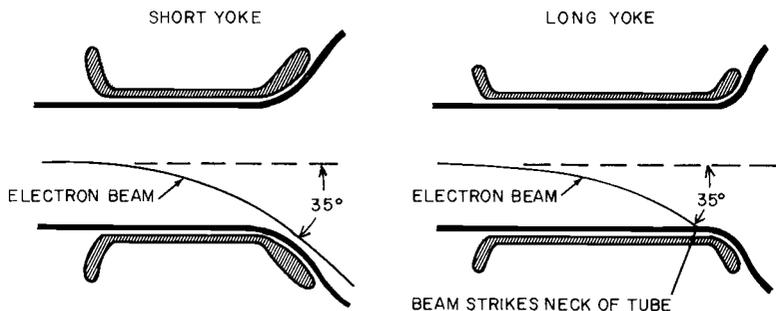
Fig. 705. Wide-angle yokes are shorter, use ferrite cores and have a higher inductance than other types of yokes.

To sweep a large-sized screen with a wide-angle yoke, the yoke must be very efficient. Let's see why this is so. The basic difference between the wide-angle yoke and its predecessors lies in the yoke length. The wide-angle yokes are *shorter*. With a long yoke, the possibility of increasing the deflection is limited by the fact that the electron beam tends to strike the neck of the tube if the angle is made too large (see Fig. 705).

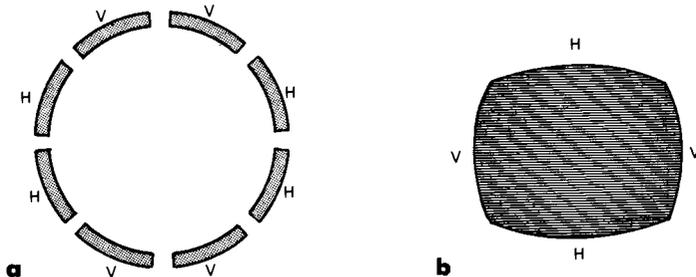
Figs. 706-a,b. Cross-section of the yoke used in older receivers. The field of this yoke is equivalent to four magnets placed as shown in the drawing at the right.

Early-make yokes tended to produce a nonuniform field because of their interlocked-winding construction. A cross-section drawing indicating this construction is shown in Fig. 706-a. The effect of such a construction is comparable to that produced by four permanent magnets, arranged as shown in Fig. 706-b. Because the field of the magnets is strongest in their immediate vicinity, deflection in these areas is greatest. The effect on the raster is *barreling*—a condition which causes a bowing outward of the raster sides (Fig. 707).

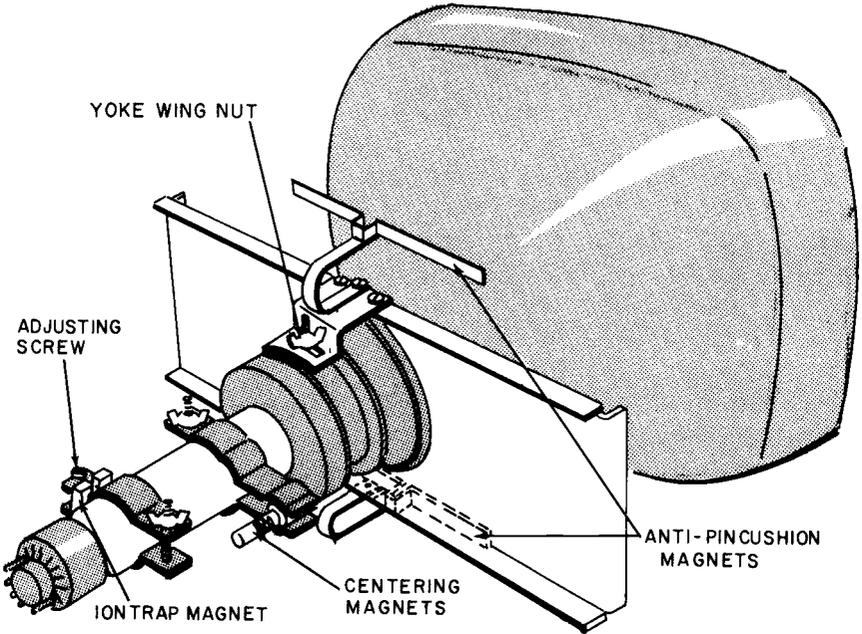
Fig. 709. This drawing shows how the anti-pincushion magnets are mounted.

Anti-pincushion magnets are used to correct the tendency of the cosine yoke to produce a nonlinear raster with squeezed-in sides. The magnets are variously known as *anti-pincushion*, *pincushion*, *pincushion correction*, *picture straightener* and *beam corrector* magnets. Small and nonstandard in size, frequently taking the form of a bar, they are mounted on or near the yoke at the side closer to the picture-tube screen (Fig. 709). The magnets come in pairs. One or two pairs of magnets may be used. A set may be found mounted above and below the yoke, as illustrated in Fig. 709, or at each side of the yoke, or both above and below the yoke *and* on each side.

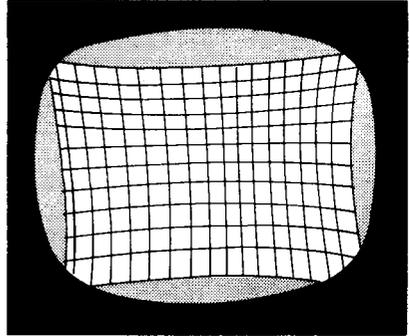
Fig. 710. *Cross-hatch pattern showing nonlinearity and pincushioning.*

or vertical pincushioning is to be checked for. Vertical bars are used in testing for horizontal pincushioning; horizontal bars for vertical pincushioning. When a cross-hatch generator is available, tests and adjustments may be made without the necessity of feeding two different inputs successively to the receiver (since the cross-hatch generator output is composed of both horizontal and vertical lines). A cross-hatch pattern which shows non-linearity and pincushioning is illustrated in Fig. 710. The appropriate magnets should be adjusted until the cross-hatch lines are straight.

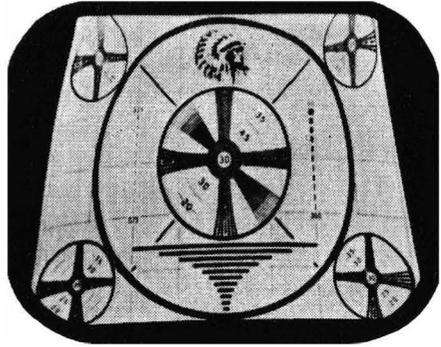
Fig. 712. *The photo shows the effect of keystoneing on a test pattern.*

A short in the horizontal yoke-balancing capacitor will greatly reduce the width of the raster; a characteristic *keystoning* will also be produced (Fig. 712).

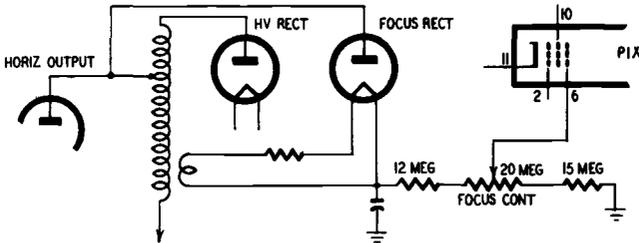
Fig. 713. High-voltage electrostatic focus.

In this system (Fig. 713) the focusing anode is connected to a high dc voltage (between 1,000 and 5,000 volts). Because of its high potential, the focus anode draws some current, causing its voltage to vary when the current through it changes for some

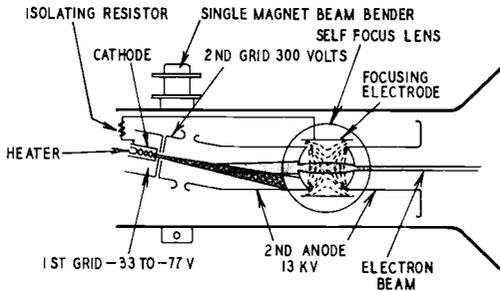
Fig. 715. Gun structure in the automatic or self-focus picture tube.

Variations in line voltage, brightness control resettings, etc. are not likely to cause defocusing because of the structure of the electron gun (Fig. 715). In this type of gun (as in the older electrostatic-focus gun) the second anode is split into two sections and the focus anode is mounted within the gap. A large-diameter focus electrode is used whose field overlaps that of the adjacent electrodes. Since the voltage between the first and second anodes at one side of the gap is always identical with the voltage between the same two anodes at the other side, the focus field remains substantially constant. A resistor, internally connected between the cathode and the focus anode, keeps the two electrodes at the same potential, preventing the defocusing that voltage variations between them might introduce. No external connection to the focus electrode is required for most automatic-focus tubes.

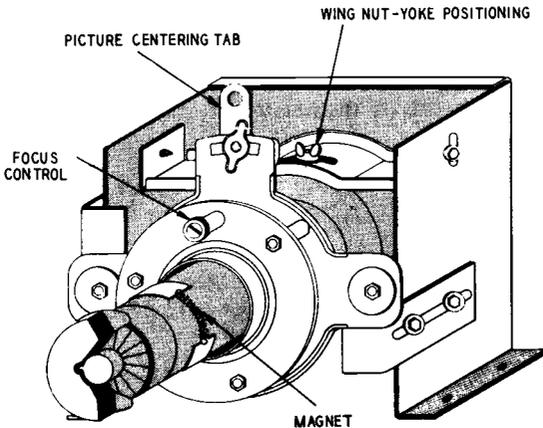
Fig. 716. Adjustment of the centering tab positions the picture.

In some receivers using a focus coil, and in most or all of those using a permanent-focus magnet, a lever on a plate or disk separate from but attached to the focus unit is employed for centering (Fig. 716). Sometimes, movement of the lever up or down provides horizontal centering; moving it right or left produces vertical centering. In other instances, up and down movement of the plate moves the picture up or down; sideways adjustment repositions the picture from side to side. Any nuts holding the lever in position must be loosened before it is free to be adjusted; these nuts are subsequently tightened.

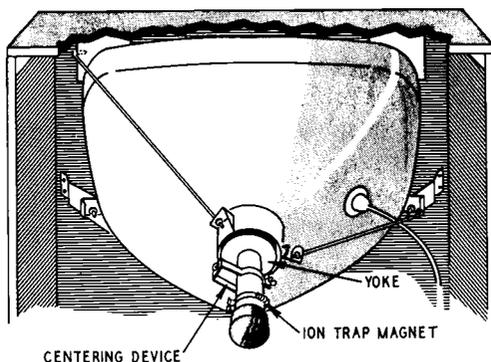
Fig. 717. The centering device is mounted on the neck of the picture tube.

A clamp type centering device completely separate from the focus assembly is used on the neck of some electrostatically-focused picture tubes (Fig. 717). To adjust such a unit, rotate it to the left or right and turn the knob at its top until centering is proper.

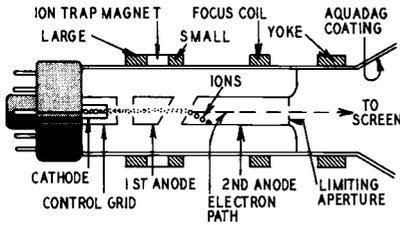
Fig. 718. The straight gun requires a double ion-trap magnet.

In the *straight-gun* (also called the *slashed-field* or *diagonal-cut*) ion trap the axis of the electron gun coincides with that of the tube neck (Fig. 718). A double ion-trap magnet is used around the tube neck. The warped electrostatic field set up in the oblique gap between the first and second anodes causes both ions and electrons to be deflected toward the neck of the tube. The rear or larger of the two ion magnets bends the electrons back to some extent. The smaller front magnet—the weaker of the two—finishes the bending job, causing the electron beam to travel through the second-anode aperture. Two internal pole pieces known as flags are attached to the gun. These units help shape the magnetic

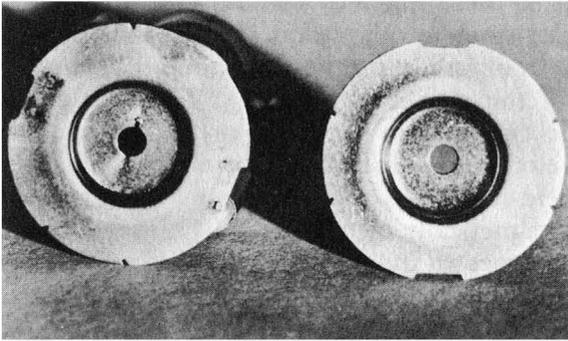
Fig. 721. *Improper setting of the ion-trap magnet can cause damage to the gun structure in the picture tube.*

A far more likely consequence of ion-magnet misadjustment is damage to the top disk of the high-voltage anode cylinder. When the adjustment is correct, beam electrons stream through the aperture in this disk. When the adjustment is incorrect, on the other hand, the direction of the beam is improper and some of the electrons in the beam may now bombard the edges of the aperture. The heat generated by this bombardment can vaporize parts of the aperture, as illustrated in Fig. 721. The damage will impair focus (since the aperture regulates the size and shape of the beam), causing a blurred or poorly defined picture. In some cases, bits of metal that have been torn away from the aperture are deposited on the screen, producing dark areas there.

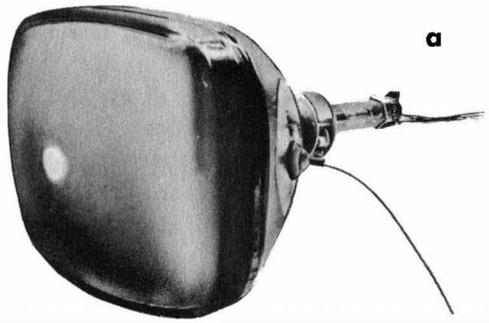
Fig. 722-a. The photo shows the appearance of the scanning spot on the picture-tube screen

Figs. 722-a through j illustrate the kinds of spot that may be seen on the screen. Figs. 722-a,b show what the spot will look like when a new good tube is present. Note the round, uniformly illuminated appearance of the spot in this case. Fig. 722-c shows what the scanning spot will look like when the tube has been in use for some time. The scattered light shadows are normal. In Figs. 722-d,e,f the shadows become progressively darker and more numerous. There is little or no cathode emission from the dark areas. Tubes that produce spots of this kind may or may not perform properly. If a picture-tube checker indicates that the emission is normal, the tube can be considered as still usable. Figs. 722-g,h-i and j show scanning spots in which extensive areas are dark. The shape of the spot in these cases is effectively distorted as well. Tubes that produce such scanning spots will have impaired focus as well as inadequate contrast.

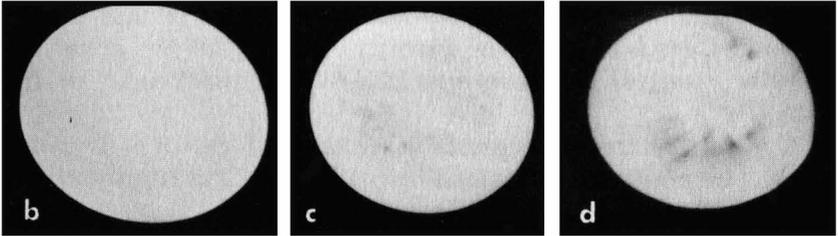
Figs. 722-b, c, d. The photo at the left shows the appearance of the scanning spot in a new tube. The other two photos illustrate the effect on the scanning spot after the picture tube has been in operation for some time.

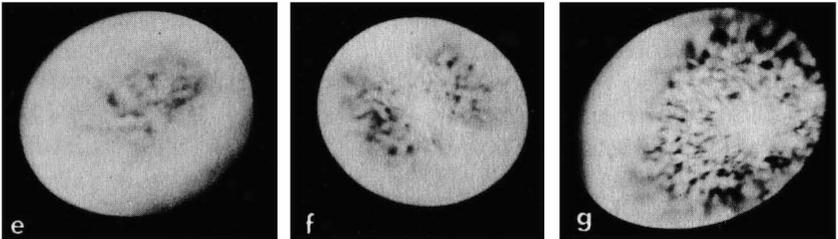
Figs. 722-e, f, g. These photos show how the scanning spot becomes progressively worse. Note the distortion of the spot and the appearance of shadows.

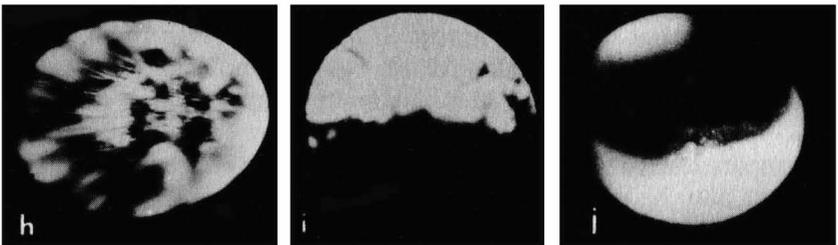
Figs. 722-h, i, j. These photos of the scanning spot indicate that a large area of the picture-tube cathode is dead. The dark shadows mean loss of cathode emission. The scanning spots are also severely distorted.

The test just described is a useful supplementary one to a test with a tube checker. When the tube checker indicates that the emission is passable, but a scanning-spot inspection reveals that large cathode areas are dead, the verdict of the spot-inspection test is the more reliable one. (It is assumed the symptoms pointing to a loss of emission in the tube are present.) If emission reads below normal and the spot resembles one of those shown in Figs. 722-h, -i, and -j, replacement of the tube is also called for.

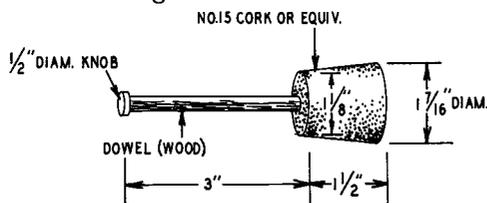
Fig. 723. A cork and a wooden dowel make a very suitable tube tapper.

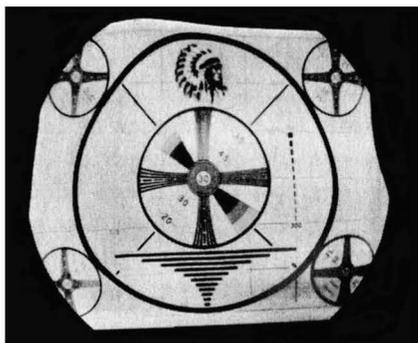
Fig. 724. This photo shows the effect on a test pattern when the metal cone of a picture tube becomes magnetized.

The metal cone of a metal-glass picture tube will become magnetized if a strong magnetic field is brought near it. Contact of the cone with the magnet of a PM speaker is the commonest cause of cone magnetization. The characteristic symptom produced is a distortion of the picture and raster. The raster's edges are generally twisted out of shape. (Fig. 724). Magnetization of

the middle and small end of the cone tends to cause the severest distortion. The defect is readily identified with the aid of a pocket compass. The needle of the compass will deflect toward the magnetic area on the cone, when the compass is brought near the latter.

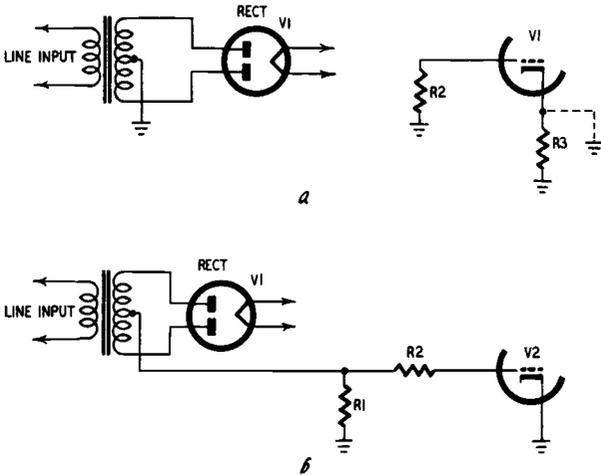
Figs. 803-a, -b. One method for eliminating hum caused by heater-to-cathode leakage is to short the cathode resistor (upper drawing) and replace it with a bias network connected to the power supply (lower drawing).

leakage (other than replacing the tube) is to ground the cathode of the tube and apply the correct amount of negative dc voltage to the grid (as a bias) from some suitable source in the set. The center-tap circuit of a power-transformer secondary in an ac receiver may provide such a source, as illustrated in Fig. 803.

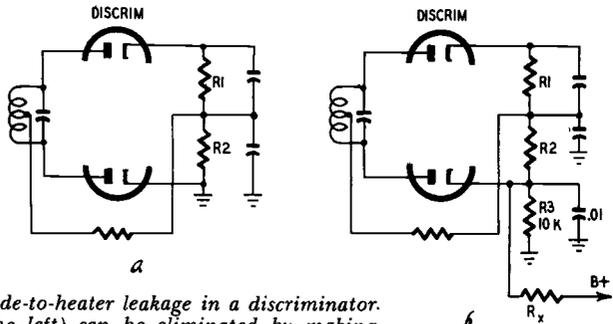
Figs. 804-a, b. Cathode-to-heater leakage in a discriminator tube (drawing at the left) can be eliminated by making circuit changes (drawing at the right).

the normally grounded cathode positive with respect to the filament (the other cathode is already positive). This may be readily achieved by inserting a resistor of about 10,000 ohms, bypassed by a .01- $\mu$ f capacitor, in series with R2 (Figs. 804-a,-b). Now add series resistor  $R_x$  as indicated in Fig. 804-b. The value of the resistor should be such that 10 to 15 volts is developed across R3, the 10,000-ohm resistor. When the B voltage is 250, use of a resistor of about 160,000 ohms for  $R_x$  will provide the correct voltage drop across R3.

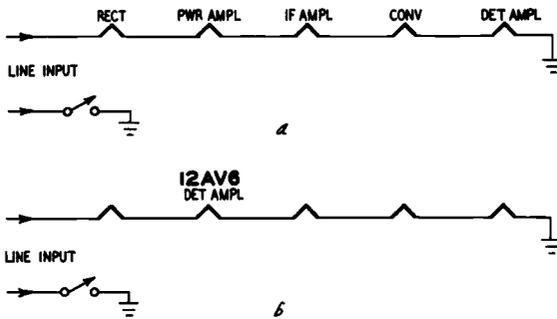
Figs. 805-a, -b. Improper wiring of the series filaments in an ac-dc receiver can be a source of hum.

tioned at too high a point in the filament string (Figs. 805-a,-b). The above-normal ac voltage present between heater and cathode of the 12AV6 produced a greater-than-usual amount of leakage between the two elements; since hum in the first audio amplifier receives more amplification than hum developed in any other stage, audio trouble resulted.

The service technician should know the correct lineup of tube filaments in ac-dc sets to recognize similar trouble. The first audio amplifier (and detector) should be at the bottom of the string or nearest ground (Fig. 805-a); next to this filament should be that of the converter (since this tube is very prone to modulation hum); then the if amplifier, power amplifier and rectifier filaments, in that order.

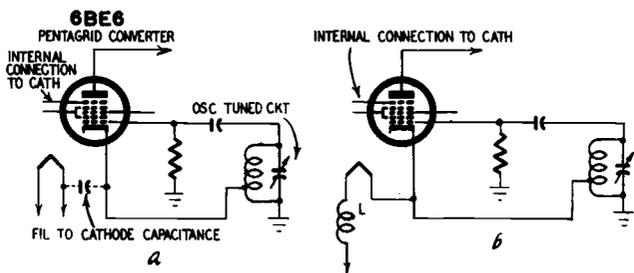
Figs. 807-a, -b. Filament-to-cathode capacitance (drawing at the left) can result in howling. One technique for minimizing this trouble is the use of an rf choke (modified circuit shown at the right).

If vibration causes the heater to move in the cathode sleeve at an audio-frequency rate, the heater-to-cathode capacitance will vary at the same rate. The oscillator frequency of operation will therefore vary at this rate. This undesired frequency modulation of the oscillator is detected along with desired FM signal and becomes audible as a howl. Connection of the cathode to the heater, either directly or through a capacitor, and the insertion of rf chokes in one or both legs or the heater (Figs. 807-a,-b) are often used to minimize such microphonics.

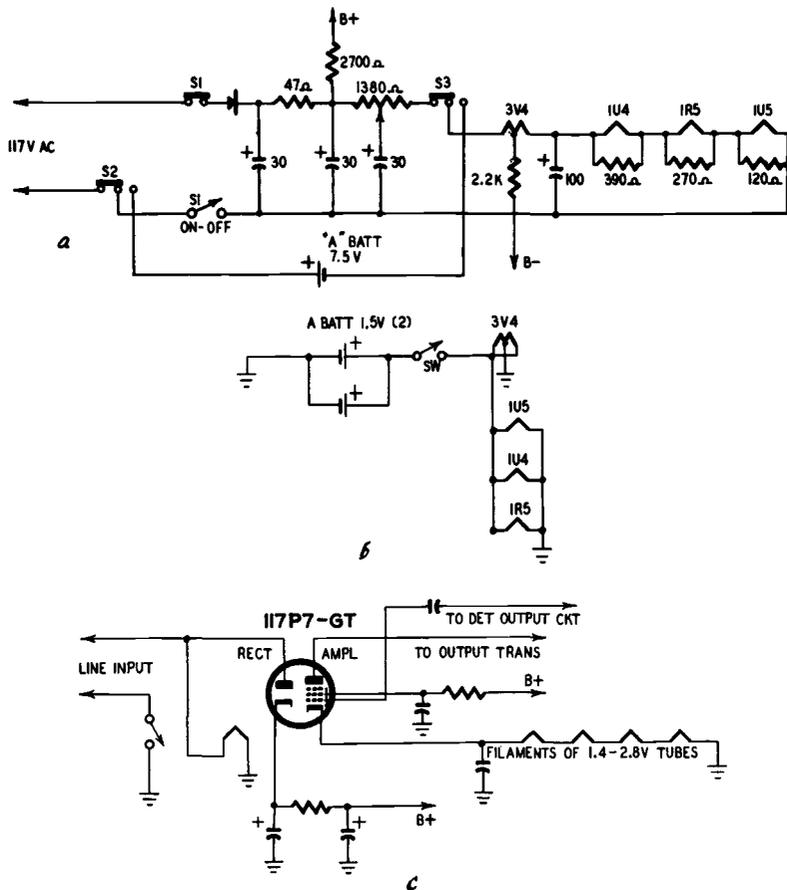
Figs. 808-a, -b, -c. Filament connections in portable radio receivers are shown in these three drawings.

Tubes used in portable sets (except for the tube rectifier that is sometimes present) have low-voltage filament cathodes. Battery operation demands such a design. The filaments are generally connected in one of the ways indicated in Figs. 808-a,-b,-c.

4. In the case of a circuit like the one shown in Fig. 808-c, where a combination rectifier-power amplifier tube is present and the amplifier section feeds the filaments of the 1.4- or 2.8-volt tubes, a loss of emission in this amplifier section may be responsible.

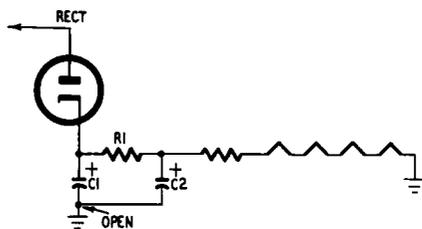
Fig. 810. Increased ripple voltage applied to the filaments (when the filter is open) can result in damage to the tubes.

4. Open in the common negative of a filter capacitor at the point indicated in Fig. 810. While such trouble is not common, it can and does occur. The filtering action is partially impaired

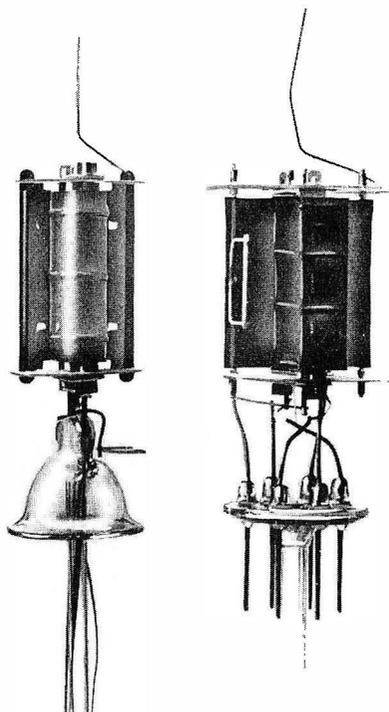
Fig. 901. *Types of stem construction.*

Significant for longer life was the changeover from the old press-stem construction to the newer button-stem construction. In press-stem construction the base leads enter the tube through the glass stem in a straight line (Fig. 901). Lead wires are necessarily thin and there is a considerable distance between the base pins and the tube mount. In button-stem construction the leads go directly from the base pin through the glass into the tube mount, being arranged in a circle similar to that used in miniature tubes. This type of construction uses heavier and shorter leads, resulting in better heat transfer from inside the tube through the base pins. It also leaves more room between the top of the tube mount and the glass, which results in improved heat radiation.
