TV and radio TUBE TROUBLES

SOL HELLER

GERNSBACK LIBRARY NO. 68

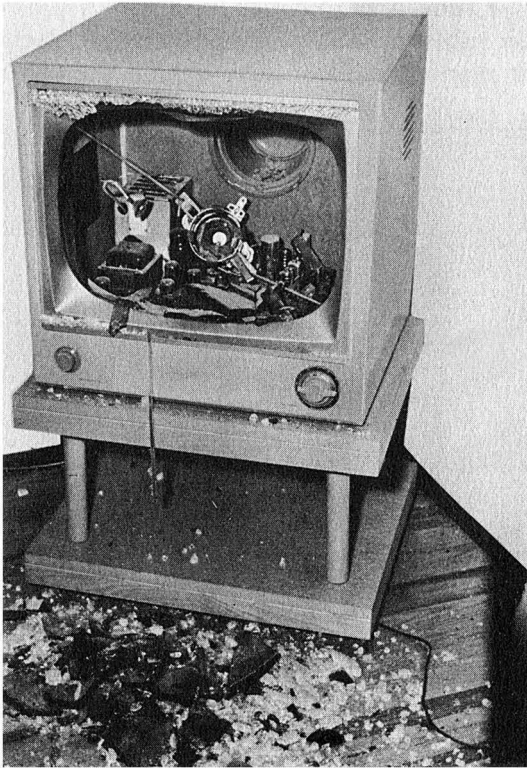
Fig. 102. Result of a cathode-ray implosion due to inadequate safety precautions.

hand between the tool and the tube to prevent the tube from being struck if the tool should slip. (The result of an implosion is shown in Fig. 102.)

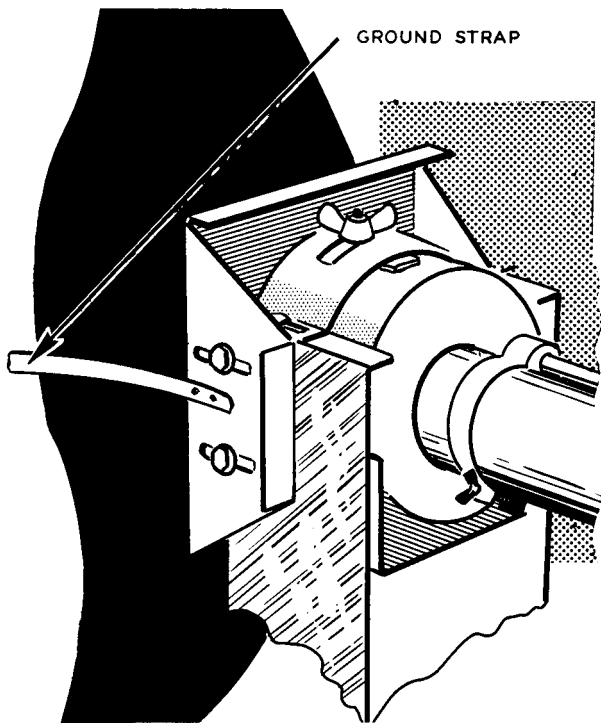
Fig. 104. Sketch showing ground strap on picture tube. Hairpin type clips are also used to place the glass envelope at ground potential.

The first precaution to take when a C-R tube is to be substituted in a TV set is to check whether the grounding clip or strap (if the tube is a glass type) is making contact with the Aquadag coating (Fig. 104). If it isn't, the proper adjustment should be made to remedy the condition and insure that no residual charge is left on the tube when the power is turned off and tubes are interchanged. The receptacle or cup of a disconnected glass C-R tube should be discharged to ground before the tube is handled.

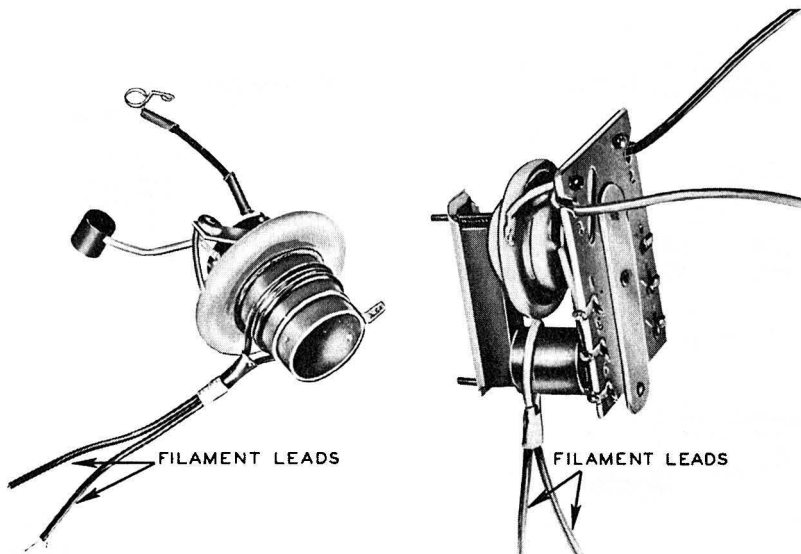
Fig. 208. Photos of flyback units, showing number and position of filament windings. One or two turns may be used, depending on the filament voltage requirements and the construction of the flyback transformer.

A shift in the coupling of the high-voltage rectifier filament winding on the flyback transformer may be the source of frequent tube burnouts (Fig. 208). If a similar flyback is present in another receiver, a comparison can be made to verify whether such a shift has occurred. If it has, the filament winding may be moved a short distance—perhaps $\frac{3}{16}$ inch or thereabouts—away from the high-voltage winding on the transformer. If set performance remains satisfactory, the winding may be left in this position.

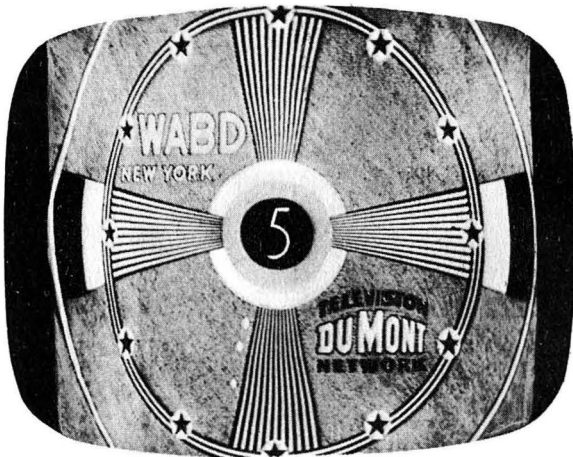
Fig. 305. Photo of test pattern indicates insufficient width.

Insufficient width (Fig. 305) may be due to a weak damper, horizontal output tube or low-voltage rectifier. When the rectifier is weak, other symptoms will generally (but not always) be mani-

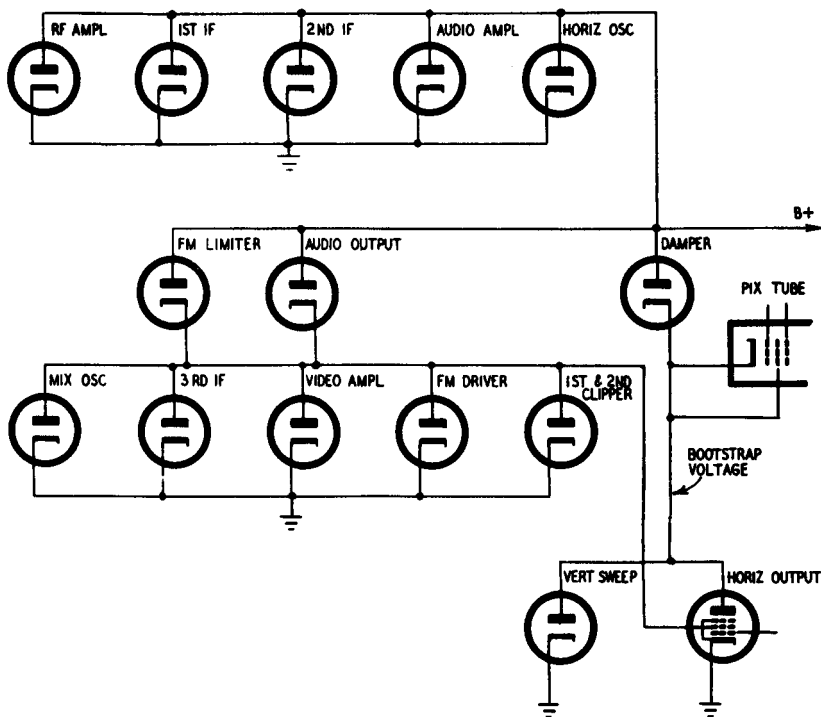
In sets with stacked tubes a defective audio output tube may be the cause of no pix and sound (Fig. 405) if the video if and

Fig. 405. Block diagram showing a tube-stacking arrangement. Failure of the audio output tube can decrease the B-plus voltages on the video signal carrying tubes with which the audio output tube is in series. Picture as well as sound can be lost.

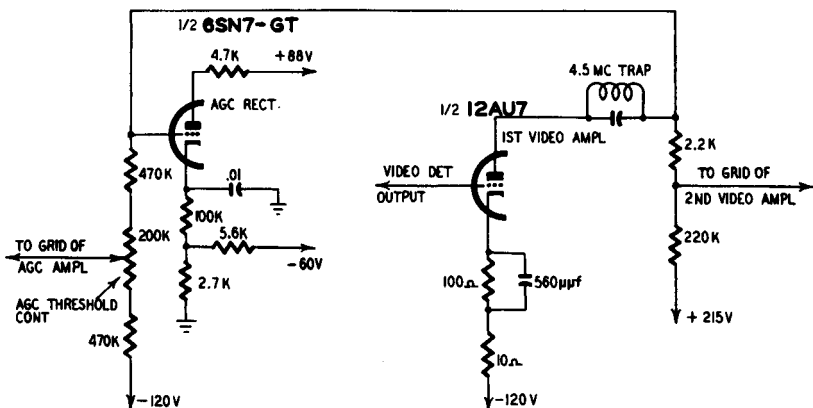
In a circuit such as that shown in Fig. 406, a defective video amplifier may cause an excessive agc bias to be developed, elim-

inating picture and sound. Since the video amplifier is not common to the sound and video signals in this split-carrier set, the technician would not ordinarily look in the video amplifier for a fault affecting both sound and pix.

Fig. 406. Video amplifier and associated circuits. Excessive agc bias can result from a video amplifier defect.

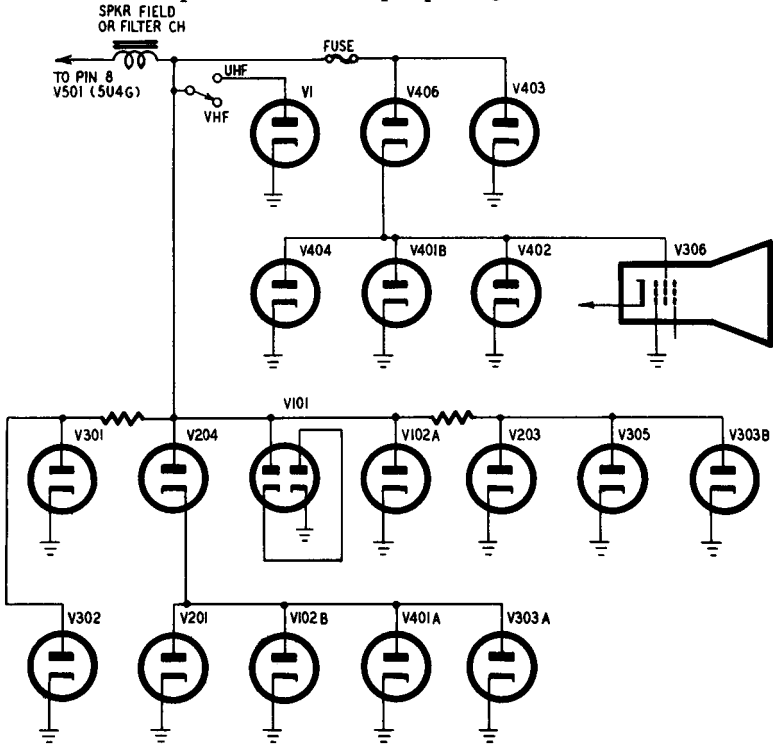
Fig. 407. Block diagram showing tube stacking. V204 is the sound output tube. Its heavy current will be reduced when it loses emission, causing the plate voltages on V101, V102A, V203, V305 and V303B to rise. The tubes are shown as diodes for the sake of simplicity

receiver's sound volume is above normal), a defect in an agc tube may be present. In a circuit such as the one shown in Fig. 407, a loss in agc bias will cause an excessive signal input to the video amplifier. The video amplifier may be driven into cutoff, thus killing the picture. The sound signal, on the other hand, will be

amplified more than usual because of the loss of agc bias at the rf amplifier and first video if stage in this split-carrier set.

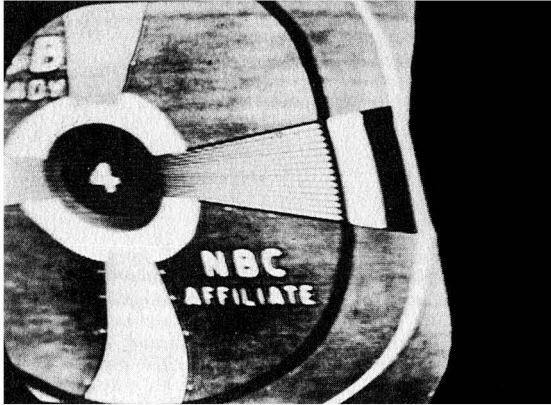
Fig. 510. Horizontal jitter or weaving. The trouble in this case was due to a short between cathode and heater of a sync clipper-amplifier tube.

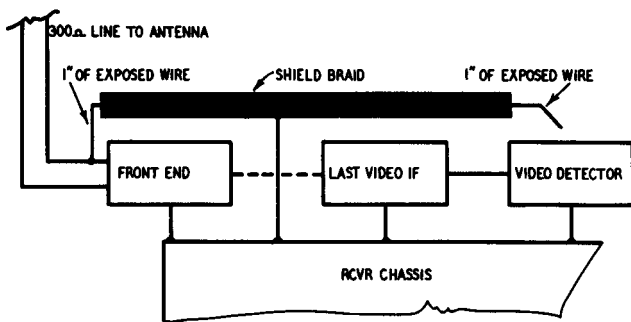
Fig. 601. Technique for checking the source of radiation interference.

To check on whether interference is due to radiation from an unshielded last video if or video detector, connect one end of a short length of shielded wire (Fig. 601) to one of the antenna input

terminals. Hold the other end close to the last video if or detector tube. Approximately 1 inch of wire should protrude from the shield at each end and the shield itself should be firmly attached to the receiver chassis. If the interference is intensified by the increased coupling, radiation from the last video if or video detector is indicated. When the source of interference is a sound or video

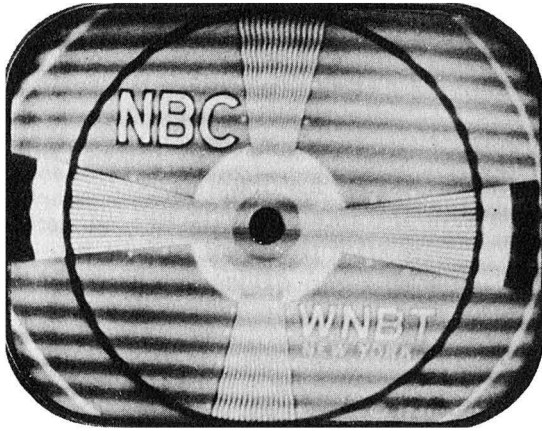
Fig. 606. Sound bars in the picture.

Possible causes of sound bars in the picture (Fig. 606) other than microphonic tubes are few if we exclude circuit troubles. A defective video detector crystal may be one such source—the correct tuning point may no longer coincide with the point where sound ripple is absent. The crystal used as video detector should be checked by substitution if sound appears in the picture when the fine-tuning control is adjusted for optimum resolution and like-lier sources of trouble have been eliminated.
