# **RAPID TV REPAIR**

**G. WARREN HEATH**

*published by gernsback library, inc.  
new york, n. y.*

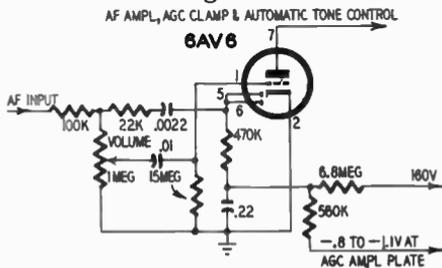
Fig. 1-A. The audio amplifier serves a number of different circuits.

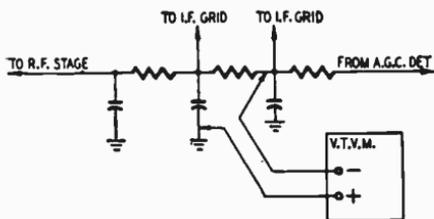
Fig. 2-A. *Measuring the agc voltage.*

The normal voltage at the grids of the rf amplifier and some video if tubes should range from zero to approximately  $-10$  volts. You can measure the agc voltage as shown in Fig. 2-A. If the bias

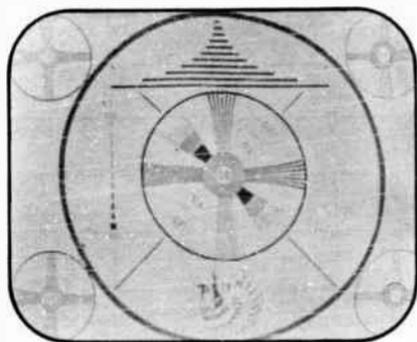
Fig. 3-A. *Effect of defective agc on the test pattern.*

on the controlled tube is excessively negative, the pix may become very faint or will be lost entirely, including the sound. On blank channels, noise spots will not appear. A defect in agc can cause no pix (sound and raster ok); no pix or sound (raster ok); pix dark with buzz, pix pulling or bending, tearing, weak and snowy pix with weak sound, and weak pix; or no horizontal and vertical sync, or hum. See Fig. 3-A.

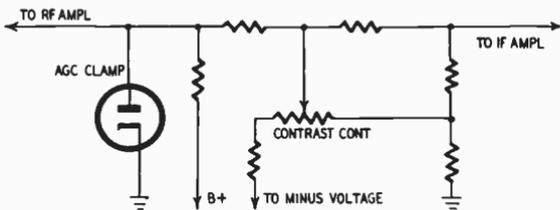
Fig. 5-A. Simple agc clamp circuit.

Changes in resistors (see Fig. 5-A) can produce any symptoms in between the above cases. A short on the resistor connected to B+ can damage rf and agc controlled tubes by application of positive voltage to their grids as well as possible destruction of the agc clamp tube. (Refer also to section on keyed agc.)

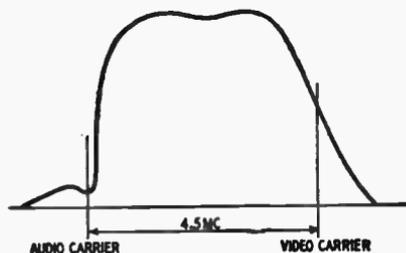
Fig. 6-A. Position of the video carrier on the slope of the if response curve.

Failure of sound and picture to track (that is, best sound and picture do not occur together) indicates need for realignment of front end or if. Note that the foregoing does *not* mean the brightest picture, as the picture carrier is placed *halfway* up the pix carrier slope on the if curve. See Fig. 6-A.

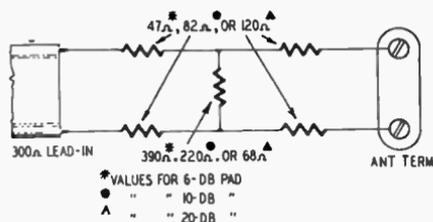
Fig. 7-A. Overloading, due to excessive signal, can be cured by using attenuator pad.

The higher the antenna, the greater the area covered. Always check direction other antennas face. Antenna should clear all trees and buildings, and should not be placed near elevators, metal surfaces or electrical devices. A very strong signal can cause the pix to smear or bounce, due to overloading of rf amplifier tube. Agc may be defective or inadequate. A simple remedy is to insert an attenuator between the transmission line and antenna terminals. See Fig. 7-A. Use 1/2 watt, carbon resistors.

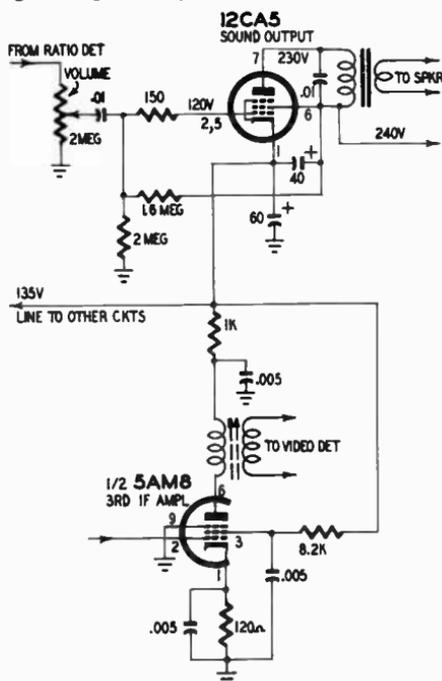
Fig. 8-A. The audio-output tube is sometimes used as a voltage divider.

When servicing the low-voltage power supply, consider the increasing tendency of set manufacturers to eliminate dropping resistors as voltage dividers to provide different plate voltages. In some sets voltage division is accomplished by using the audio-output tube (see Fig. 8-A.) as a dropping resistor in series with several other stages, especially the video if tubes.

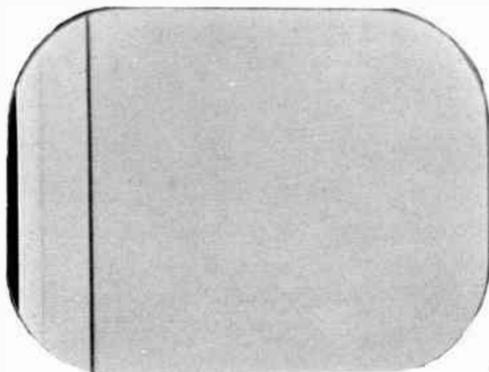
Fig. 1-B. *Appearance of Barkhausen oscillation on screen.*

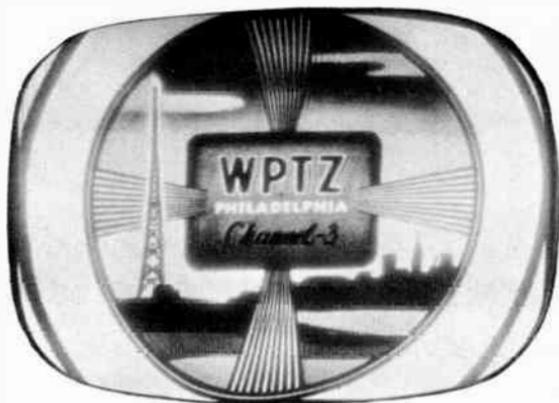
Fig. 2-B. Vertical wedges show severe bending.

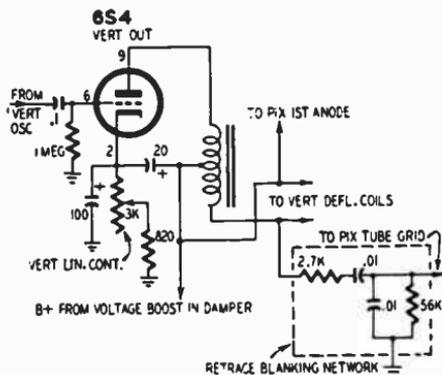
Fig. 3-B. This vertical-output circuit gets its plate voltage from the B+ boost in the damper.

When trouble develops in a vertical circuit operating from the B+ boost line, check the electrolytic decoupling capacitor at the B+ feed line. The boost voltage may be increased by connecting the vertical sweep to another B+ source.

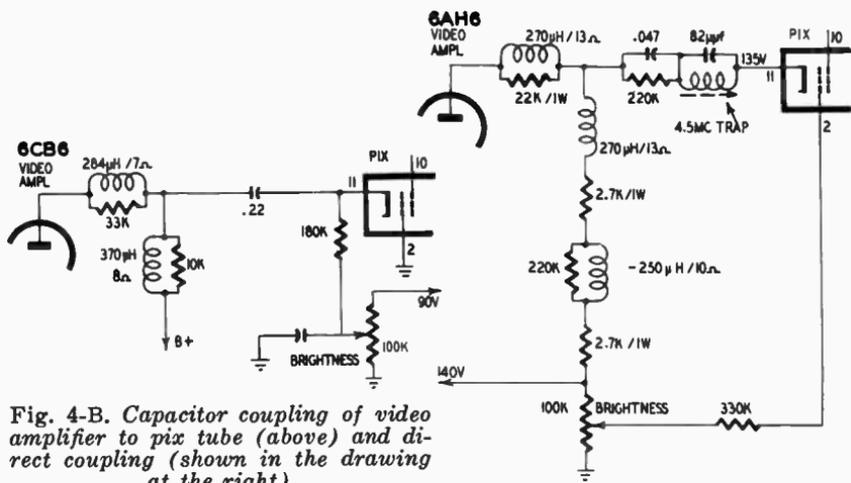
Fig. 4-B. Capacitor coupling of video amplifier to pix tube (above) and direct coupling (shown in the drawing at the right).

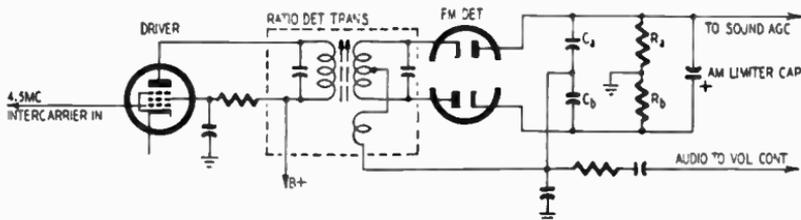
Fig. 5-B. *Typical ratio-detector circuit.*

company pix distortion, but disappearing with a weak signal. Occasionally buzz will be heard only with a weak signal produced by unbalance in the ratio detector and caused by defective ratio-detector capacitors ( $C_a$  and  $C_b$  in Fig. 5-B), or resistors ( $R_a$  and  $R_b$  in Fig. 5-B).

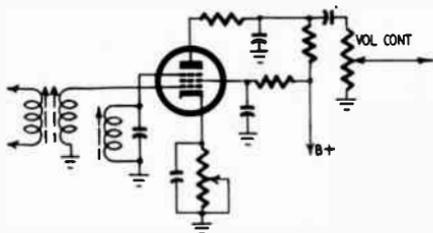
Fig. 6-B. Gated beam FM detector circuit.

**SYMPTOMS:** The gated-beam FM detector circuit (Fig. 6-B) becoming increasingly employed by set manufacturers, incorporates a 6BN6 tube serving as a limiter-detector in the audio circuit.

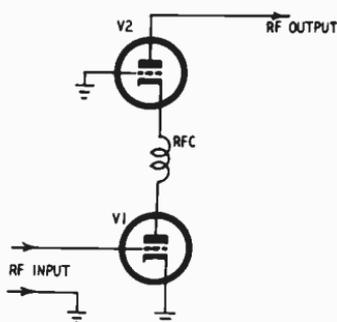
*Fig. 1-C. Simplified circuit of the cascode tuner. The two tubes are connected in series across the B+ line. Because the cathode of V2 is about 125 volts above ground, there can be a breakdown between the filament and cathode.*

While the cathode of V1 (Fig. 1-C) is at ground potential, the cathode of V2 is about 125 volts above ground. Thus, while a heater-cathode leakage is of little consequence in V1, it can cause a great deal of trouble in V2. Because of the large potential difference between heater and cathode of V2 these elements frequently short.

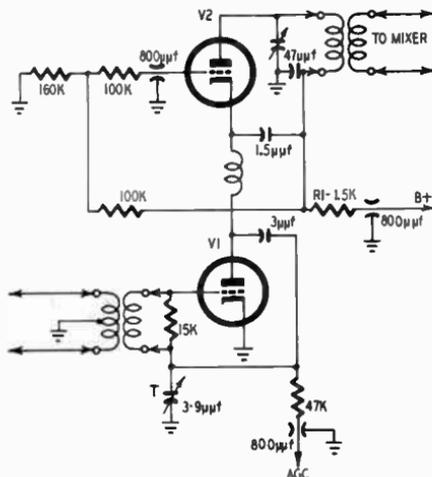
Fig. 2-C. *Circuit of the cascode tuner.*

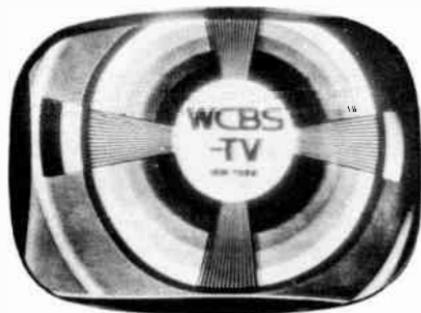
*Fig. 3-C. Pix is improperly centered due to intermittent horizontal shift.*

**SYMPTOMS:** Intermittent, horizontal shift of pix. See Fig. 3-C.

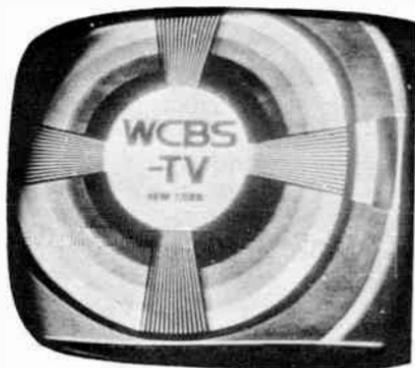
Fig. 4-C. *Shifting of pix by misadjusted focus assembly.*

**SYMPTOMS:** Picture has shifted. Dark, crescent-shaped area around the left side and bottom of the picture. See Fig. 4-C.

**SERVICE:** Accidental shifting of deflection yoke and focus unit (when installing new picture tube) produces this effect. The yoke and focus unit are usually mounted in brackets which permit the units to be shifted slightly in all directions. Moving the deflection yoke toward the rear or shifting the focus unit to one side or rotating it about either axis will produce this trouble.

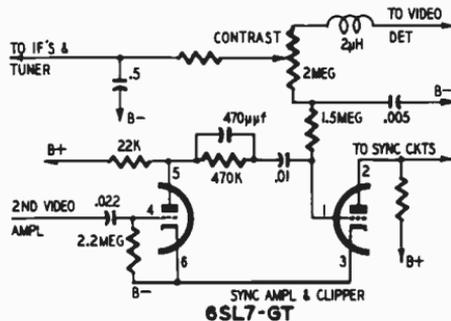
Fig. 5-C. Contrast-control circuit.

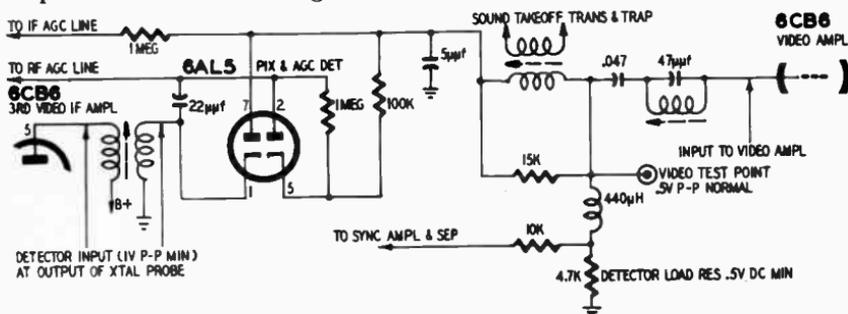
Fig. 6-C. Schematic diagram of a representative video-detector circuit.

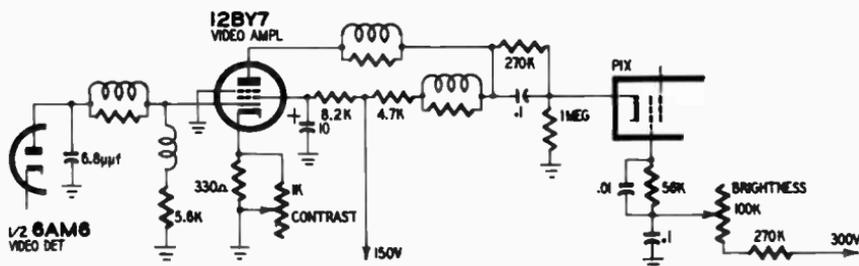
Fig. 7-C. Contrast control in the cathode circuit of the video amplifier. Compare with that shown in Fig. 5-C.

The contrast control may be either in the video if section or the video amplifier. In sets of early vintage, without agc, the contrast control had to be varied to adjust the amount of signal at the video detector; in sets with agc, the contrast control is in the video amplifier section. See Fig. 7-C.

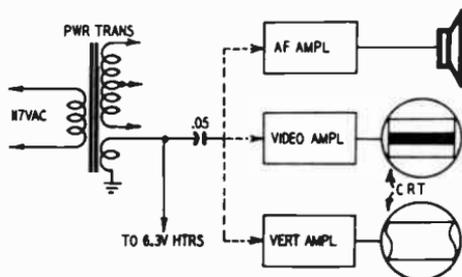
Fig. 8-C. Filament voltage can be used as a signal source.

The intensity of the bars is usually made greater as the generator lead is moved back from stage to stage. Any circuit causing a reduction in signal strength is the defective stage. If you do not have a portable signal generator, use the receiver filament voltage (do not use rectifier filament) as a signal source, as shown in Fig. 8-C. Click testing may be helpful.

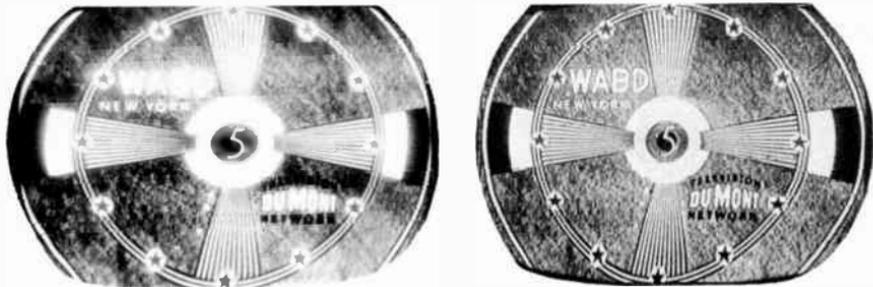
*Fig. 9-C. A photo of the face of the picture tube (before cleaning) is shown at the left. The photo at the right shows the same test pattern after the screen and the mask were cleaned. The high voltage of the picture tube seems to attract dust and will deposit a uniform layer of it over the screen.*

**SERVICE:** The high electrostatic charge on the face of the pix tube attracts dust. This forms a fine uniform film of dirt across the screen, even though it is covered by a mask. Fig. 9-C shows pictures taken before and after cleaning the tube. Pull plug from line and make sure that there is no voltage or charge on tube. Clean face carefully with soft cloth and lukewarm water. Do not use soaps, abrasives or cleansers. Clean mask at the same time.

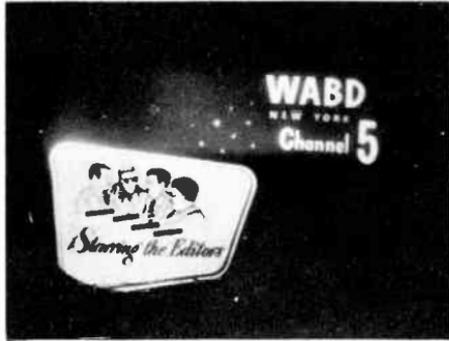
*Fig. 1-D. Poor dc restoration results in a gray picture. Dc restorers are found in old receivers, many of which are still in use.*

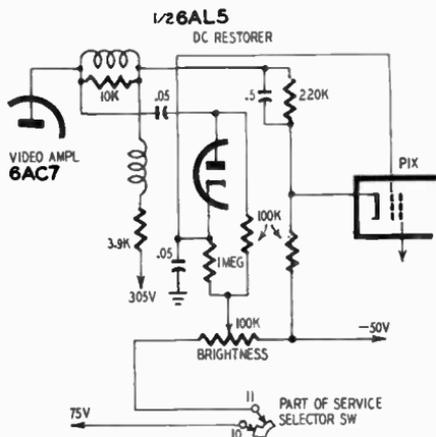
Fig. 2-D. The dc restorer acts as an automatic brightness control.

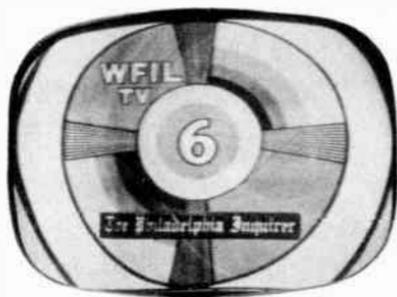
Fig. 3-D. Poor pix detail because of loss of higher video frequencies.

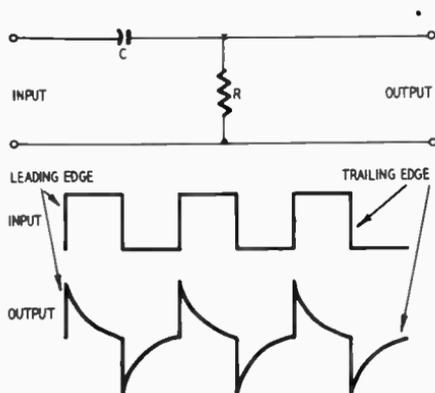
Fig. 4-D. Effect of differentiator on horizontal-sync pulses.

**SERVICE:** Differentiator is an R-C network (high-pass filter) used to separate horizontal pulses for triggering the horizontal

oscillator. See Fig. 4-D. From sync separator, the output is usually fed to afc circuit of horizontal-sweep system. Check for defective capacitors or resistors in differentiator circuit. Test these small-valued capacitors by substitution, and not by shunting.

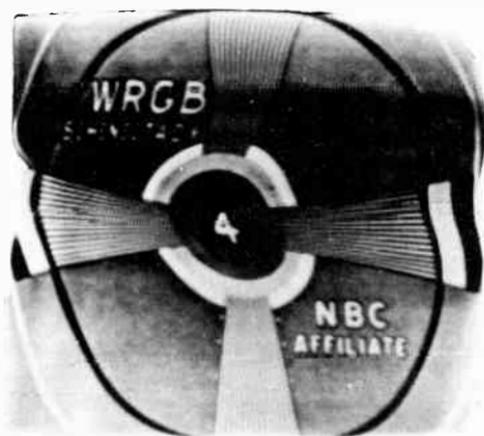
Fig 5-D. *Distortion due to hum voltage*

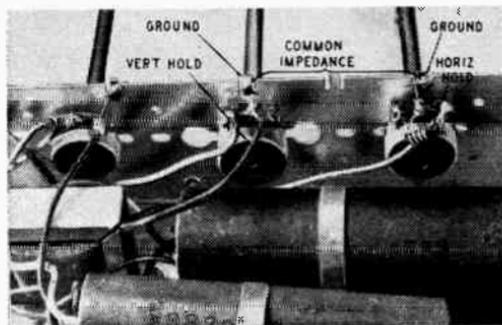
Fig. 6-D. Photo shows close positioning of vertical- and horizontal-hold controls.

Fig. 6-D). The chassis ground currents from these controls will thus mix.

The chassis has relatively low resistance and reactance, hence a low impedance to currents of these frequencies. But the large flyback pulse of the vertical oscillator can feed directly into the horizontal-oscillator circuit and distort the first few lines of the horizontal sweep, causing a hook or bending at the top of the picture. Additional afc control line filtering will not help much in this situation; neither will more complete filtering of the B-plus

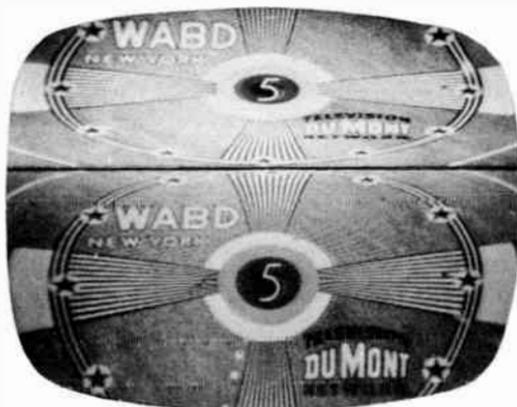
Fig. 7-D. *Double pix caused by vertical oscillator working at 30 cps.*

**SERVICE:** Caused by vertical oscillator working at 30 cycles per second instead of 60 cycles, due to increase in time constant of vertical-oscillator circuit.

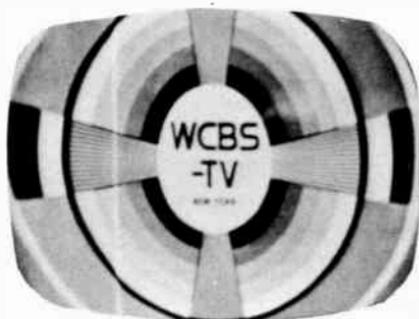
Fig. 8-D. *Overdrive indicated by vertical white line.*

**SYMPTOMS:** Short life of horizontal-output tube. High-voltage fuse may blow. Overdrive lines appear on screen. Pix may stretch

on left-hand side, sync is not steady. See Fig. 8-D.

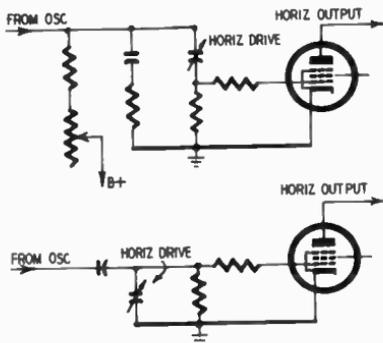
Fig. 9-D. *Typical horizontal-drive control circuits.*

Typical horizontal-drive controls are illustrated in Fig. 9-D.

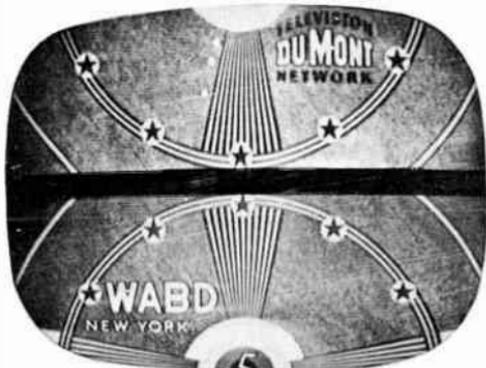
Fig 1-E. *Rolling pix vertically permits examination of blanking bar.*

**SERVICE:** Check adjustment of vertical size, linearity and centering controls when receiving program. Remove vertical-output tube. This will result in a horizontal white line. Adjust centering control until line is in vertical center of screen. Replace vertical-output tube and adjust vertical size and linearity controls for correct pix. Rotate vertical hold to allow pix to roll slowly. See Fig. 1-E. Blanking bar should not change thickness going from top to bottom.

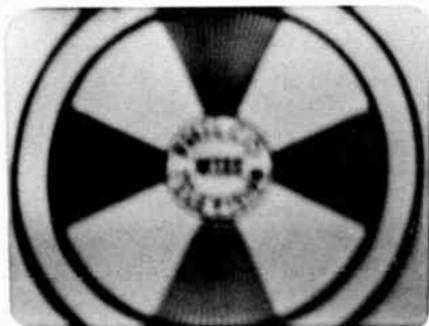
Fig 1-F. *Blurred pix due to poor focus.*

**SYMPTOMS:** Improper focus, resulting in blurred pix. See Fig. 1-F.

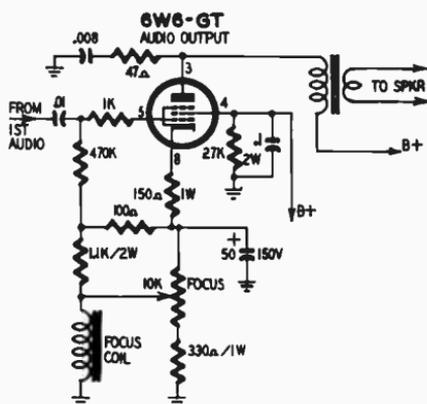
Fig. 2-F. Focus coil in audio-output circuit.

The focus coil often forms part of the cathode, screen, or plate circuit of the audio-output tube. See Fig. 2-F. Focus is controlled by a potentiometer placed in the cathode circuit of the same tube. The focus coil is usually bypassed by a large electrolytic capacitor. Any of the usual troubles in the audio stage can cause an out-of-focus condition—leaky coupling capacitors, defective output tube, shorted screen, plate or cathode bypass capacitors, open output transformer primary, and defective audio-amplifier tube. If the speaker should become detached, the focus coil would lose voltage and be inoperative.

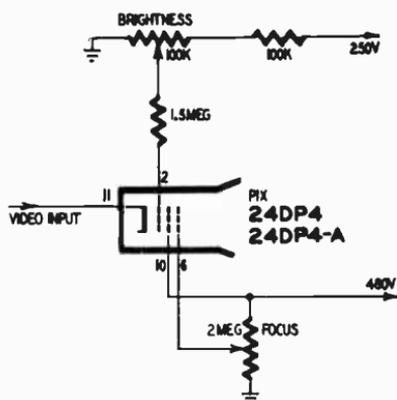
Fig. 3-F. This circuit uses electrostatic focusing.

Erratic focus can be due to a defective focus potentiometer. See Fig. 3-F. Connect a vtvm from center arm of the potentiometer to either end. Rotate the variable arm and watch meter needle. Needle movement should be smooth. If jumpy, replace control.

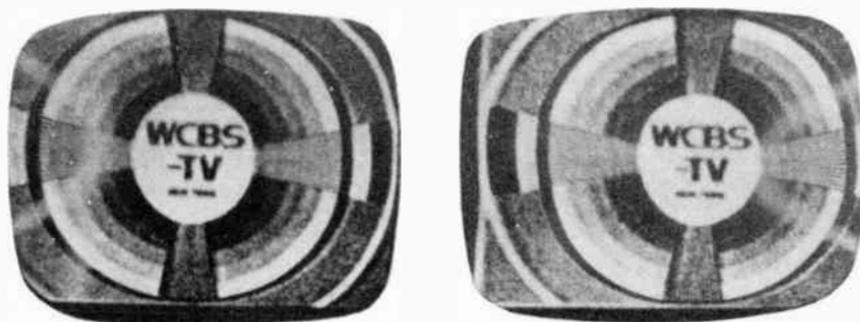
Fig. 4-F. Foldover can appear at left side of screen (pix at left) or at right side (see pix at the right).

(this includes damper, HV, and yoke circuits) will lengthen the retrace time. With most high-efficiency transformers the entire pix information is not contained in a single line, but continues for a short period of the otherwise invisible retrace, giving the appearance of a transparent folding-over of the pix on the edge.

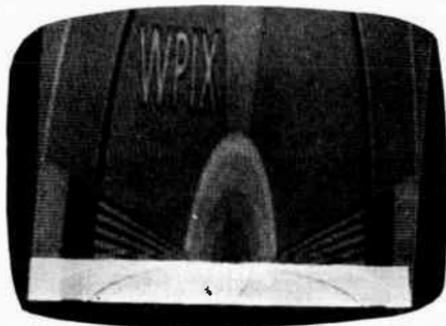
Fig. 6-F. Photo shows vertical foldover.

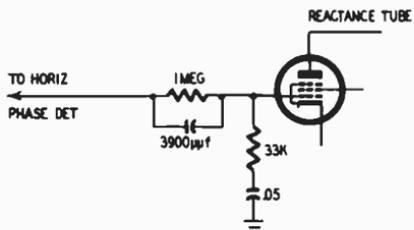
Fig. 1-G. Anti-hunting network is connected between the horizontal-phase detector and the reactance-tube control grid. A defect here produces a gear tooth effect on the screen.

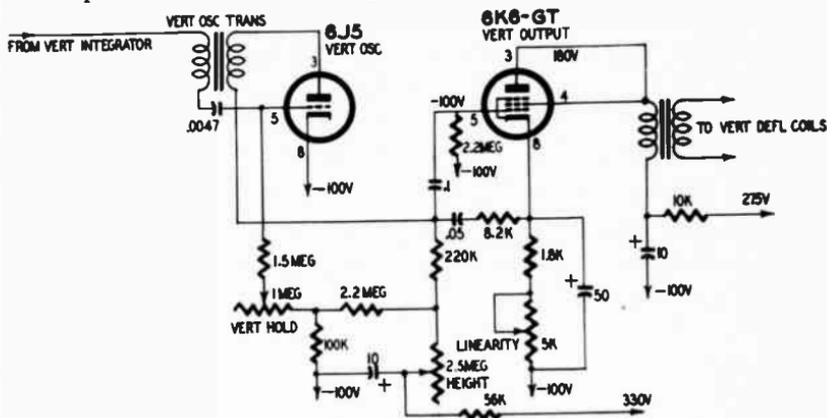
Fig. 1-H. Circuit shows location of vertical hold, size, and linearity controls.

Check vertical size and linearity controls for misadjustment. See Fig 1-H. May be caused by weak vertical-oscillator or vertical-output tubes, LV rectifier or low line voltage. In sets having damper output connected to both vertical and horizontal ampli-

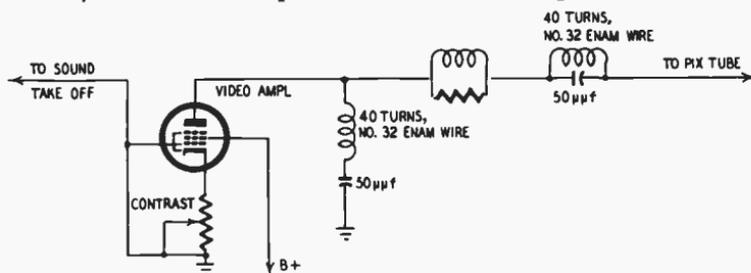
Fig. 2-H. Series trap helps keep 4.5-mc signal out of pix tube.

To adjust the trap, connect a modulated, 4.5-mc AM signal generator to the grid of the first video amplifier. Set the generator output to maximum, producing horizontal black and white bars on the face of the picture tube. Adjust the trap for minimum intensity of the bars. An alternate method is to tune in a signal and adjust the trap for minimum interference.

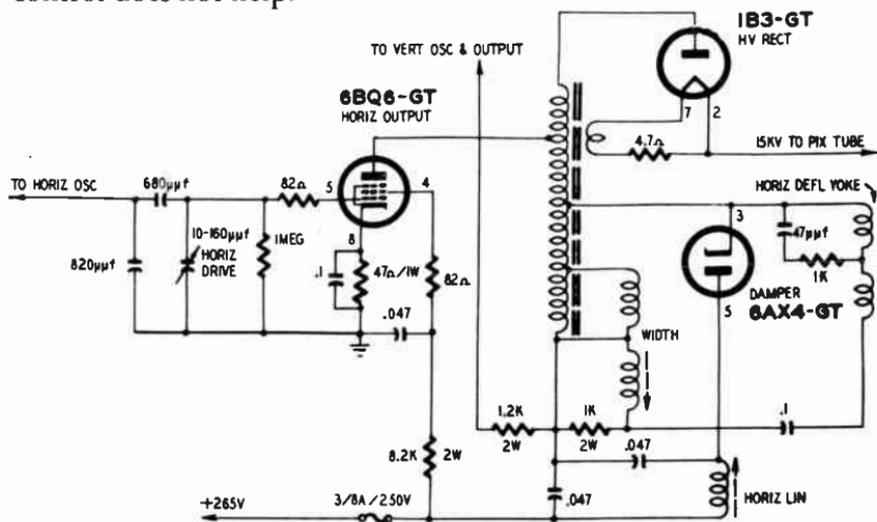
Fig. 3-H. Typical horizontal output and high-voltage circuit.

**SERVICE:** Reduce drive by adjusting horizontal-drive control trimmer. Reduce screen voltage on horizontal-output tube by replacing resistor at screen with one of higher value. Shunt width coil with capacitor of value giving best results. Shunt damper tube with 15K, 10-watt resistor. Reduce B+ voltage to flyback transformer with a series 500-ohm, 10-watt resistor. This condition may also result from a reduced value of cathode resistor in the horizontal-output cathode circuit or a leaky cathode bypass across that resistor. A leaky coupling capacitor to the horizontal-output tube increases the voltage on its grid (less bias) with resultant large output and excessive high voltage.

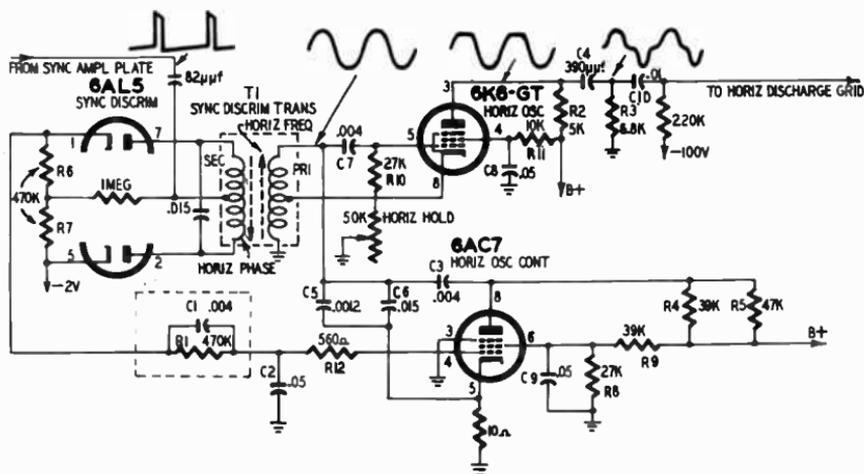
Coupling capacitor (C3) plate of horizontal-oscillator control tube.

Fig. 4-H. Synchrolock horizontal-oscillator afc circuit.

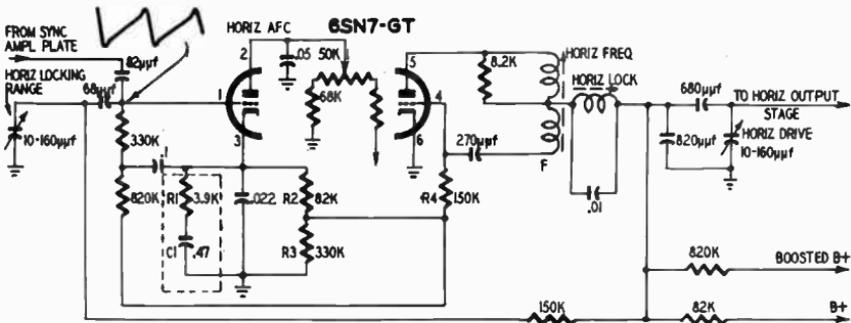
Differentiating network (R3 and C10) in plate circuit of horizontal oscillator.

Resistors (R1 and R12) between grid of horizontal-oscillator control tube and cathode of horizontal-sync discriminator.

Fig. 5-H. Synchroguide horizontal-oscillator afc circuit.

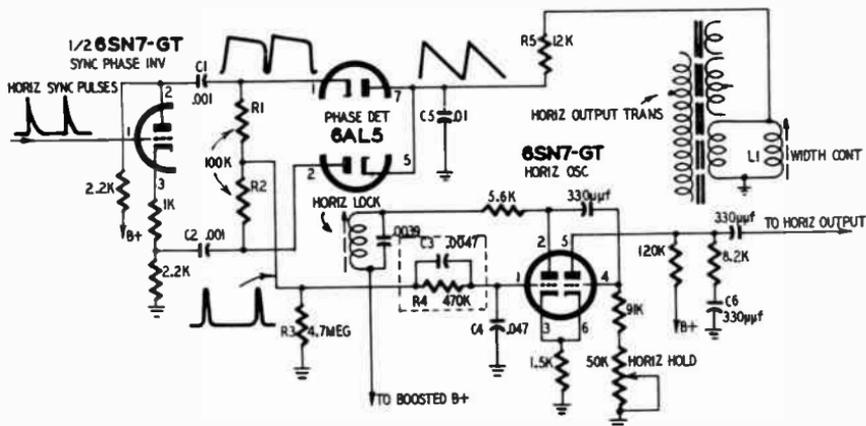
Plate-load resistor at pin 5 of horizontal multivibrator. See Fig. 6-H.

Peaking resistor, plate (pin 5) of horizontal multivibrator.

Fig. 6-H. Horizontal phase detector and multivibrator.

Hum in horizontal-deflection circuits causes waviness or pulling in pix without bars, due to defective tube. See Fig. 10-H. The waving or buckling of vertical objects as pix changes is often due to defective .01- $\mu$ f capacitor (C5 in Fig. 6-H) in horizontal-phase detector circuit. In some instances, replacing .001- $\mu$ f capacitors in

this circuit (C1 and C2 in Fig. 6-H) by  $\mu$  units will overcome hum condition.

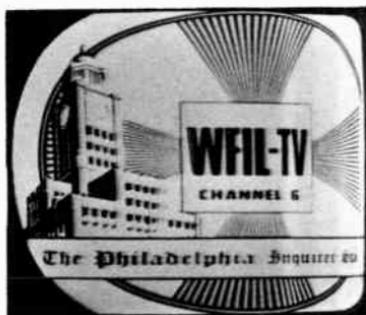
Poor linearity can take the form of an uneven sweep (Fig. 7-H)

*Fig. 7-H. Photo shows example of horizontal nonlinearity.*

or foldover. The linearity coil itself is usually effective only in the case of slight nonlinearity. In such a case, the slug should be varied. If turns are shorted (this lowers the inductance) all adjustments will either be ineffective or critical and unstable.

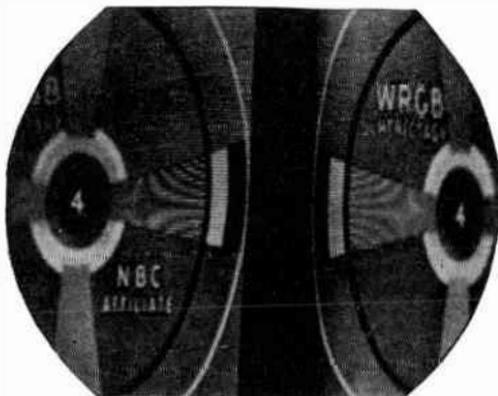
**SYMPTOMS:** Out-of-phase condition usually evidenced by a split pix, blanking bar in center, right half on left and left half on right.

**Fig. 8-H.** *Blanking bar is indication of incorrect horizontal phasing.*

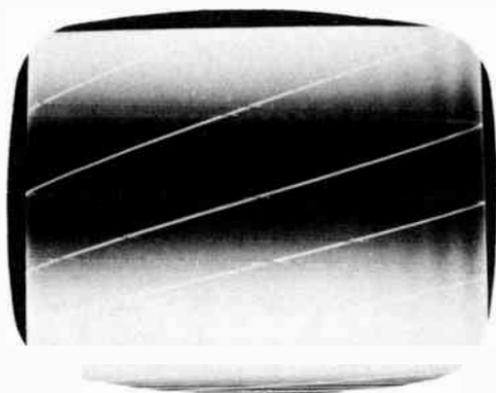
Usually evidenced by one wide dark bar across the CRT. See Fig. 9-H. Kill pix by removing a tube from last pix if amplifier. If bar continues, trouble is probably in video amplifier which includes second detector, the dc restorer and pix tube. Replace and check for single bar on all channels, including off channels. If not seen on blank channels, trouble is in the tuner or video if section. If bar is seen on off channels, trouble is in the video detector or video-amplifier stages.

Fig. 9-H. 60-cycle hum in pix.

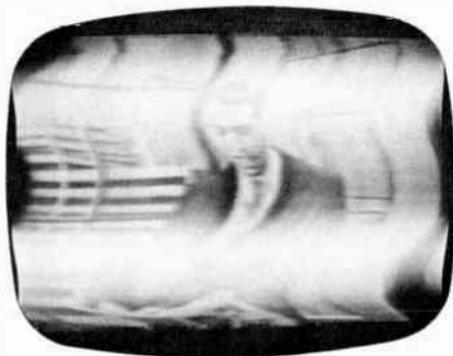
Fig. 10-H. 120-cycle hum in pix.

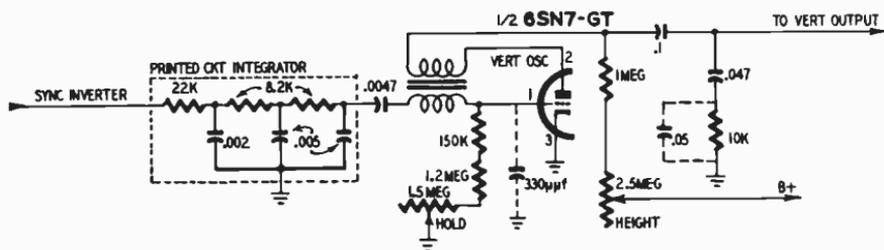
oscillator tubes. A typical network consists of three resistors, 22K, 8.2K, and 8.2K in series; parallel capacitors .002  $\mu$ f, .005  $\mu$ f, and .005  $\mu$ f at junctions of these resistors; all capacitors connected to ground. See Fig. 1-1 for typical circuit .

A defect in the integrator network can cause poor interlace,

Fig. 1-1. Three-section sync integrator and its location with reference to the vertical oscillator.

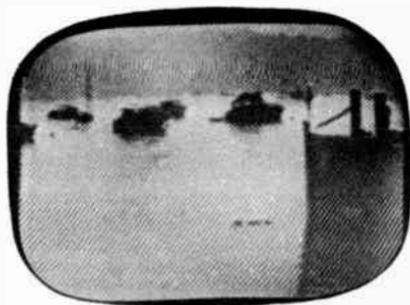
Fig. 3-I. *Strong interference produces diagonal lines on screen.*

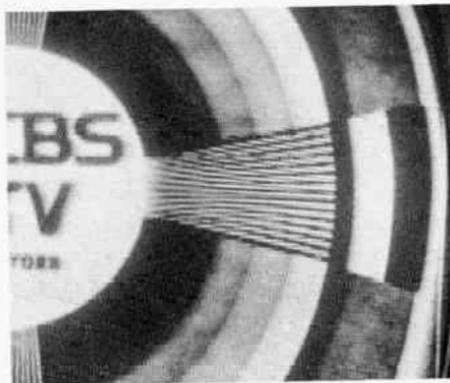
**SYMPTOMS:** Poor interlace indicated on screen by moire effect of horizontal wedge in test pattern. White horizontal sweep lines not equally spaced but close together, or both light and dark. Pairing of lines with black space between is especially noticeable on large screens. Horizontal lines look coarse. See Fig. 4-I.

Fig. 4-I. Poor interlace as indicated by moire effect on horizontal wedge.

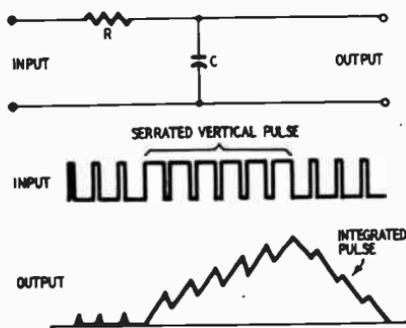
Fig. 5-I. Integrator circuit showing input and output waveforms.

**SERVICE:** To get best interlacing, adjust brightness control until retrace lines can be seen. Turn vertical-hold control until the retrace lines are equally spaced. This usually happens with the vertical-hold control set close to the point where the pix breaks out of vertical sync and starts rolling upward. If this adjustment of the vertical-hold control does not eliminate pairing of retrace lines (that is, if all the retrace lines cannot be spaced evenly) then there may be trouble in the integrator network (input to the vertical oscillator). Defective capacitors in the integrating network are the most common cause. The action of a simple integrating network is shown in Fig. 5-I.

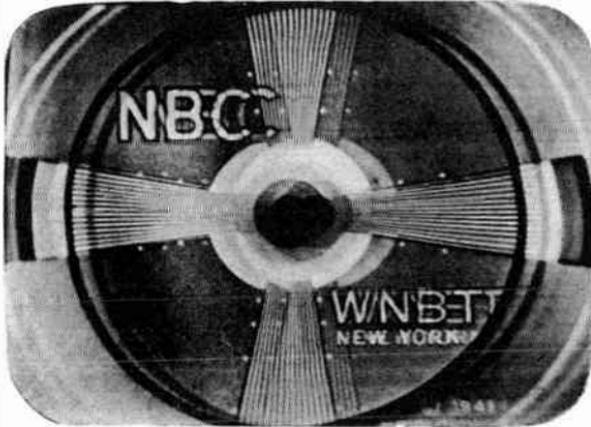
Fig. 1-J. Example of horizontal jitter.

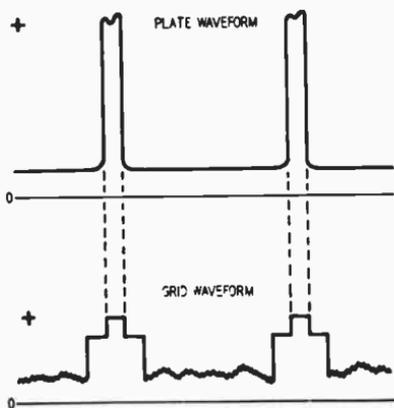
Fig. 2-K. Keyed agc grid and plate waveforms.

It might seem that one of the essentials of proper keyed agc action, that of simultaneous positive grid and plate voltages, would be automatic. Refer to Fig. 2-K. Yet, if the horizontal oscillator is out of sync, the horizontal plate pulse will not occur at the right time, and proper agc voltage will not be developed. The same trouble can occur with a poorly operating afc circuit, since this circuit has considerable control over the horizontal oscillator.

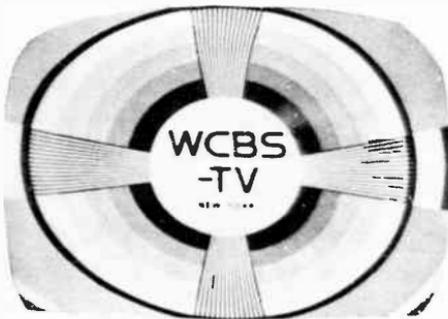
Fig. 1-L. Test pattern shows left-hand stretch.

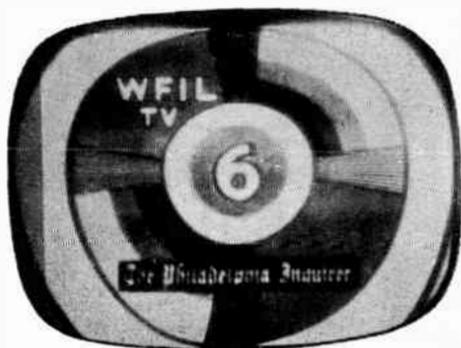
**SYMPTOMS:** Picture size and contrast change when electrical appliances are turned on. See Fig. 2-L.

Fig. 2-L. Effect on pix of line-voltage change.

**SERVICE:** The trouble is often caused by excessive voltage drop in the power lines when electrical appliances are turned on. This can be checked by measuring the voltage across the line in the various receptacles and lamp sockets when the appliances (refrigerator, toaster, broiler, etc.) are running. If the voltage is low on the receptacles but not on the lighting circuit, the voltage drop is confined to the line feeding the receptacles. The effect is not harmful, but may be annoying. You can eliminate it by having a special heavy line run to the outlet. If the voltage drops on the lighting circuits as well, it may be caused by using too small a wire between the meter and distribution panel or fuse box. Have an electrician check the lines for voltage drop and install heavier lines where necessary.

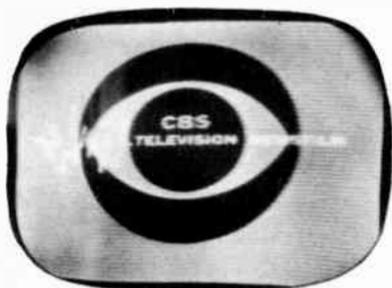
The effect of line voltage on pix size can be seen from the following data based on a 20-inch tube. (All figures given are in inches.)

Fig. 3-L. *Low-voltage B+ causes reduction in height and width.*

<i>Width</i>	<i>Height</i>
Line voltage at 115	17 $\frac{1}{4}$	14 $\frac{1}{4}$
Using line stabilizer	17 $\frac{3}{4}$	15
Drop to 105 volts on line	16 $\frac{1}{4}$	12 $\frac{3}{4}$
Increase to 120 volts on line	18 $\frac{1}{4}$	15 $\frac{3}{4}$

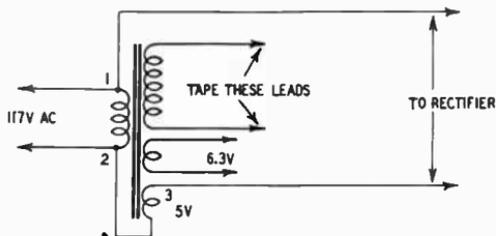
Connect the ac power line to the 117-volt primary winding as shown in Fig. 5-L. Now make a temporary connection of the filament winding and measure the voltage across 1 and 3. If it is less than the voltage across 1 and 2, reverse the filament connections.

Where 5- and 6.3-volt windings are used, connect them in series, checking to make sure their voltages add. Mount this auxiliary transformer in the TV cabinet away from the picture tube, possibly in some corner or in the bottom section of a console. Solder all leads and tape them securely before mounting the transformer.

Fig. 5-L. Spare power transformer can be used to give line voltage boost.

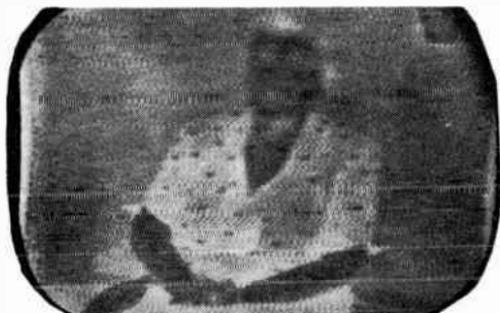
*Fig. 1-N. Negative pix can be caused by overloading, defective pix tube, outside interference, or circuit defects.*

Fig. 1-N, for example, shows a negative pix, but does this type of pix occur only for the strongest station? If so, it would indicate temporary overloading. Does the pix turn negative only occasionally? If so, it might indicate strong local interference from a shortwave station. Is the pix always negative, even though the antenna lead-in is disconnected and receiver circuits check all right? The pix tube is probably defective. The agc can cause a negative pix on weak stations too. It all depends on the setting of the agc control. Obviously, a correct diagnosis of the trouble can be made only if all symptoms are considered.

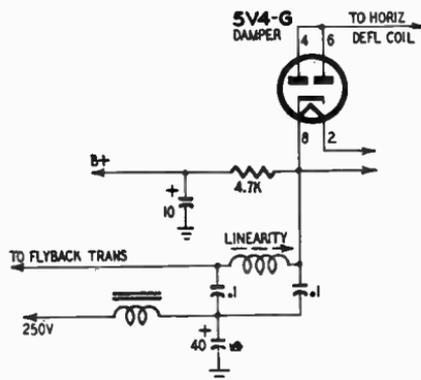
Fig. 2-N. *Damper tube and horizontal-linearity circuit.*

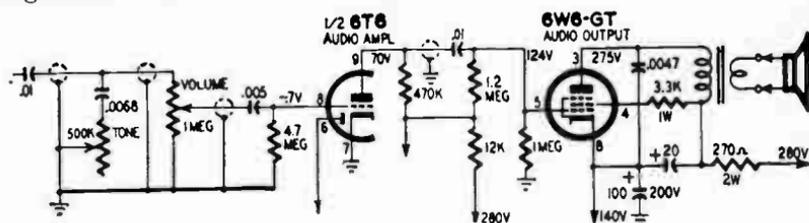
**SERVICE:** In some sets the focus coil feeds the screen and plate circuits of the audio-output tube, and focusing is controlled by a

potentiometer in the cathode circuit. Any defect in the audio stage such as coupling capacitors, screen and plate bypass capacitors, cathode resistor, audio-output transformer and audio tube might cause this condition.

Fig. 3-N. Typical audio amplifier and output circuits.

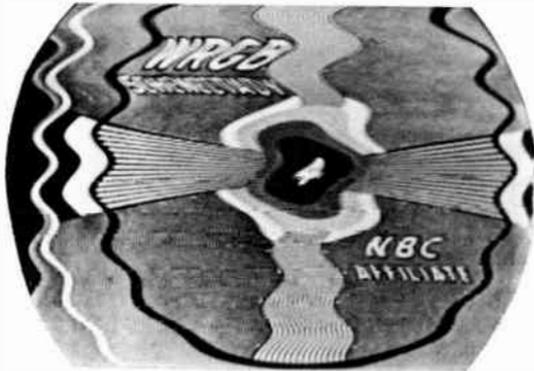
Fig. 1-P. *Pie-crust effect in pix.* courtesy G-E Techni-talk

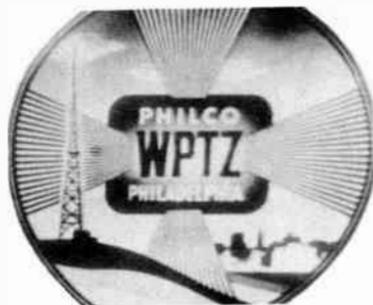
*Fig. 2-P. Pincushion effect in pix.*

Unless a station pattern is on, or a cross-bar generator used, the pincushion effect may not be too noticeable. But when viewing televised scenes with vertical or horizontal sections, the viewer would notice the bending effect and distortion. Adjustments are simplified if the picture size is reduced slightly so the pincushion effect can easily be seen. The magnets should then be adjusted until the picture is perfectly rectangular, after which the size can be increased to fill the mask properly.

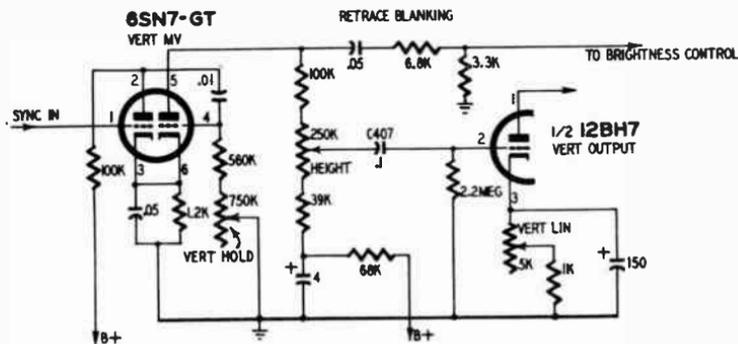
Fig. 3-P. Defective components in vertical oscillator and output can cause pix compression at top.

**SERVICE:** May be caused by misadjustment of vertical size and linearity controls by set owner. See Fig. 3-P. Check vertical-output tube, components in circuit; also possibility of defective resistor connected to one side of vertical-linearity control.

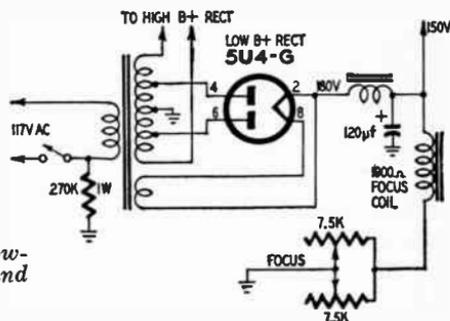
Fig. 4-P. Focus coil is part of low-voltage supply. See also Fig. 2-F and Fig. 3-F.

Checks should be made on the focus-control circuit. See Fig. 4-P. If the focus control requires an extreme setting, or is entirely ineffective, the voltage across the focus coil as well as the current through the resistive network of the control should be tested against manufacturer's data. Changes in resistance values in the focus-control circuit or a defective focus coil can bring about inability to secure good focus. Low or abnormal high voltage can also produce defocusing. (Modern receivers do not have electromagnetic focus units but use permanent magnet units instead. Adjust the screws or slugs of the pm unit to see if a sharper pix can be obtained.)

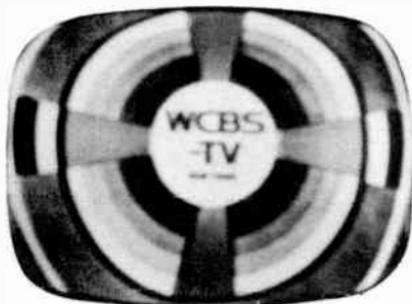
Fig. 5-P. Defect in video amplifier can produce poor-quality pix.

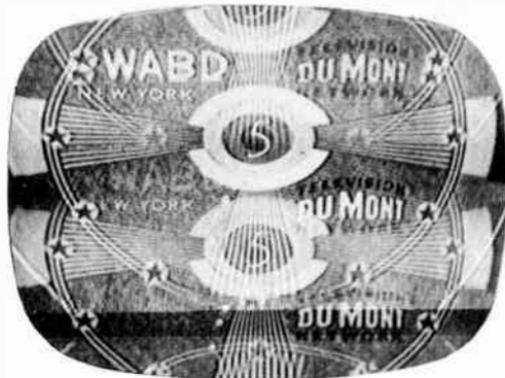
Fig. 6-P. Defect caused by trouble in vertical-hold control circuit.

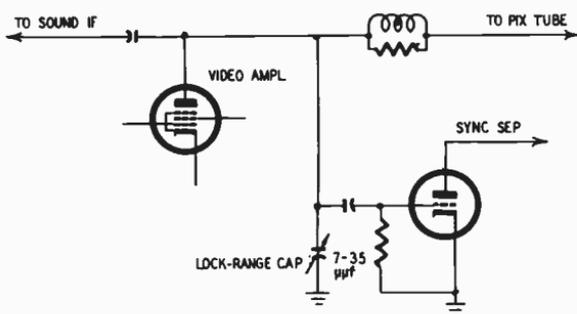
Fig. 7-P. Lock-range capacitor in sync separator circuit.

coupling capacitor from sync to afc, or use a lock-range capacitor. This last item is simply a trimmer bypass capacitor on the sync feed from the video amplifier. It bypasses part of the sync signal to ground, just as drive controls work on the horizontal-amplifier grid. The trimmer is adjusted for suitable locking range. See Fig. 7-P.

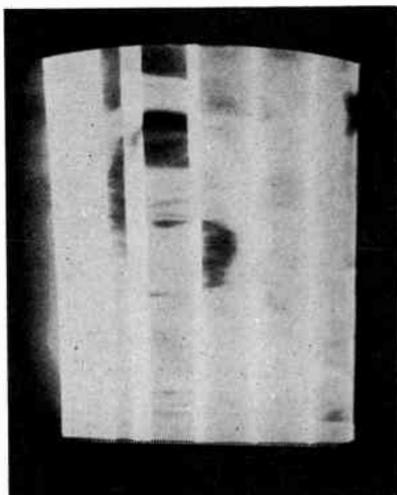
Fig. 8-P. *Pix pullout caused by open coupling capacitor.*

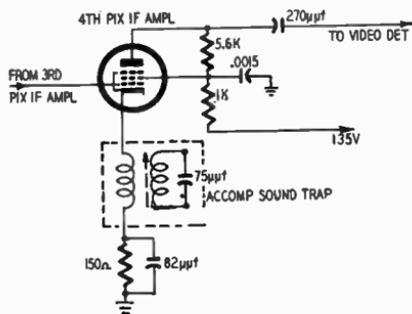
Fig. 9-P. Overloading of last pix if amplifier produces loss of horizontal and vertical sync.

**SERVICE:** Pix tearing and rolling on strong signals may be caused by overloading of the 3rd video if amplifier. The low plate voltage of this tube and higher signal input (compared to preceding stages) can prevent it from properly handling strong signals. (Check bias on this tube.) See Fig. 9-P.

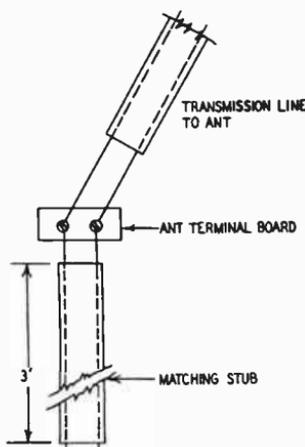
Fig. 10-P. Matching stub can be made from scrap piece of transmission line.

Connect about three feet of line to antenna terminals. See Fig. 10-P. This piece is a matching stub. Starting at end closest to antenna terminals, short the transmission line with a sharp razor blade. Set should be tuned to channel giving worst smear. At point where shorting the line with the blade produces the best pix, cut across with diagonal cutters and join the ends together. The regular antenna line should remain connected in the usual way and not be disturbed during this repair. Stub can be allowed to hang

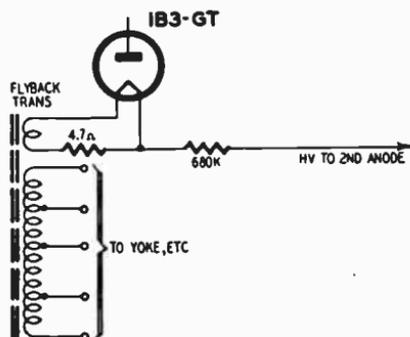
Fig. 1-R. HV rectifier circuit.

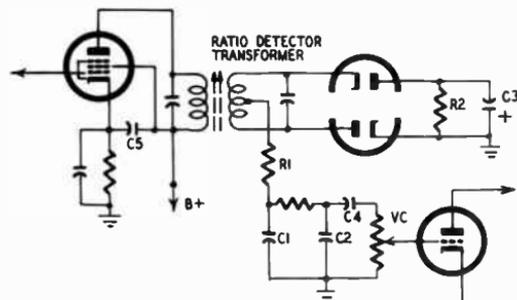
Fig. 2-R. *Ratio-detector circuit. See ratio-detector check list.*

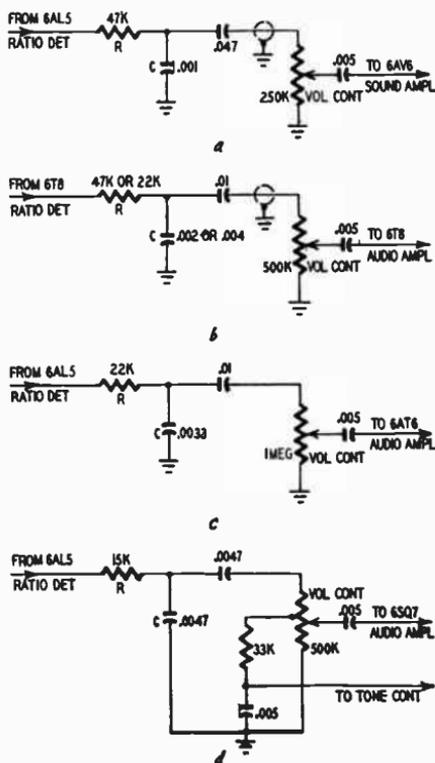
Fig. 3-R. Typical de-emphasis networks.

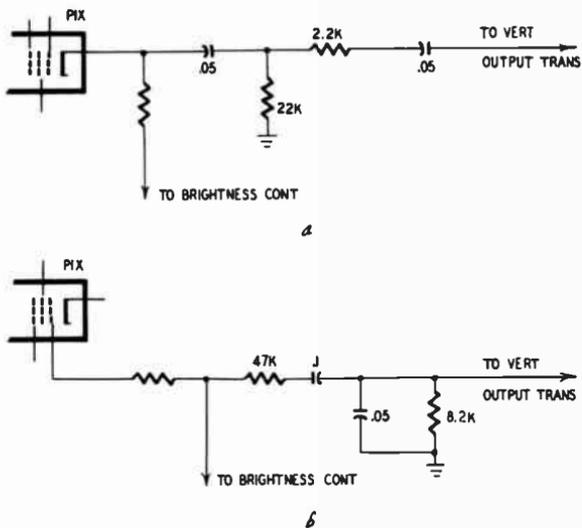
Fig. 4-R. Vertical-retrace blanking networks.

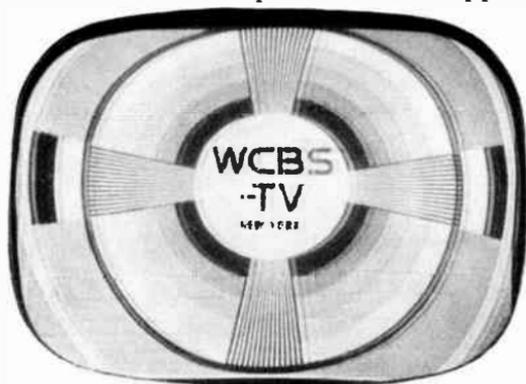
Fig. 5-R. *Pix of test pattern shows echo.*

Echo or ringing usually occurs for *every* station tuned in. Contrast this to ghost reception which will usually show up for only one or two stations, and has more pronounced picture displacement. Echo effect (see Fig. 5-R) is caused by an overpeaked video amplifier or by a misaligned video if section. High-frequency components of the signal pulse the offending stage into transient oscillation which causes the repeat lines to appear as sharply

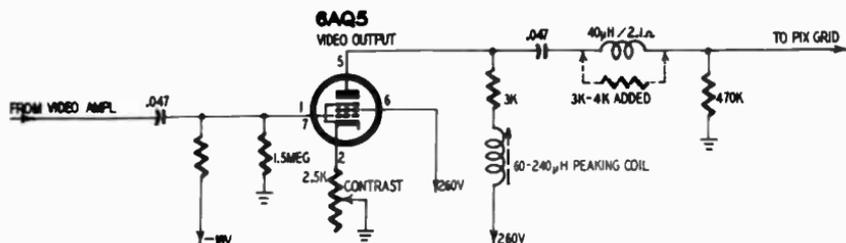
Fig. 6-R. Resistor across peaking coil helps eliminate ringing.

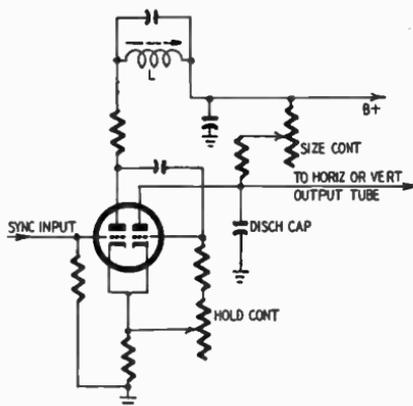
Fig. 7-R. Horizontal multivibrator may have ringing coil, L.

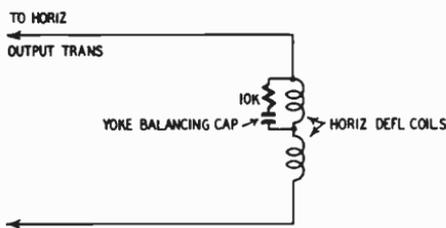
Fig. 8-R. R-C network across horizontal-deflection coil reduces ringing.

... the correct value of this capacitor is important, and the voltage rating). In some instances addition of a 10K ohm resistor in series with the yoke balancing capacitor may overcome this trouble, though width may be reduced. See Fig. 8-R. For high-impedance yokes try connecting a .047  $\mu\text{f}$ , 400-volt capacitor across the vertical section of the yoke. Another cure might be connecting a 5,600-ohm resistor across the horizontal-linearity coil.

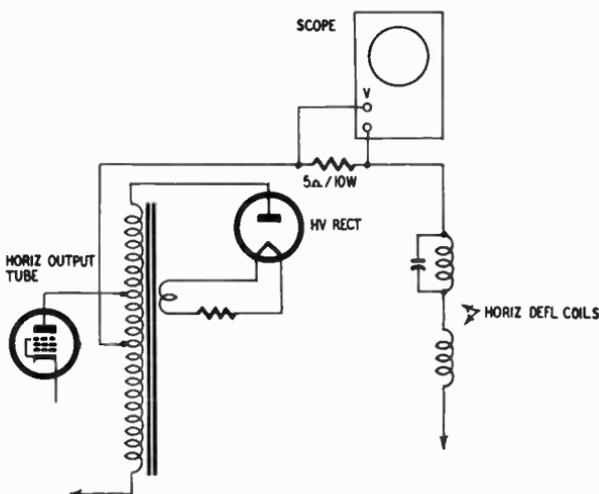
Fig. 10-R. Method of checking horizontal-sweep waveform.

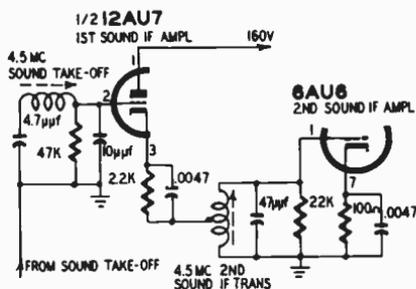
Fig. 2-S. Typical sound if stages.

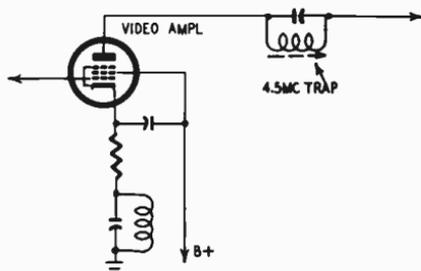
Fig. 3-S. Misaligned sound trap results in sound bars in pix.

**SERVICE:** Misaligned traps in the video if or in the video amplifier (Fig. 3<sup>A</sup>S) are a common source of sound bars in the pix. Adjacent-channel sound interference is easily recognized since the bars do not follow the sound accompanying the picture on the screen. In addition, adjacent-channel audio will usually cause trouble on only one channel and even then not all the time.

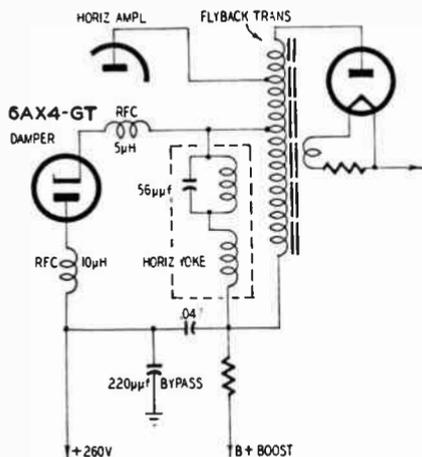
Fig. 4-S. Spooks can be eliminated by rf chokes in the damper-tube circuit.

a new damper tube. Insert rf chokes (from  $1 \mu\text{h}$  to  $5 \mu\text{h}$ ) in the plate, cathode, and heater circuits of the damper tube. Small by-pass capacitors (HV types,  $47 \mu\text{f}$  or less) can also be used.
