# **RAPID TV REPAIR**

**G. WARREN HEATH**

*published by gernsback library, inc.  
new york, n. y.*

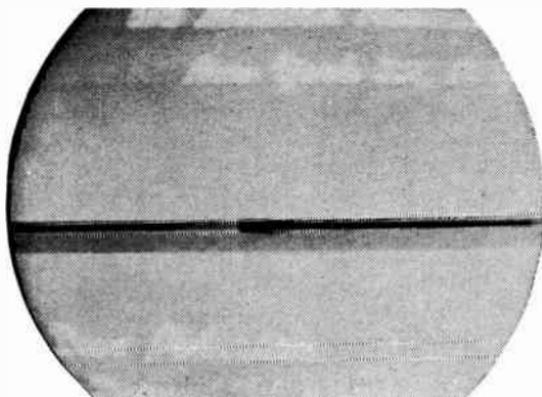
Fig. 5-S. *Blanking bar showing sync pulse.*

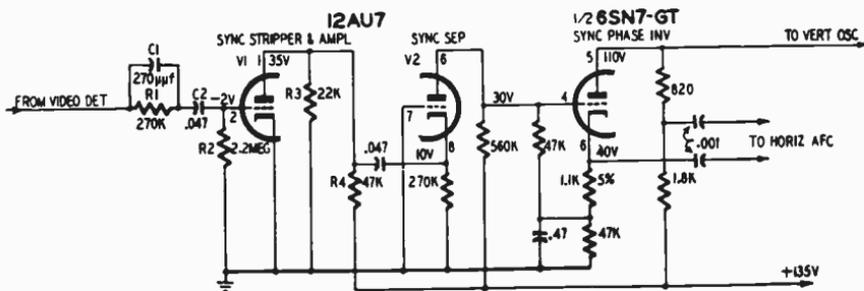
Fig. 6-S. Check sync circuits when pix rolls or tears.

If the horizontal- and/or vertical-hold controls bring proper synchronization momentarily without going to either extreme, the trouble is in the sync section. See Fig. 6-S. A pix with good quality and contrast, but poor sync also indicates trouble in the sync section. Generally, a weak pix with insufficient contrast will prevent synchronization, and noise interference will also affect the sync. Multiple images (usually ghosts) are sometimes responsible. Sync take-off points are the video detector, video amplifier and dc restorer.

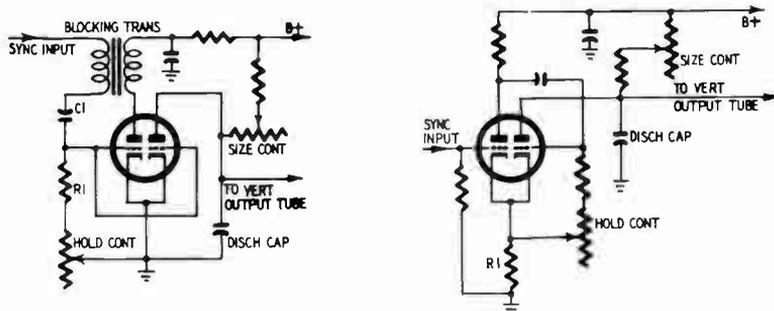
Fig. 1-V. Vertical-blocking oscillator and multivibrator circuits.

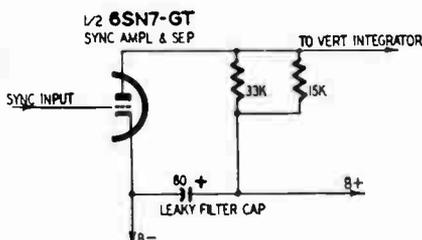
Fig. 2-V. Leaky filter capacitor can produce vertical jitter.

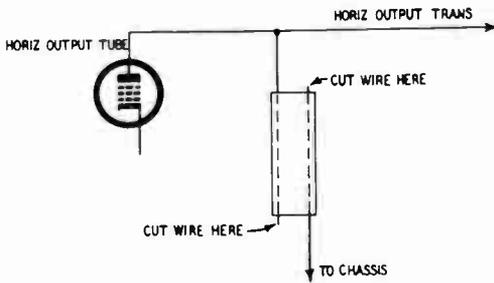
*Fig. 3-V. Capacitor made from a small piece of transmission line. Use the minimum amount of transmission line needed to increase pix width. One side of the line can connect directly to the plate cap of the horizontal-output tube. Fasten the other side of the line to the chassis.*

circuit resulting from the rapid rise in deflection current. If the condition is very annoying, it may be possible to increase the width of the raster slightly to move the line beyond the mask. Adjust width control for maximum pix width. If this does not help, connect a high-voltage capacitor from the plate cap of the horizontal-output tube to chassis. You can easily make this capacitor from a small piece of transmission line as shown in Fig. 3-V. Use the smallest amount of line that will give the desired result. Keep the line clear of the chassis.

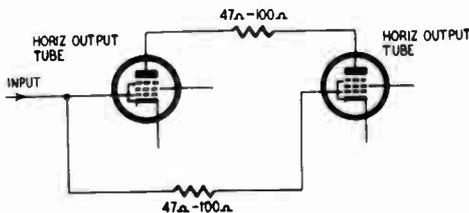
**Fig. 6-V.** Method of connecting parasitic-suppression resistors to horizontal-output tubes when the tubes are operated in parallel.

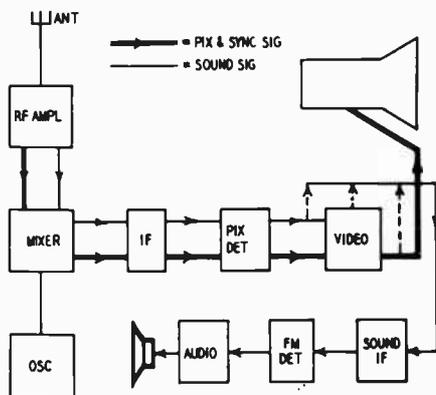
Fig. 8-V. Block diagram shows the paths of the pix, sync, and sound signals in an intercarrier receiver.

The video detector performs two functions: as an AM detector it rectifies and filters the modulated if input to deliver a composite video signal to the video amplifier. As a mixer it heterodynes the AM picture carrier with the FM sound carrier to produce the 4.5-mc intercarrier sound. Fig. 8-V shows the course of the signals.

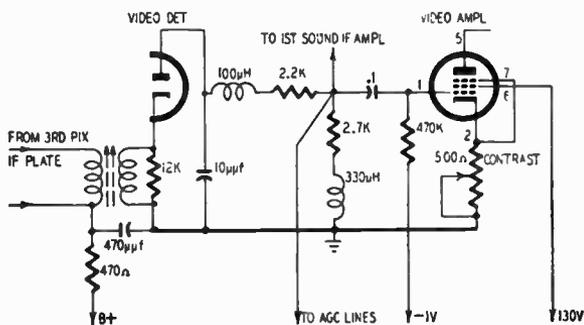
Fig. 9-V. Video detector using one half of vacuum-tube duo-diode. Usually found in older sets. More modern receivers (including color TV) use crystals (1N64). Load for the detector is less than 5,000 ohms.

The video detector may be a tube such as half a 6AL5. See Fig. 9-V. Typical modern crystal detector usage is shown in the schematic of Fig. 10-V; the crystal is in the last if can. The most

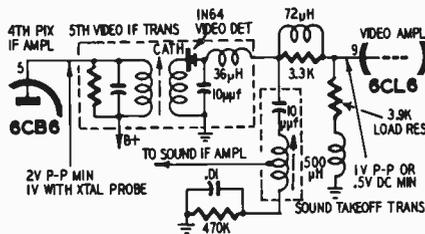
Fig. 10-V. Typical crystal-detector circuit. Crystal is enclosed in can with last if transformer.
