**BLACK & WHITE TV**

# The Tele-vue Trouble-Shooter

# THE PRACTICAL APPROACH TO BLACK & WHITE TV THEORY

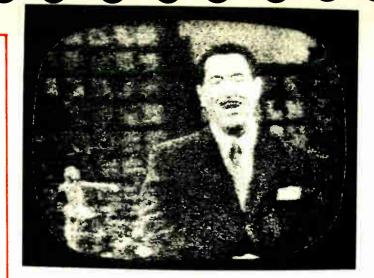
A SNOWY PIX MUST BE CAUSED BY EITHER THE R.F. AMPLIFIER STAGE OR THE AN-TENNA CIRCUIT, IN SOME RARE CASES THE A.G.C. MAY BE TOO GREAT TO THE GRID OF THE R.F. AM-PLIFIER IN WHICH CASE TROUBLE-SHOOTING THE A.G.C. WOULD BE NECES-SARY. THIS VOLTAGE WOULD HAVE TO EX-CEED - 6 VOLTS.

IN A VERY WEAK SIG-NAL AREA A SNOWY PIX IS NORMAL, IF SET WAS WORKING NOR-MALLY, THEN SOME TROUBLE MUST BE SUSPECTED. WHEN THE R.F. AMP. DOES NOT AMPLIFY, DUE TO SOME DEFECT, OR THE INPUT IS VERY WEAK (POOR AN-TENNA) NOISE WILL BE STRONG AS THE SIGNAL, AND WILL APPEAR AS A SNOWY EFFECT OVER THE PICTURE.

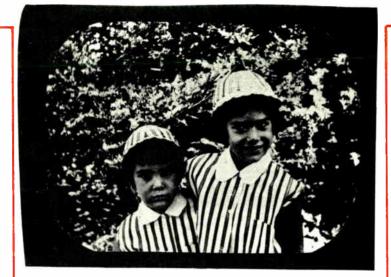
THE CONDITION KNOWN AS DRIFTING CAN BE RECOGNIZED BY THE FADING THAT TAKES PLACE IN THE SOUND AFTER THE TV SET IS SWITCHED ON FOR A FEW MINUTES. THE OUTSTANDING FEATURE OF THIS TROUBLE IS THE FACT THAT A RE-ADJUSTMENT OF THE FINE TUNING CON-TROL WILL BRING BACK THE SOUND. FADING MAY CON-TINUE IN THE ABOVE FASHION FOR 10 MIN-UTES IN SOME CASES FINE TUNING WILL BRING SOUND BACK EVERY TIME.

THE CAUSE OF DRIFT-ING IS THE LOCAL OSCILLATOR CIR-CUIT. AS THE TV SET WARMS UP SOME COM-PONENT CHANGES VALUE. THIS IN TURN CAUSES THE LOCAL OSCILLATOR TO CHANGE FREQUENCY SLIGHTLY. SINCE THE SOUND IS MOST CRI-TICALIN TVA SLIGHT CHANGE IN LOCAL OSCILLATOR FRE-OUENCY WILL AF-FECT THE SOUND WITHOUT ANY NO-TICEABLE EFFECT ON THE PICTURE. THIS CONDITION IS FOUND MAINLY IN SPLIT CARRIER RECEIVERS. In the tuner schamatic shown this would be 6-115 and c-116 Replace both.

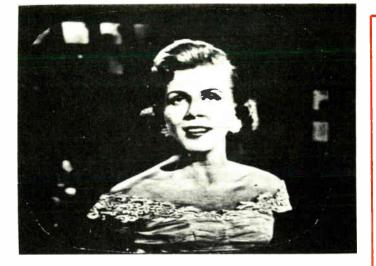
**VERY DARK PIX**

A PIX THAT IS TOO DARKCAN BE JUST AS BAD AS A PIX THAT IS VERY WEAK. UNDER THIS CONDITION THE PIX BECOMES TOO CONTRASTY AND THE DIFFERENT SHADES DONOT STAND OUT AS WELL AS THEY SHOULD INMOST GOOD OPERA-TING SETS. WHEN THE CONTRAST IS AT A MAXIMUM THE PIX SHOULD BE TOO DARK TO WATCH. IN SOME CASES THE A.G.C. CONTROL MAY BE SET INCORRECTLY, THIS SHOULD BE CHECKED FIRST, NOT ALL SETS HAVE AN A.G.C. CON-

TOO DARK A PIX CAN BE CAUSED BY INCOR-**RECT CONTRAST SET-**TING, OR A.G.C. CON-TROL SETTING. THIS SHOULD BE CHECKED FIRST SINCE THIS IS THE EASIEST THING TO CHECK. TUBES MAY ALSO BE INTERNALLY SHORTED CAUSING MAXIMUM GAIN AS THE PASSES SIGNAL THROUGH IT. THESE MUST BE CHECKED BY REPLACEMENT. AL-IGNMENT COULD ALSO CAUSE THIS TROUBLE BUT THIS SHOULD ONLY BE SUSPECTED IF THE SET HAS BEEN TAMPERED WITH.

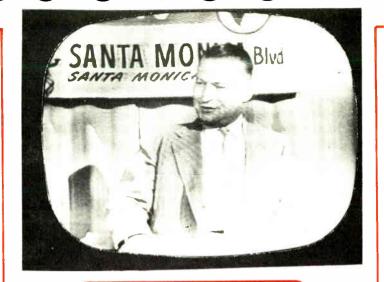
PIX BRIGHT -**NO CONTROL**

THIS IS AN IMMEDIATE INDICATION THAT THE PIX TUBE IS BAD. AL-THOUGH IN SOME CASES A BAD BRIGHT-NESS CONTROL COULD CAUSE THIS CONDI-TION. IT WILL BE NO-TICED THAT IF THE BRIGHTNESS CONTROL DOES AFFECT THE PIX.THAT IT WILLNOT CAUSE THE RASTER TO DISAPPEAR AS FOUND UNDER NOR-MAL OPERATING CONDITIONS.

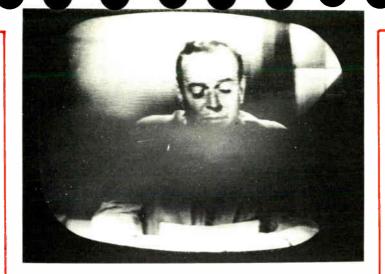
WITH A BLACK BAR ON C.R.T. THE TROUBLE IS LIMITED TO THE VIDEO CIRCUITS. THIS COULD BE THE FRONT END - VIDEO I.F. - -OR VIDEO AMP. INCLU-DING THE C.R.T. THIS HOLDS TRUE IF ONE BLACK BAR IS NOTI-CED. IF TWO BLACK BARS ARE NOTICED THEN TROUBLE IS IN THE POWER SUPPLY. THIS SHOULD BE DE-TERMINED **BEFORE BEGINNING TROUBLE-**SHOOTING.

IN THE CONDITION OF ONE BLACK BAR THE TROUBLE IS A SHORT BETWEEN HEATER & CATHODE OF ANY VIDEO TUBE WITH TWO BLACK BARS THE TROUBLE IS AN OPEN FILTER IN THE POWER SUPPLY SINCE TWO BARS INDICATE 120 CPS AND THIS IS FOUND ONLY IN THE POWER SUPPLY.

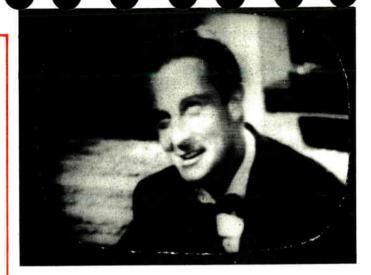
MANY TIMES IN A TV SET A BUZZ WILL BE HEARD IN THE SOUND. THERE ARE MANY CAUSES OF THIS CON-DITION RANGING FROM ALIGNMENT TO TROU-BLES AT THE STA-TION: CERTAIN STEPS MUST BE TAKEN TO LOCALIZE THIS TROU-BLE TO ONE PARTI-CULAR STAGE OR CIR-CUIT. IN THIS CASE THE FRONT PANEL CONTROLS ARE A GREAT HELP, FOR EX-AMPLE IF THE VER-TICAL HOLD CONTROL IS VARIED AND THE BUZZ INCREASES OR DECREASES IN PITCH, THEN THE TROUBLE IS RADIATION FROM THE VERTICAL CIR-CUIT.

BUZZ IN THE SOUND HAS TWO COMMON CAUSES, ONE IS THE VIDEC IF TUBES BEING DRIVEN TO CUTOFF BY THE SIGNAL WHICH WOULD INDICATE A.G.C. TROUBLE.THE OTHER BEING POOR ALIGNMENT WHICH WILL INTRODUCE A BUZZ IN THE SOUND SIGNAL. SOME CASES OF RADIATION FROM THE VERTICAL OUT-PUT XFMR FEEDING INTO THE AUDIC AMP-LIFIERS HAVE BEEN ENCOUNTERED BUT THIS IS NOT A COM-MON TROUBLE, SOME OF THE TV SETS HAVE A BUZZ CON-TROL ON THE BACK PANEL THESE SETS USE A 6BN6 AS A SOUND DETECTOR.

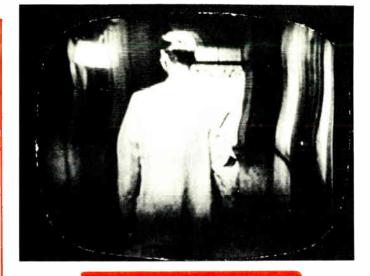
PICTURE PULL

THIS CONDITION OC-CURS WHEN THE SCENE CHANGES OR WHEN A COMMERCIAL IS SHOWN AND THE CAMERA SWITCHES BACK TO THE PROGRAM, ITMAY ALSO BE NOTICED THAT IF VERY LITTLE VIDEO IS ON THE SCREEN, OR THERE IS LITTLE MOVEMENT IN THE SCENE, THE PIX MAY APPEAR VERY GOOD, WITH NO PUL-LING AT ALL. IF GREAT ACTIVITY IS TAKING PLACE THEN PIX PULL WILL BE

TROUBLE THIS CAUSED BY VIDEO IN-FORMATION IN THE TRYING SYNC TRIGGER THE HORI-ZONTAL OSCILLATOR. THIS WILL NOT AF-FECT THE VERTICAL OSCILLA TOR SINCE THE INTEGRATING NETWORK WILL BY-PASS ALL VIDEO IN-FORMATION. USUALLY LEAKY COUPLING CAPACITORS IN THE SYNC CIRCUIT WILL THE CAUSE. IN SOME CASES MISAD-JUSTMENT OF THE A.G.C. CIRCUIT WILL GIVE THE SAME

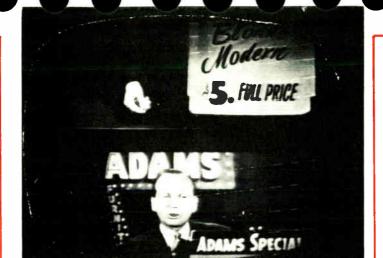
THE TROUBLE IN THIS SYMPTOM IS LIMITED TO A VERY SMALL SECTION OF THE TV RECEIVER. SOME -WHERE BETWEEN THE OUTPUT OF THE SYNC CIRCUITS, AND THE INPUT TO THE VER-TICAL OSCILLATOR. POOR SYNC MAY GIVE ALMOST THE SAME CONDITION AS LOSS OF VERTICAL SYNC EXCEPT THAT THE HORIZONTAL WILL BE VERY TOUCHY AND HARD TO LOCK IN.

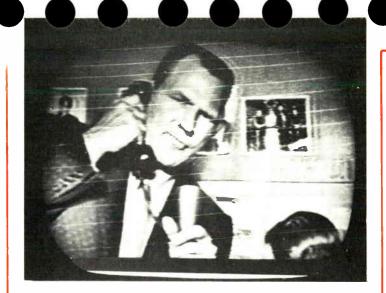
If sync is normal at grid of 2nd video amp. check signal at plate. THIS TROUBLE IS A VERY MISLEADINGONE BECAUSE THE TROU-BLE APPEARS TO BE THE VERTICAL CIRCUIT. HOWEVER, WE FIND THIS TROU-BLE TO BE IN VIDEO AMP. OR IN THE SYNC CIRCUIT. IN MOST CASES A DECREASE IN COUPLING CAPA-CITOR IS THE TROU-BLE, OR SOMETIMES AN OPEN 4.5 MC TRAP COIL. THE SCOPE IS A MUST IN QUICKLY FINDING THIS CON-DITION SINCE WE CAN SEE EXACTLY WHERE THE TROUBLE IS OC-CURING.

VERTICAL PHASING OCCURS WHEN THE VERTICAL SYNC PULSE IS OUT OF PHASE WITH THE ORI-GINAL VERTICAL SYNC PULSE SENT FROM TRANSMITTER. THIS WILL HAPPEN IF THE 60 CPS SYNC IS PASSED THROUGH A SMALL CAP. BEFORE THE SYNC TAKE OFF POINT OR WHILE PASS-ING TO THE SYNC OUT-PUT CIRCUIT, THIS TROUBLE WILL NOT BE CAUSED BEFORE THE VIDEO DETECTOR. PICTURE IS LOCKED IN AT THIS POINT ON SCREEN AND USUALLY RETRACE LINES ARE NOTICED.

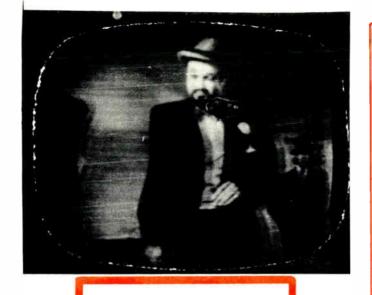
120 C. P. S. PULL

WITH A 120 CYCLE PULLIN THE PICTURE THE TROUBLE MUST BE IN THE POWER SUPPLY SINCE THIS IS THE ONLY PLACE IN A A TV SET THAT HAS 120 CYCLES IN IT. IT SHOULD BE SIMFLE TO TELL IF THERE IS THIS CONDITION OC-CURING BECAUSE A CLOSE CHECK ON THE SIDE OF THE PICTURE WILL SHOW IF THERE ARE TWO VARIATIONS IN THE PULL FROM THE TOP OF THE PIC-TURE TO THE BOT-TOM. IF ONLY ONE VARIATION IS NOTI-CED THEN THE TROU-BLE MUST BE CAUSED BY A 60 CYCLE HEAT-ER TO CATHODE SHORT.

IN A FULL WAVE REC-TIFIER CIRCUIT THE INPUT FREQUENCY IS DOUBLED BY THE RE-CTIFYING ACTION IN THE POWER SUPPLY. WITH A 60 CYCLE IN-PUT TO THE POWER SUPPLY OF A TV SET WE WILL END UP WITH 120 CYCLE OUTPUT. IF POOR FILTERING IS TAKING PLACE, THEN A PULL WILL BE NO-TICED IN THE PIC-TURE. THIS TROUBLE THEREFORE MUST BE CAUSED BY AN OPEN FILTER IN THE B+ CIRCUIT.

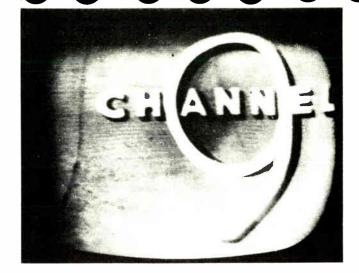
A LARGE NUMBER OF TV SETS TODAY ARE USING SELENIUM RE-CTIFIERS AS A MEANS OF OBTAINING THE LOW VOLTAGE. THIS IS A CHEAPER METHOD THAN THE USUAL 5U4G TUBE, AND WITH NORMAL CARE THE SELENIUM RECTIFIER SHOULD LAST THE LIFETIME OF THE SET. IN MOST CASES HOW-EVER THE SELENIUM IS MISUSED IN THAT IT IS OFTEN PLACED UNDER THE CHASSIS WHERE THE MOST HEAT IS PRESENT, AND THE MILIAMP RATING IS AT A MINI-MUM. MOST COMMON TROUBLE IS LOW OUTPUT VOLTAGE CAUSING NOT EN-

SELENIUM RECTIFIERS ARE MADE BY COATING A PLATE OF IRON WITH A LAYER OF SELENIUM AND PLACING A NUMBER OF THESE PLATES IN SERIES. IF THE CURRENT PASSING THROUGH THE PLATES SMALL ENOUGH FOR THE PLATES TO REMAIN COOL THEN THE RECTIFIER SHOULD LAST FOR MANY YEARS. IT IS A L-WAYS ADVISABLE TO REPLACEA SELENIUM RECTIFIER WITH A CURRENT LARGER RATING THAN WAS USED IN THE SET, IF THE SPACE IS AVAIL-ABLE, THAT IS, FOR EXAMPLE, A 250 MA CAN BE REPLACED WITH A 300 MA.

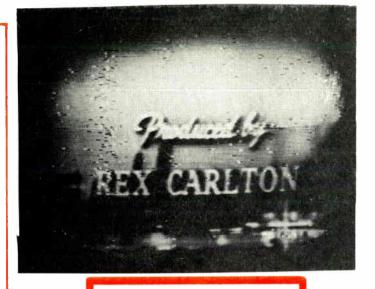
H.V. ARCING

VERY OFTEN HV ARC-ING OCCURS IN TVRE-CEIVERS. THIS ARCING WILL OCCUR MORE OFTEN IN THE SUM-MER TIME DUE TO HUMIDITY IN MANY AREAS. THE ARCING MAY BE NOTICED AS THE SET IS FIRST SWITCHED ONOR DUR-ING THE TIME THE SET IS PLAYING. ARC-ING MAY REMAIN DUR-ING THE ENTIRE TIME THE SET IS ON AND WILL CAUSE A NUMB-ER OF FLASHES TO CONTINUALLY BE SEEN ON THE SCREEN, THIS IS VERY ANNOY-ING TO THE CUSTOM-ER AND THE SET SHOULD BE CHECKED CAREFULLY FOR THIS TROUBLE **BEFORE** SENDING BACK AS A FINISHED JOB.

HV ARCING USUALLY OCCURS AT THE BASE OF THE HV RECT. DR IN THE FLYBACK IT-SELF AND IN ORDER TO SEE THE ARCING IT MAY BE NECES-SARY TO TAKE THE SET INTO A COMPLE-TELY DARK ROOM AND WATCH THE HV SEC-TION. THERE ARE MANY HV SPRAYS ON THE MARKET THAT MAY BE USED TO CLEAR UP THIS TROU-BLE BUT IN MOST CASES IT HAS BEEN FOUND THAT TO RE-PLACE THE DEFEC-TIVE PART IS BY FAR BEST SOLUTION.DUST, DIRT, AND POOR IN-SULATION ARE THE MOST COMMON CAUSES OF THIS TROUBLE.

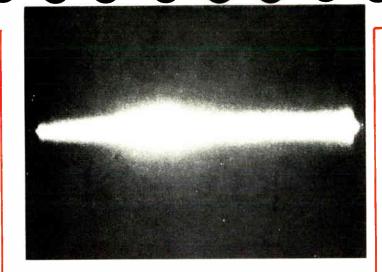
NO VERTICAL SWEEP

THIS IS ONE OF THE EASIEST SYMPTOMS TO RECOGNIZE SINCE ALL THAT WILL BE ON THE SCREEN IS A STRAIGHT, HORIZON-TAL LINE IN THE CENTER OF THE C.R.T.

THIS LIMITS THE TROUBLE TO THE VERTICAL SWEEP CIRCUIT, SINCE IT SWEEPS THE BEAM FROM TOP TO BOTTOM.

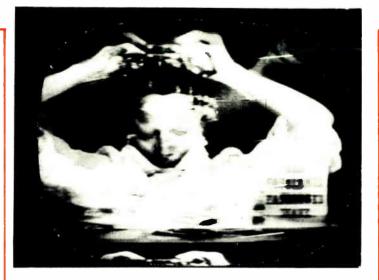
VERTICAL SWEEP OFF FREQUENCY

THIS SYMPTOM IS EASY TO FIND SINCE THE VERTICAL HOLD CON-TROL WILL BE UN-ABLE TO BRING ONE PICTURE ON THE SCREEN. IF ONE PIC-TURE DOES MOMEN-TARILY APPEAR THEN THE TROUBLE IS LOSS OF VERTICAL SYNC, AND YOU SHOULD REFER TO CHART #23. IN THIS OFF FREQUENCY CON-DITION YOU MAY FIND MANY PICTURES ON SCREEN. OR LESS THAN ONE PICTURE WHERE PART OF THE PICTURE SEEMS TO LAP OVER THE OTHER PART.

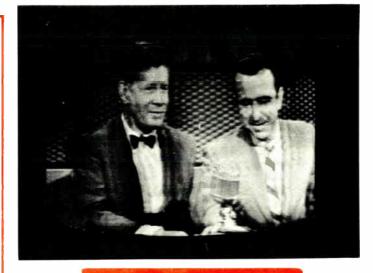
WITH NOT ENOUGH WIDTH THE SIDES OF THE SCREEN WILL BE BLACK. THIS MAY BARELY BE NOTI-CEABLE, OR IT MAY BE IN AS MUCH AS TWO INCHES ON EACH SIDE.ADJUSTMENT OF THE WIDTH CONTROL SHOULD BE TRIED FIRST BUT USUALLY THIS CONTROL WILL ONLY MOVE THE WIDTH ABOUT HALF AN INCH ON EITHER SIDE. TUBES IN THE HORIZONTAL CIR-CUIT WILL VERY OF-CAUSE TEN THIS

WITH A WEAK SIGNAL APPLIED TO THE DE-FLECTION YOKE THE HORIZONTAL SWEEP WILL NOT COVER THE ENTIRE SCREEN, THE CAUSE OF THIS CAN BE TUBES. THE FLY-BACK CIRCUIT, OR EVEN THE DEFLEC-TION YOKE ITSELF-MOST COMMON TROUBLE IN THE HORIZONTAL OUTPUT TUBE AND ITS AS-SOCIA TED COMPO-NENTS- INSUFFICIENT B + WILL ALSO CAUSE LACK OF WIDTH.

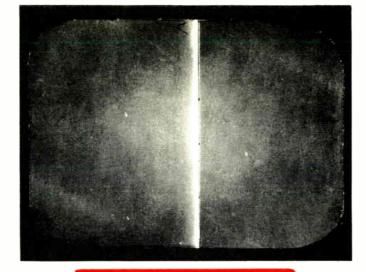
WHITE LINE IN CENTER OF SCREEN

IF THE RASTER ON THE SCREEN SHOWS A THIN WHITE LINE IN THE CENTER, THE CAUSE MUST BE LIMI-TED TO TROUBLE IN THE YOKE OR OUTPUT CIRCUIT OF THE FLY-BACK TRANSFORMER. THERE ARE A NUMBER OF SETS ON THE MAR-KET THATWILL CAUSE THIS SAME CONDITION TO OCCUR BECAUSE OF TROUBLE IN THE HORIZONTAL SWEEP CIRCUIT, BUT THESE SETS ARE THE 7" SCREEN TYPE AND HAVE ELECTROSTAT-IC CRT.

WHEN THE DEFLEC-TION YOKE IS OPEN. THE SIGNAL THAT COMES FROM THE HORIZONTAL SWEEP CIRCUIT WILL NOT CAUSE THE BEAM TO SWEEP THE CRT SIDE-WAYS **AL THOUGH** THERE STILL WILL BE HIGH VOLTAGE DEVE-LOPED. THIS WILL MEAN THAT A SINGLE WHITE LINE WILL BE NOTICED ON THE SCREEN.IN THE SMALL 7" TV SETS THE HV SYSTEM HAD NOTHING TO DO WITH THE HOR-IZONTAL SWEEP CIR-CUIT AND ANY TROU-BLE IN THE SWEEP SECTIONWOULD IN NO WAY AFFECT THE HV. IN THIS CASE LOSS OF SWEEP WOULD GIVE
