**RCA Victor
SERVICE NOTES**

1923 — 1928

RCA Radiola

Service Division

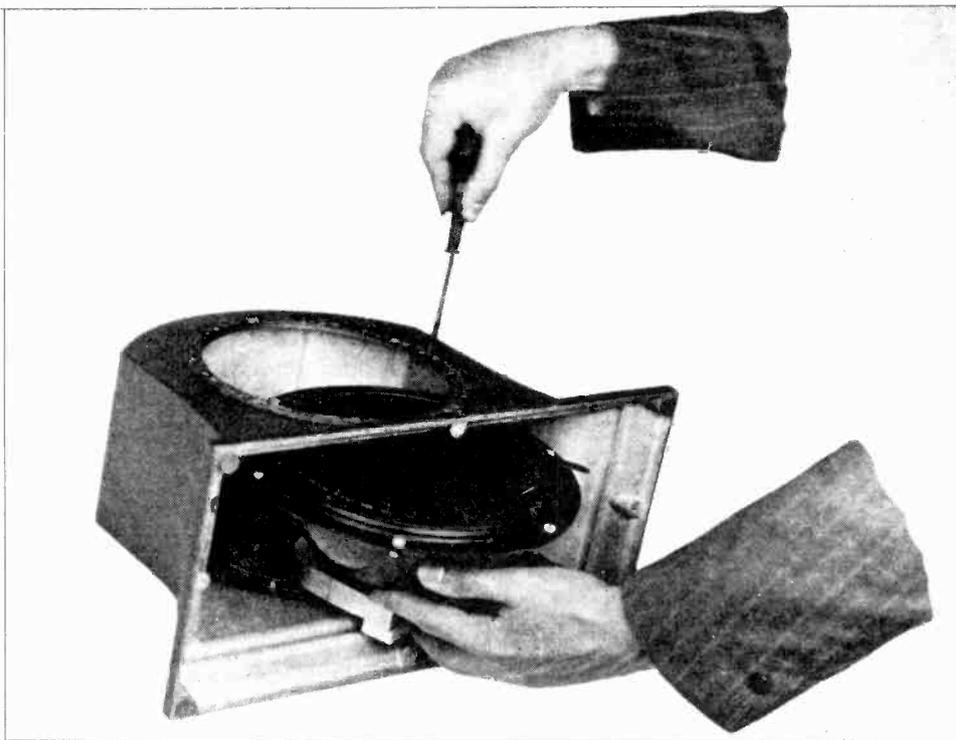
Figure 3—Removing mechanism assembly from housing
