# *The* CORNELL-DUBILIER **CD** *Capacitor*

NOVEMBER, 1945

# SERVICING MESSED-UP SETS\*

# F-M DISCRIMINATORS\*

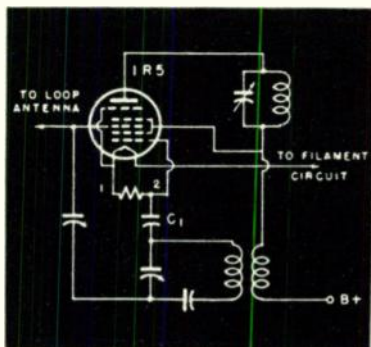
Fig. 1.—Voltage between points 1 and 2, when measured by a v-t voltmeter, would be very low if C1 was open, or missing, since C1 is in a grid-leak circuit.

When tampering is gross, but not obvious, service is not quite as simple. To illustrate, an instance may be cited where an oscillator coupling capacitor

had been removed from a camera-type portable. Extensive voltage, resistance, and other tests were made before the radioman realized that the capacitor was missing.

Service would have been simplified if the radioman had possessed a vacuum-tube voltmeter. Grid bias measurement with this meter would have shown an abnormally low negative voltage to cathode from the oscillator grid (see Fig. 1). The next step would have been to check the coupling capacitor for a decrease in capacity, which would have resulted in quick discovery of the unit's absence.

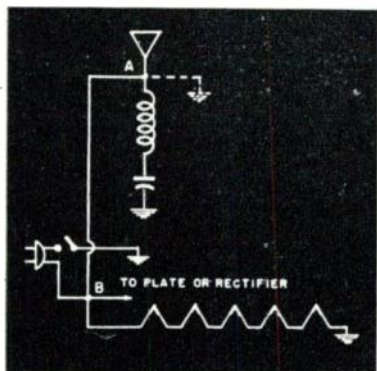
Fig. 2.—Improper connection of the aerial lead to the ungrounded side of the line became readily apparent when A was shorted to ground, resulting in fuse blow-out.

Another instance of gross, but not too obvious tampering, was found in the connection of an aerial to one side of the power line. This occurred on a set in which the external aerial is mechanically, but not electrically, connected to the line cord, and is normally left unterminated at the plug. An electrician, noticing the unconnected wire, thought it had worked itself loose from the plug, and attached it there. The result was a decrease in volume that led the owner to take his set to a more competent technician.

The radioman suspected that the antenna coil primary was defective, and shorted it to B— to see if volume was affected. The resultant fuse blow-out led to quick location of the trouble (see Fig. 2).

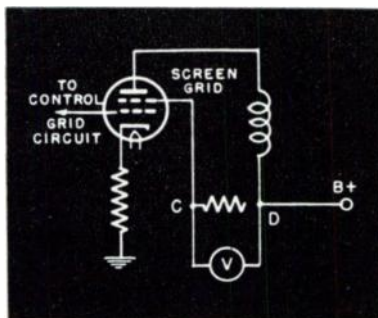
Fig. 3.—Flexible resistor C-D opened at its slack end only when set was right side up. When set was turned over for testing, the resistor had to be gently tugged after heating up, before the intermittent registered an absence of voltage between C and D.

The defective screen resistor was a wire-wound, flexible type, and had a

slack, unwound section of wire at one terminal. When the set was over-turned the weight of the resistor caused it to open at this end. The second technician was immediately suspicious of this resistor because the loose wire looked weak. Placing his voltmeter test prods from screen to B+ (see Fig. 3), he tugged gently at the resistor, waited for it to heat up, then tugged at it again. On the second trial, an intermittent reading occurred on the voltmeter. Replacement of the unit followed.

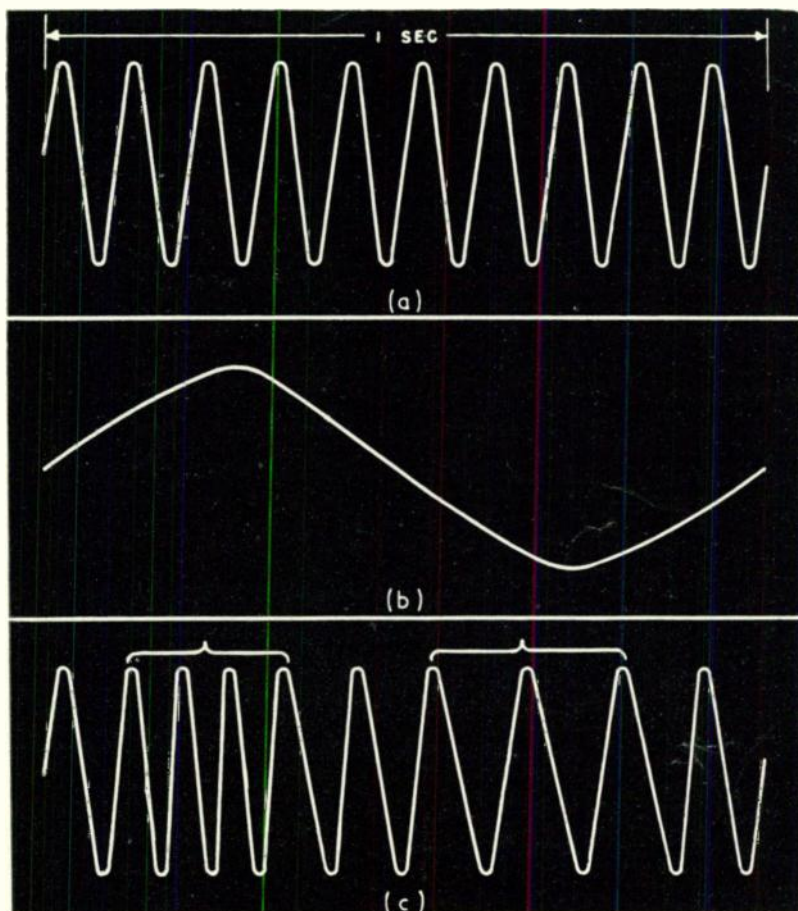
Fig. 1a represents 10 cycles of a 10-cps wave; 1b shows a 1-cps modulation wave; 1c is the resultant wave form when the two are combined in f-m. Note variation in individual wave form.

Let us consider a sine wave of 10 cps, Fig. 1a. This sine wave is to be frequency modulated by a sine wave of 1 cps, Fig. 1b. The 10-cps carrier

one second. In this manner the carrier would then contain the two characteristics of the modulating signal, its frequency and its amplitude; resultant wave is shown in Fig. 1c.

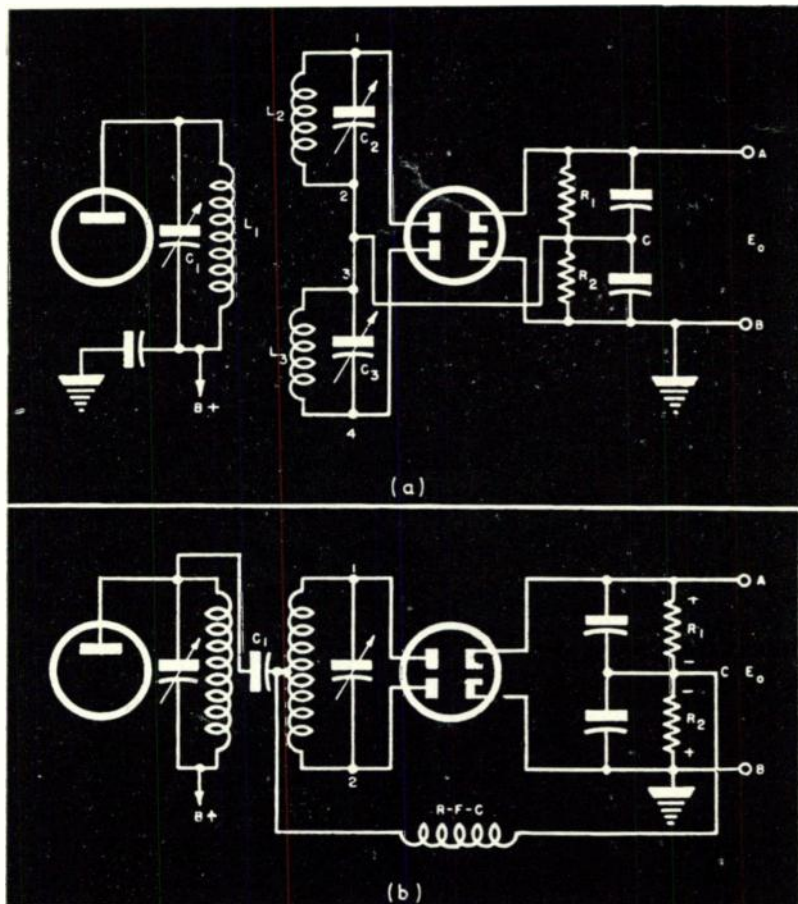
Fig. 2a and b . . . Here are two types of discriminator circuits. Circuit of Fig. 2b is used in most f-m receivers.

Two types of discriminators are in popular use; Fig. 2, a and b. Both circuits perform the same function, to demodulate the f-m signal in terms of audio frequency and amplitude.

In Fig. 2a,  $L_1 C_1$  is tuned to the i-f frequency, say 4,000 kc.  $L_2 C_2$  is tuned to 4,075 kc, and  $L_3 C_3$  to 3,925 kc. When a signal voltage of intermediate frequency appears across both  $L_2 C_2$  and  $L_3 C_3$  even though they are not tuned to 4,000 kc. This occurs because of the proximity of their resonant frequencies to that of the i-f, or center

The system shown in Fig 2b is the more popular of the two. Here again, at center frequency, the voltages from points 1 and 2 to ground are equal and identical in polarity. When the frequency of the i-f signal is reduced, the voltage from point 2 to ground will rise and that from point 1 to ground will decrease. Since both voltages have the same polarity, only the difference voltage will appear across A and B. A similar condition occurs when the i-f signal swings upward in frequency, but now the polarity of the voltage across A and B is reversed.

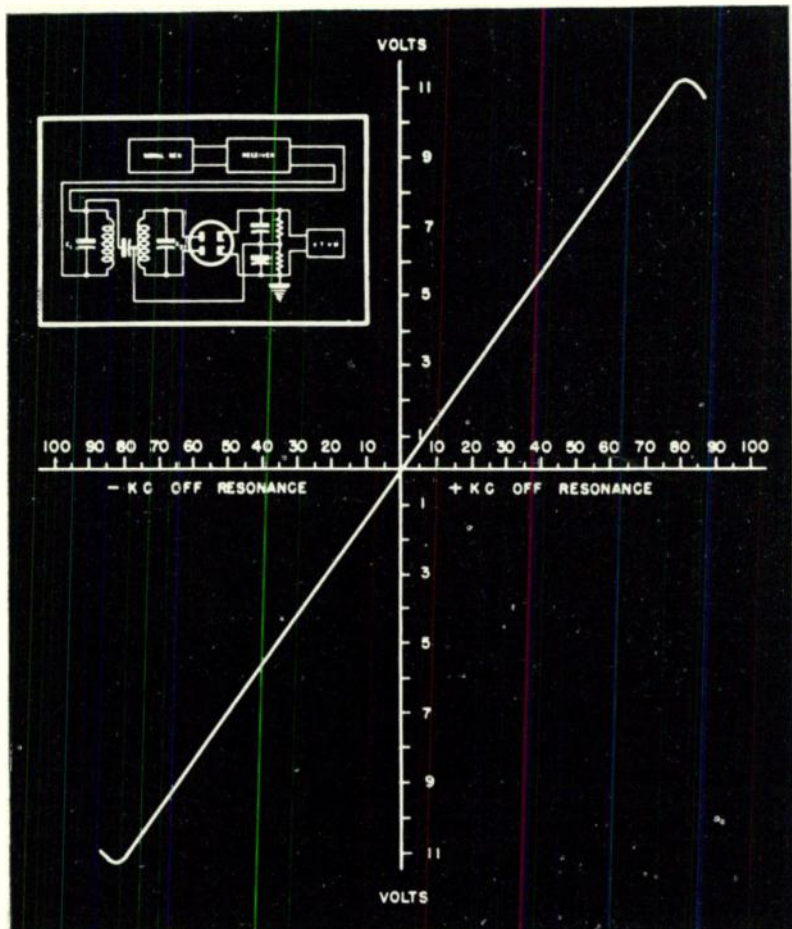
Fig. 3.—A typical response curve for the circuit shown in the insert. Developed voltage is a function of off-resonance frequency within the limits of broadcast f-m.

should be equal and opposite in polarity for both conditions. If these voltages are not equal,  $C_1$  must be reset. A check should then be made again at center frequency to insure zero voltage. A typical graph for a discriminator, displaying ideal characteristics, also appears in Fig. 3.

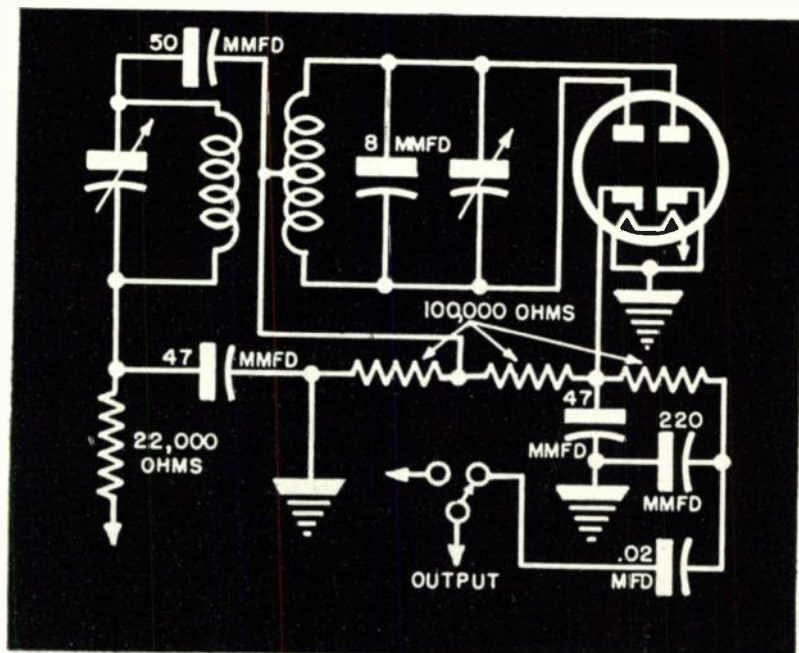
Fig. 4.—G. E. J FM discriminator. A temperature-compensated condenser is used in parallel with the secondary trimmer for frequency stability.

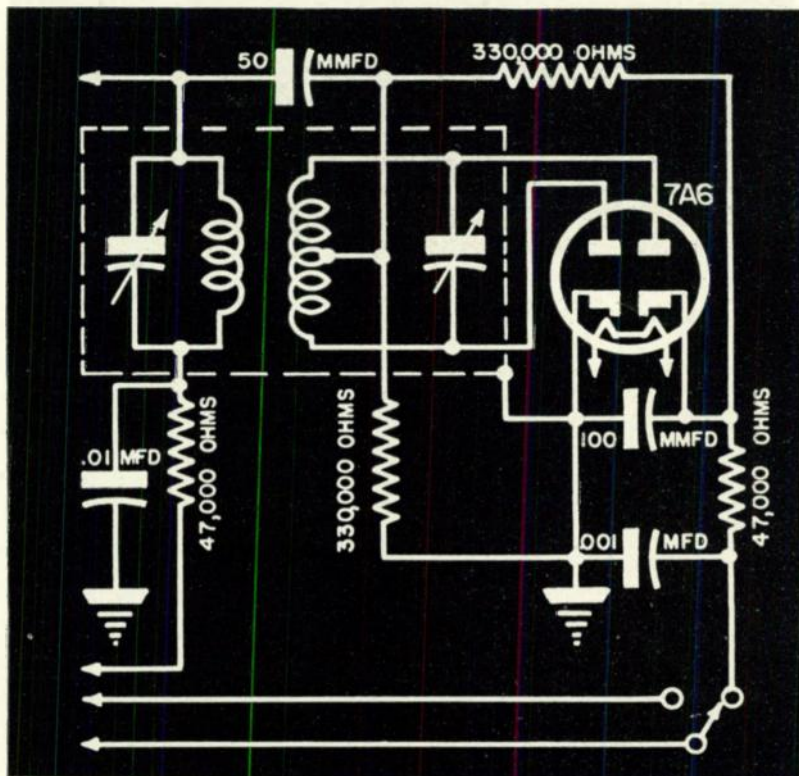
Fig. 5.—Pilot 300 discriminator. This circuit is similar to the G.E. circuit. The 47,000-ohm resistor and .001-mfd condenser are used to filter the r-f in the audio feed line.

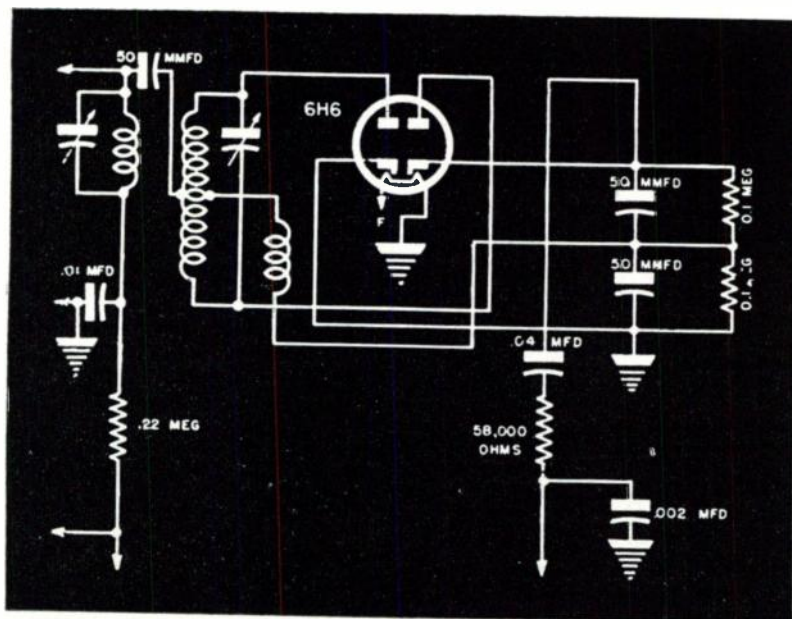
Fig. 6.—Stromberg-Carlson 25 discriminator. The choke in series with the secondary tap is used to reduce the loading effect of the two .1-megohm resistors on the transformer secondary.

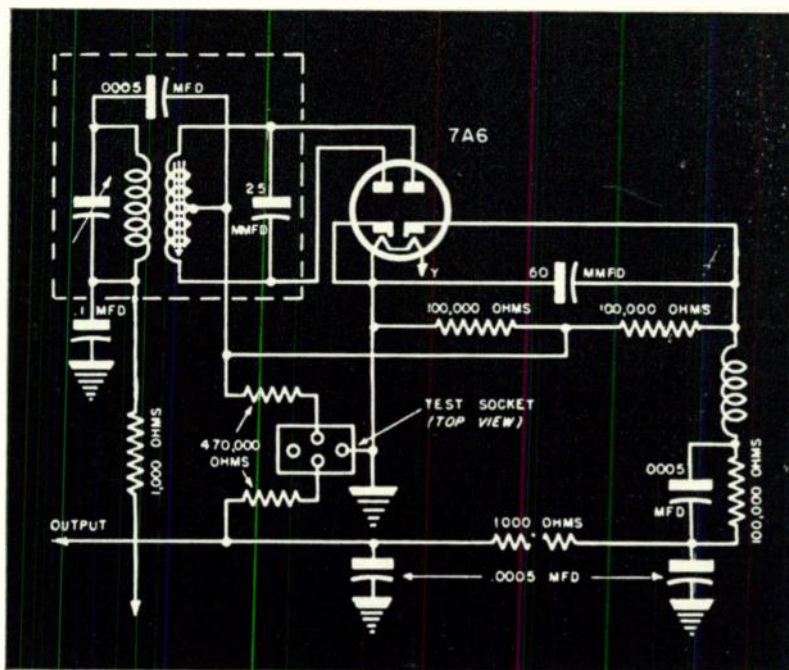
Fig. 7.—Zenith 12H678 discriminator. A socket is provided on the chassis to permit insertion of instruments for discriminator alignment.

The discriminator used in the Zenith 12H678 (chassis 12A6) is shown in Fig. 7. An iron core is used in the secondary of the discriminator for alignment. The RC network in the lower right-hand corner is an a-f com-

pensation circuit for uniform frequency response. A special socket is included on the chassis to permit quick checking of the discriminator with a vtvm.
