journal
September/October 1976

September/October 1976
Volume 34, No.5

Moonlighting

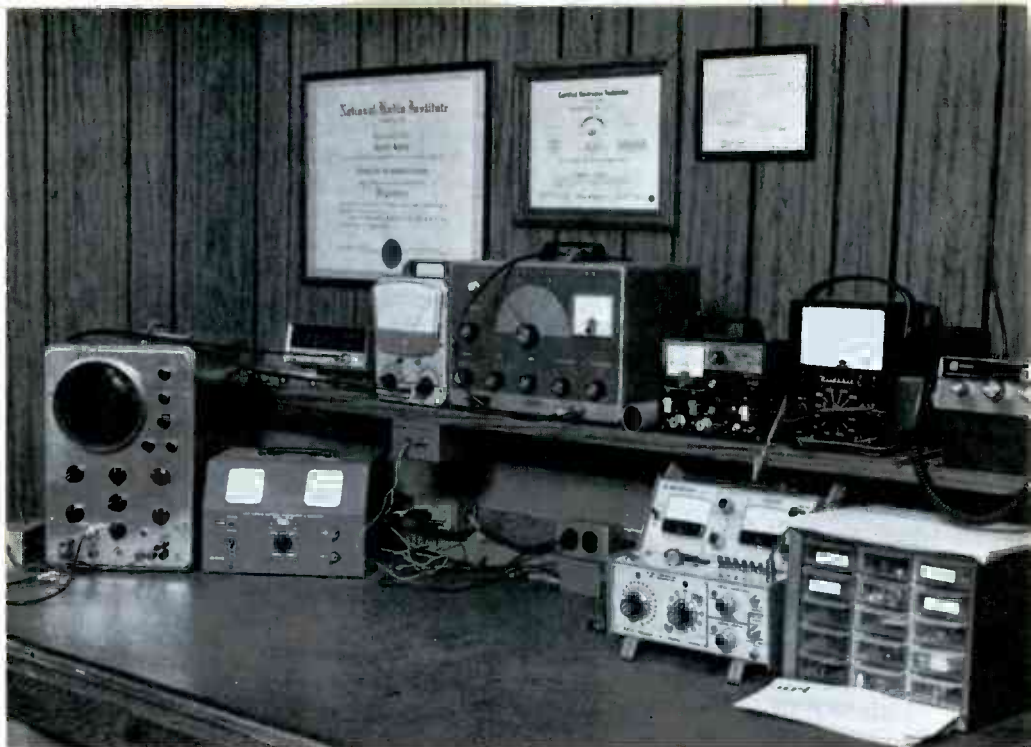
FIGURE 3. (L. TO R. ON SHELF) HEATHKIT IB1100 FREQUENCY COUNTER, CONAR MODEL 211 VTVM, HEATHKIT IG42 SIGNAL GENERATOR, JOHNSON TRANSCEIVER TESTER, HEATHKIT MODEL MM1 MULTIMETER, AND JOHNSON 123A CB TRANSCEIVER. (L. TO R. ON BENCH TOP) CONAR MODEL 250 OSCILLOSCOPE, EICO MODEL 1060S BATTERY ELIMINATOR, AND NIKOLTRONIX CB ANALYZER.

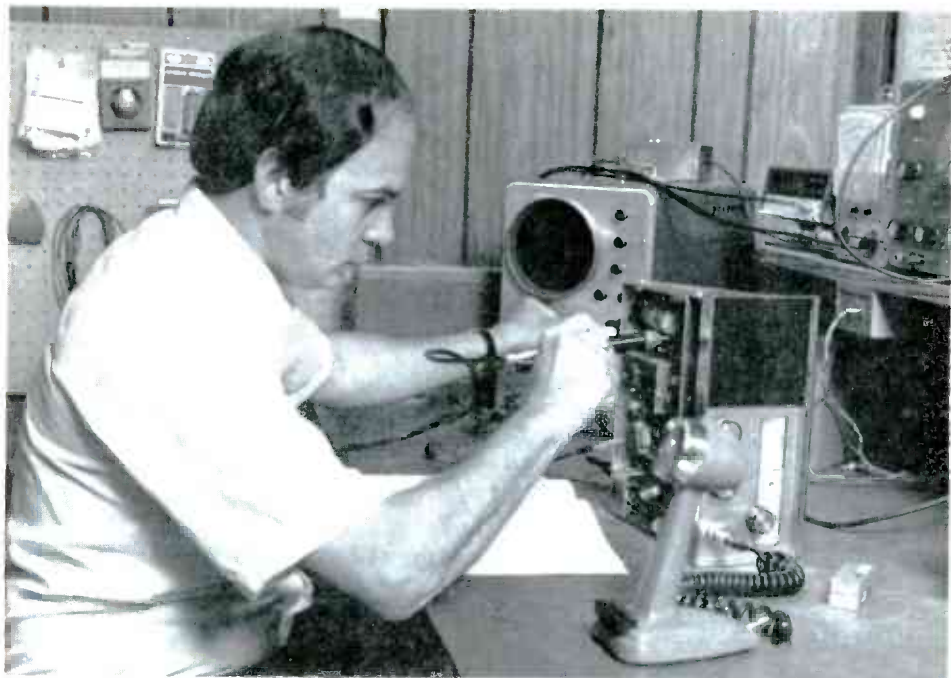
FIGURE 5. CHECKING POWER SUPPLY RIPPLE IN JOHNSON 223 TRANSCEIVER USING OSCILLOSCOPE.
