MONOGRAPH

A Mobile Laboratory for
UHF and VHF Television Surveys

by
E. W. TAYLOR, M.A.
and
L. C. MUNN

No. 34

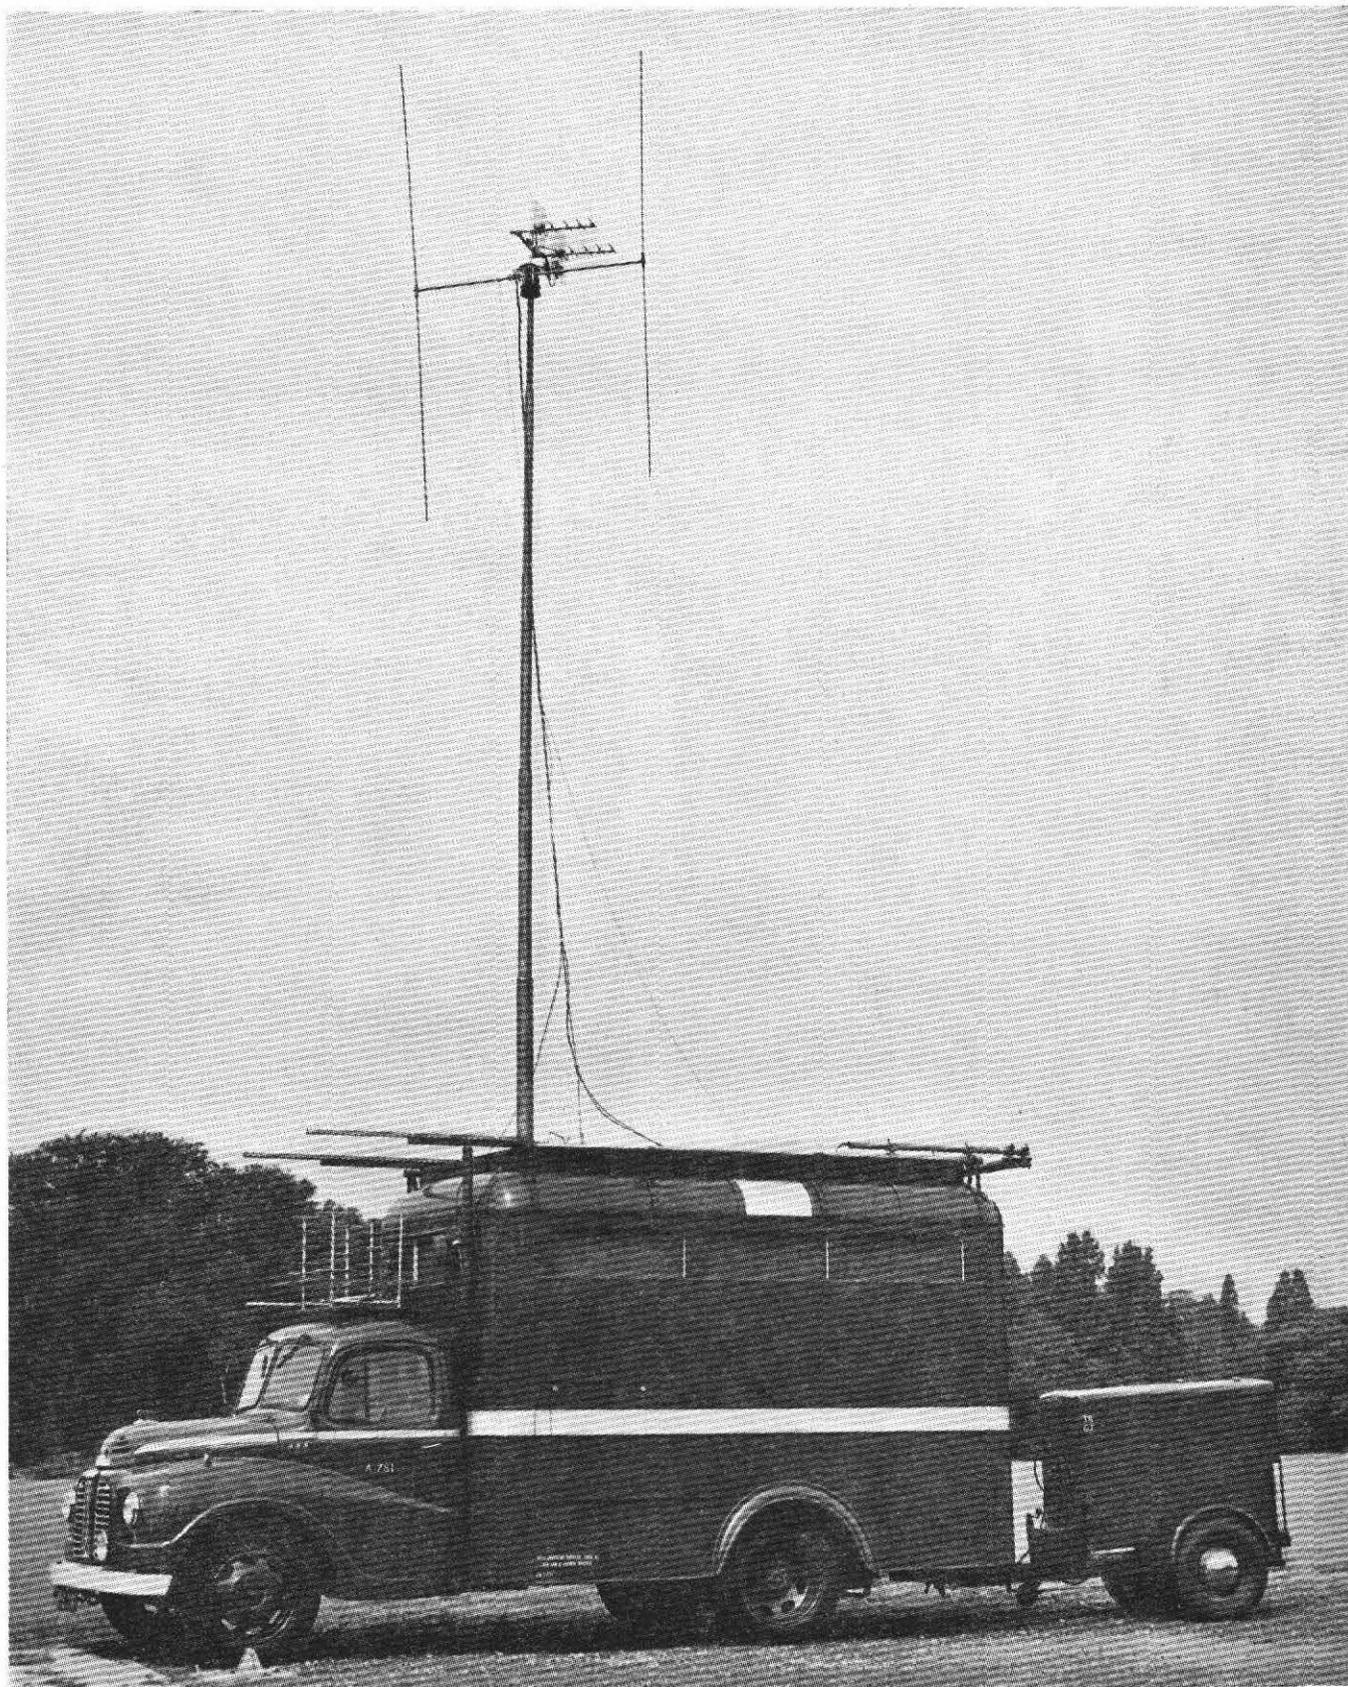
Fig. 1 — The mobile laboratory equipped for the Series B tests

members; these can be seen projecting over the driver's cab in Fig. 1.

sites all requiring the same array. When not in use the one-array and four-array aerials were carried on the roof of the driver's cab (these can be seen in Fig. 1), and the two-array aerial was carried inside the vehicle.

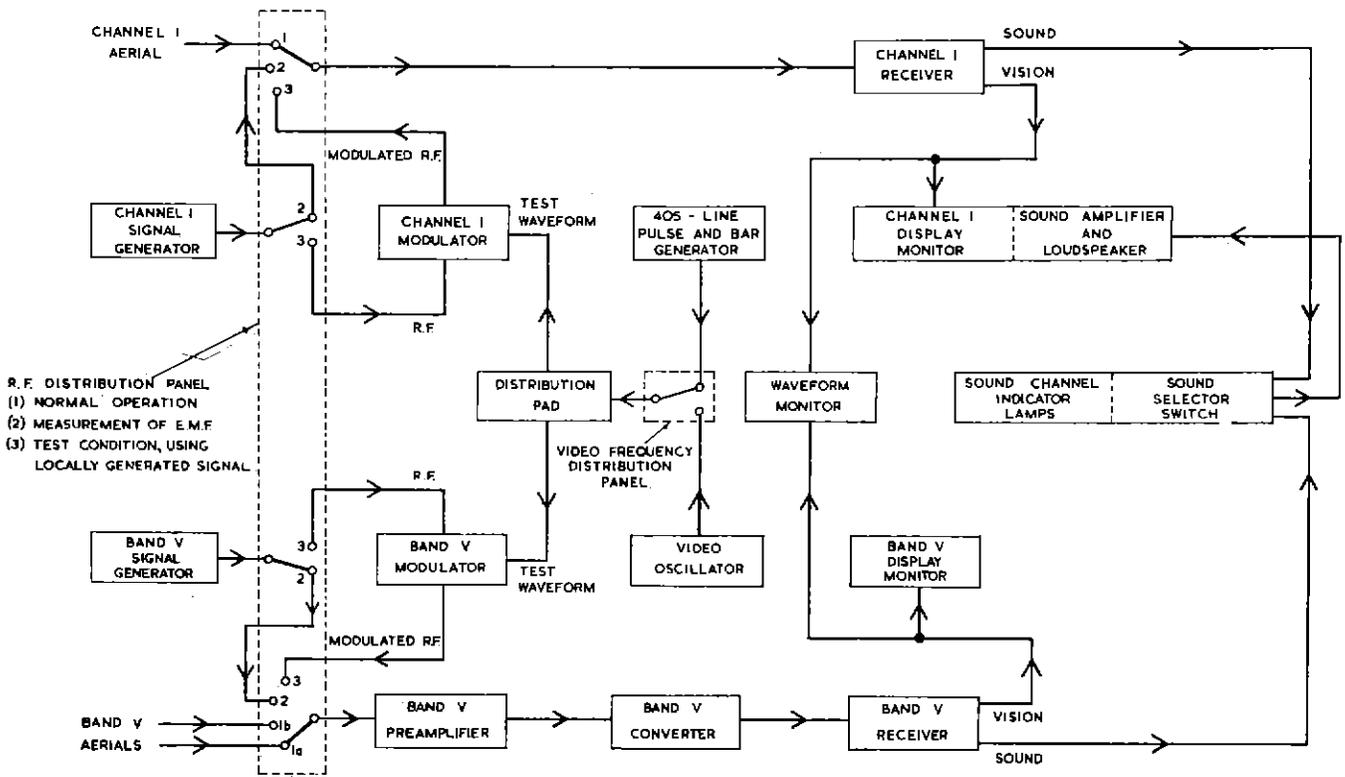
Fig. 2 — Block schematic of equipment used for the Series A tests

In both the above diagrams the interconnections normally used on the distribution panels are represented as switches; other connections were available if required

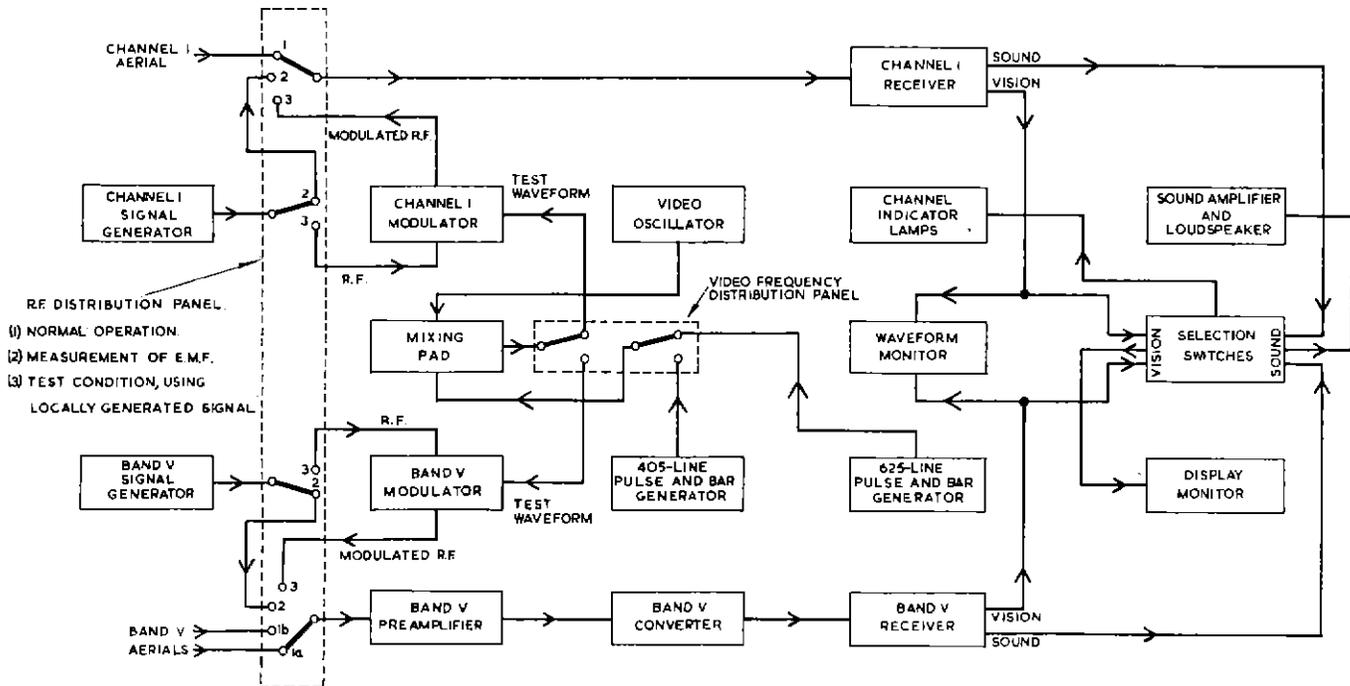
Fig. 3 — Block schematic of equipment used for the Series B tests

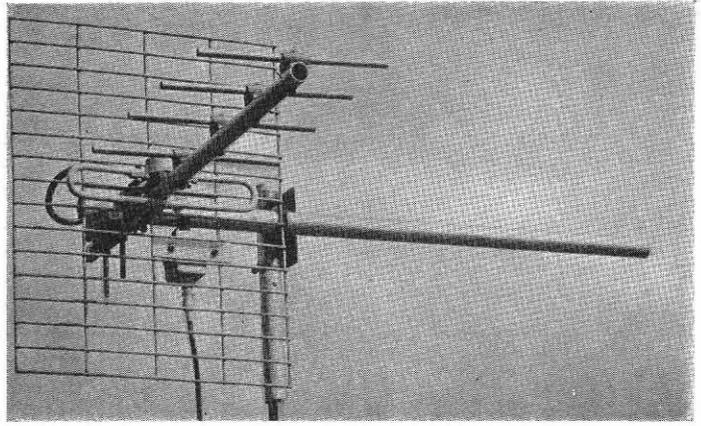
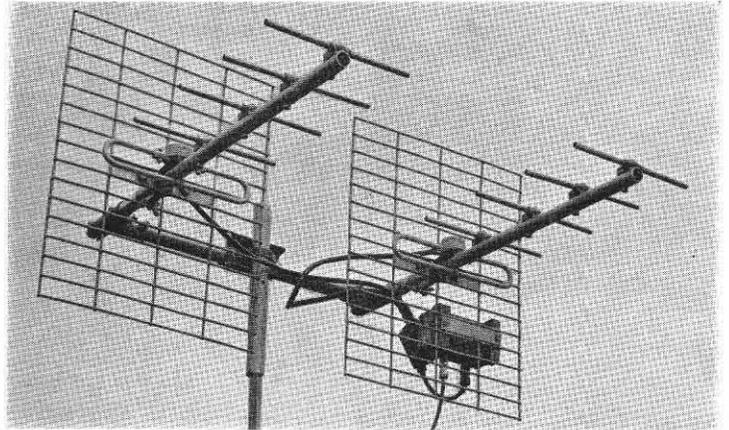
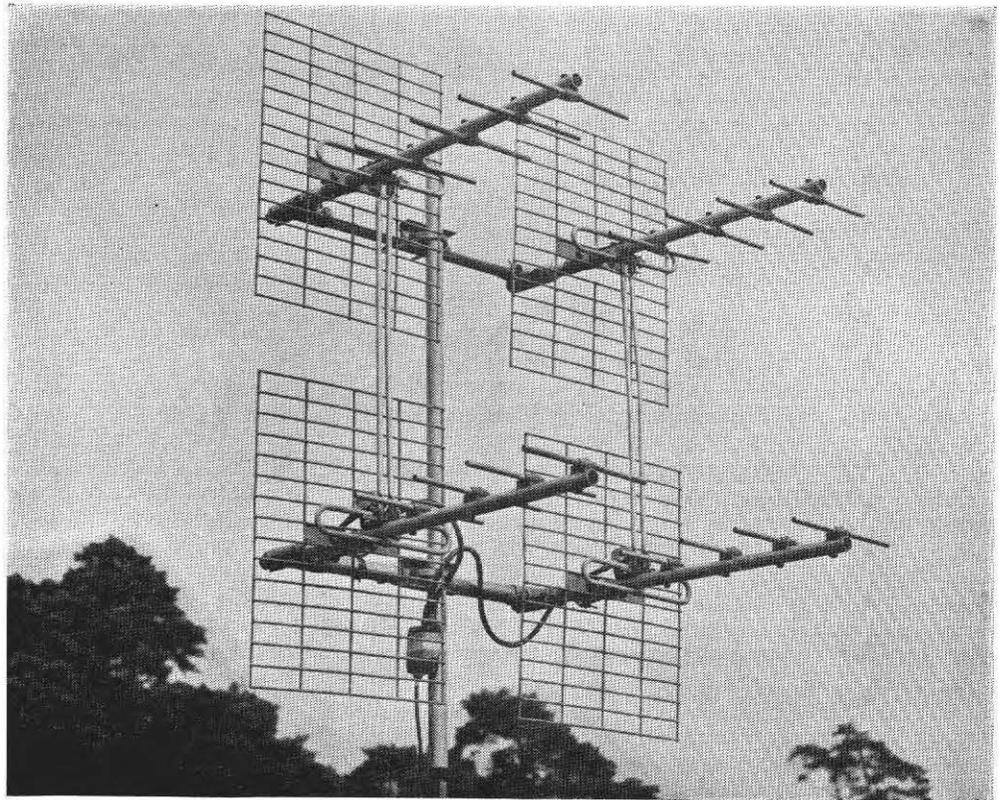
Fig. 4 — *Band V aeriels*

(a) *Low gain*

(b) *Medium gain*

(c) *high gain*

During the survey a very large range of field strengths was encountered and three aerials of different gains were therefore carried. The aerials were all based on a Yagi array consisting of four directors, a folded dipole, and a wire-mesh reflector. Assemblies comprising one array (Fig. 4(a)), two arrays (Fig. 4(b)), and four arrays (Fig. 4(c)) provided aerials with low, medium, and high gains respectively. The aerial chosen for use at a particular site (during the Series A tests) was the least complicated array that would produce a satisfactory picture. Usually the choice was influenced by the necessity of having sufficient aerial gain to provide an adequate input to the receiving chain and so ensure a good signal-to-noise ratio, but sometimes an aerial of higher gain than was necessitated by this consideration had to be used to reduce unwanted echoes. For the Series B tests the aerial used at each site was the same as had been previously used for the Series A tests, in order to make the two series of tests more directly comparable.

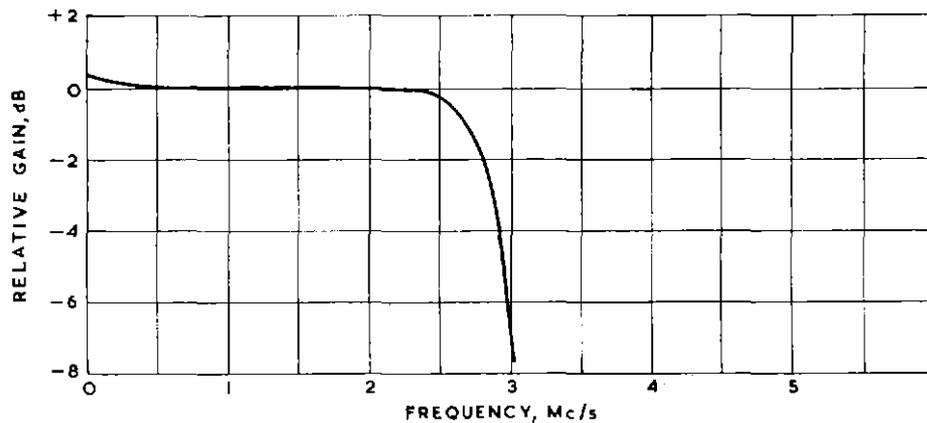
Fig. 5 — Overall modulation/frequency characteristic of Band V receiving chain—Series A tests

The output of each of the receiving chains was a composite video signal: Figs. 5 and 6 show the overall modulation/frequency characteristics of the two chains.

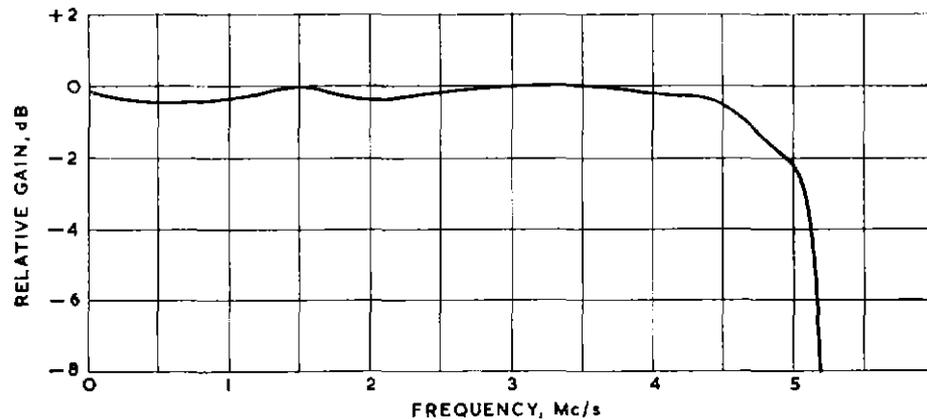
Fig. 6 — Overall modulation/frequency characteristic of Band V receiving chain—Series B tests

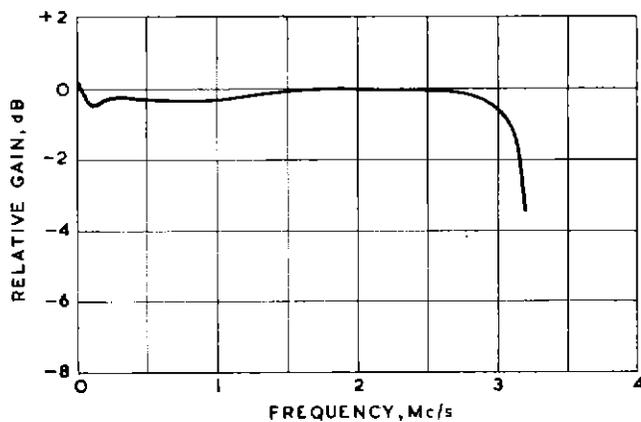
Fig. 7 — Overall modulation/frequency characteristic of Channel 1 receiver—Series A tests

Figs. 7 and 8 show the overall modulation/frequency characteristics of the 405-line receivers used for the Series A and Series B tests respectively.

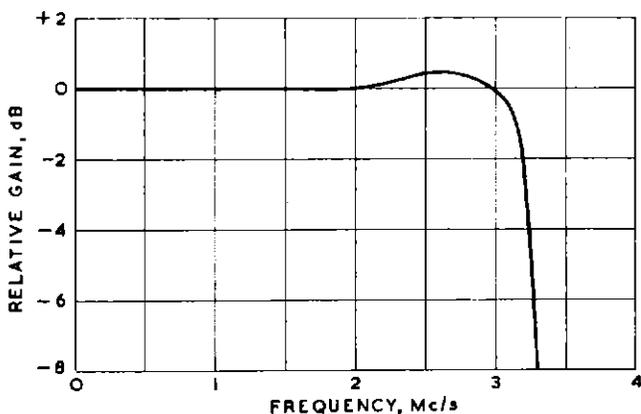
Fig. 8 — Overall modulation/frequency characteristic of Channel 1 receiver—Series B tests

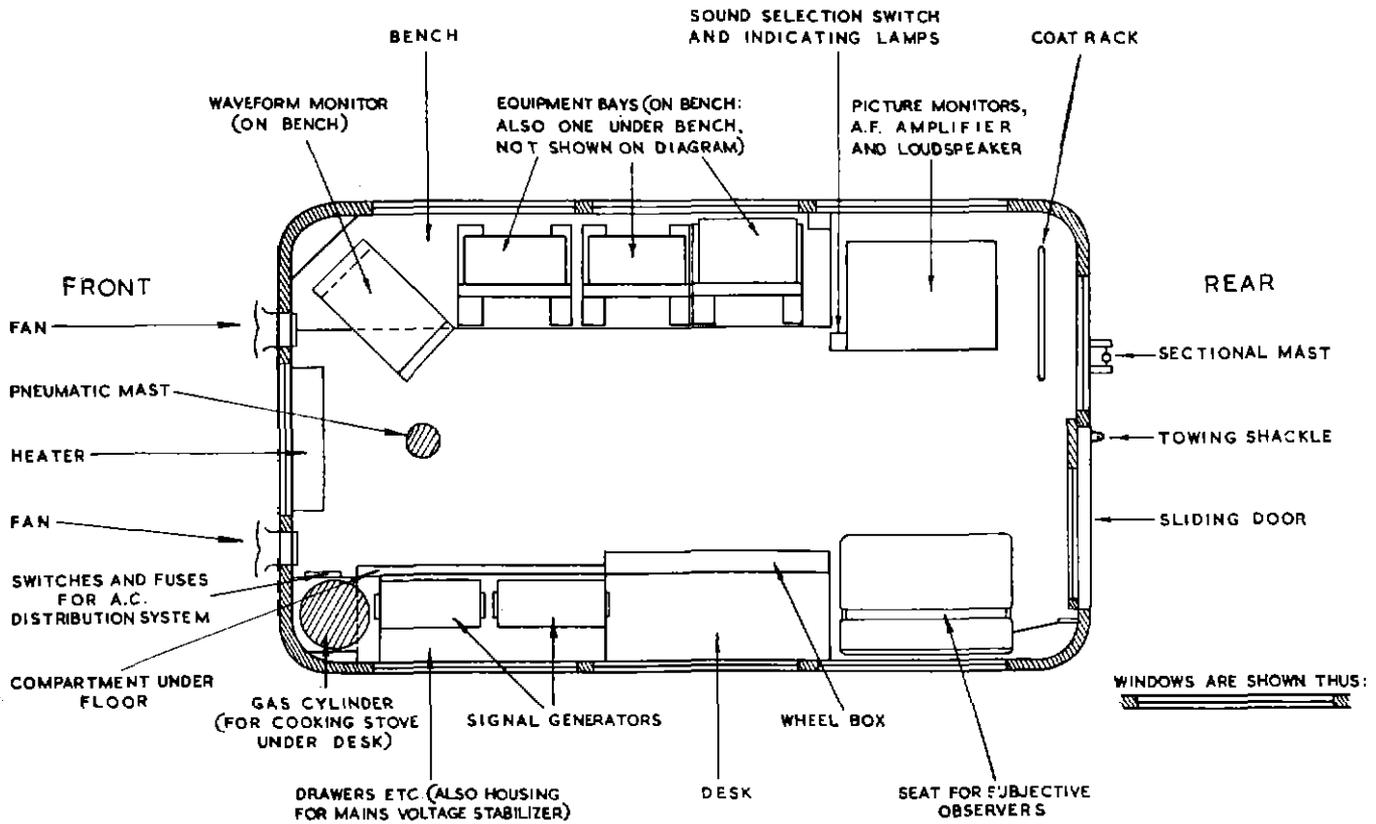
Fig. 9 — Plan of the mobile laboratory equipped for the Series A tests

The equipment layouts for the two series of tests are shown in Figs. 9 and 10. During the Series A tests the seat for the subjective viewers was near to the door of the working space of the mobile laboratory, and their work was interrupted when the door was opened: in the Series B tests their assessments could be carried out without disturbance. Figs. 11 and 12 show photographs of the interior arrangements for the Series B tests.

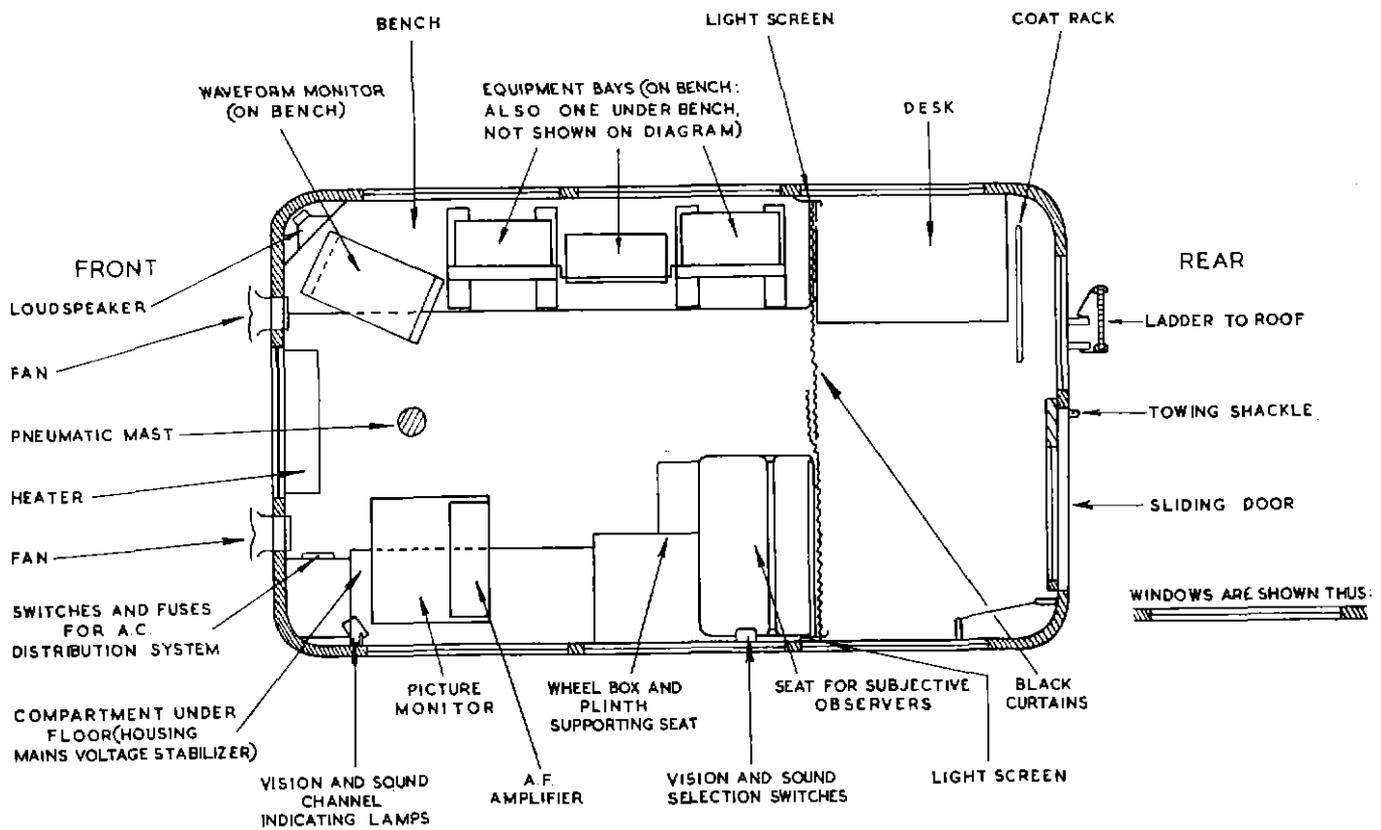
Fig. 10 — Plan of the mobile laboratory equipped for the Series B tests

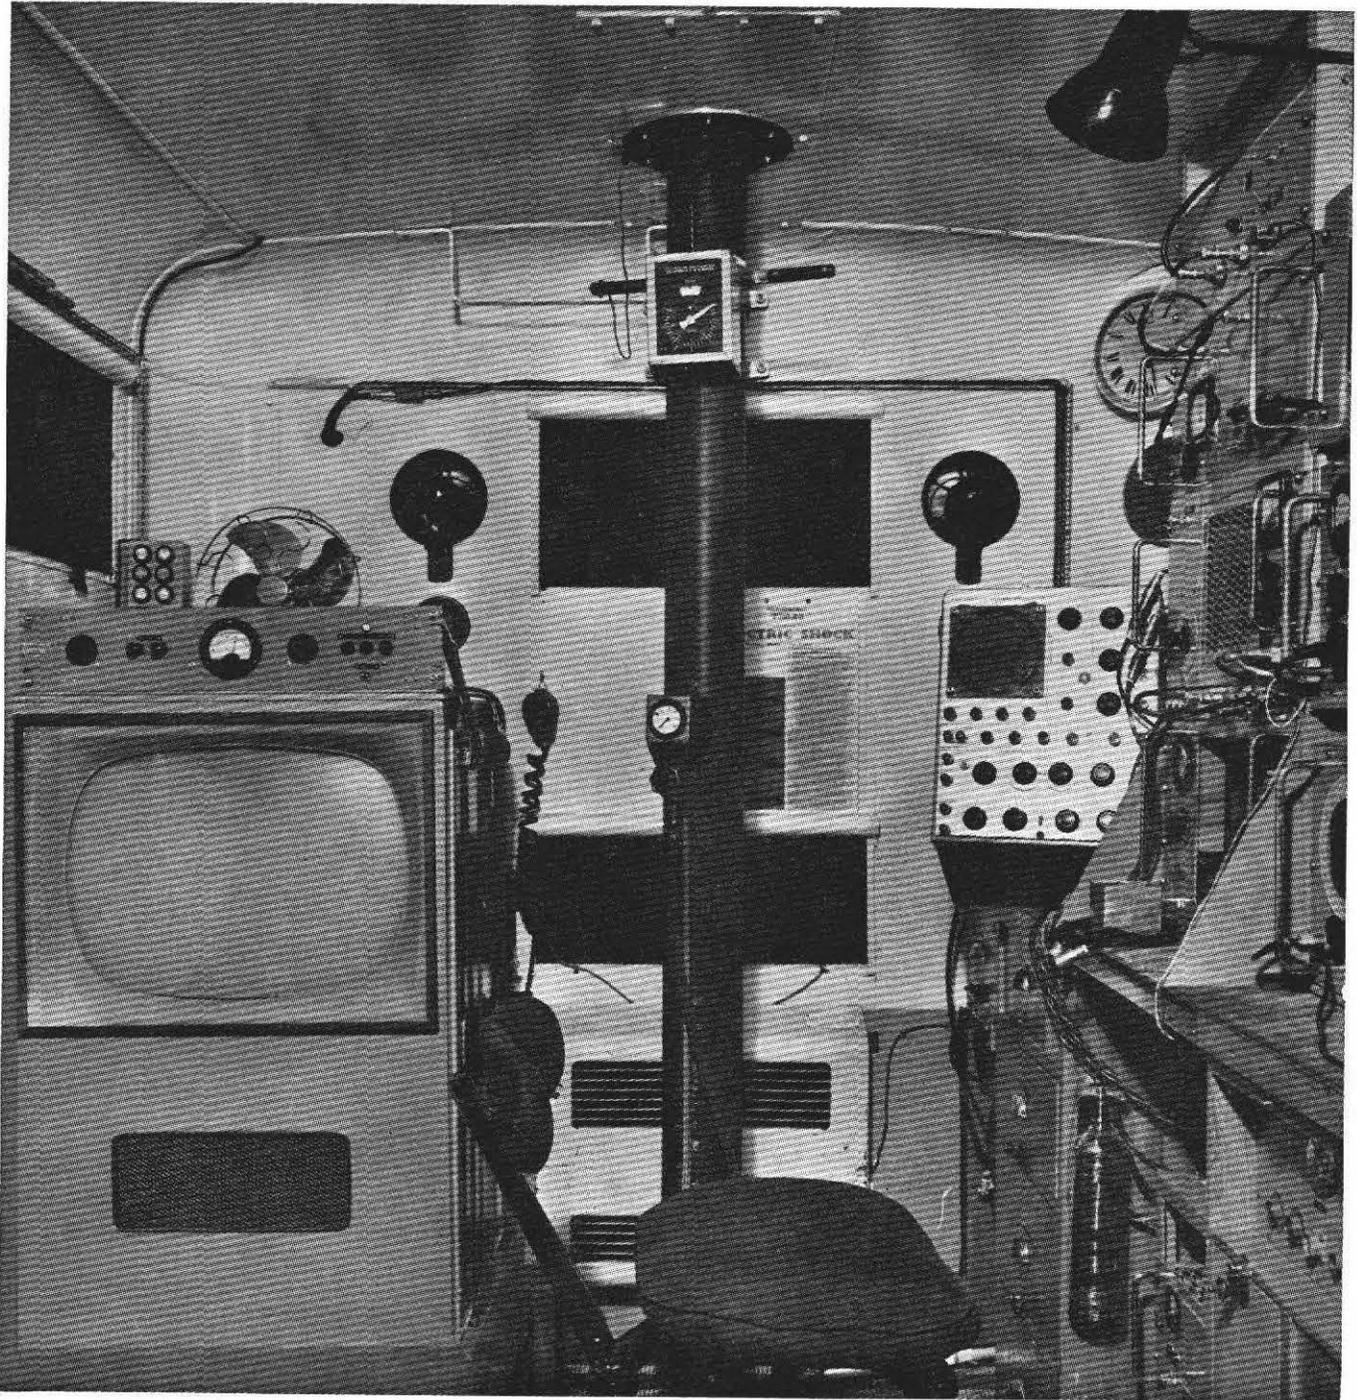
Fig. 11 — Mobile laboratory—view looking forward, showing picture monitor (left), pneumatic mast (centre), and waveform monitor (right) as arranged for Series B tests

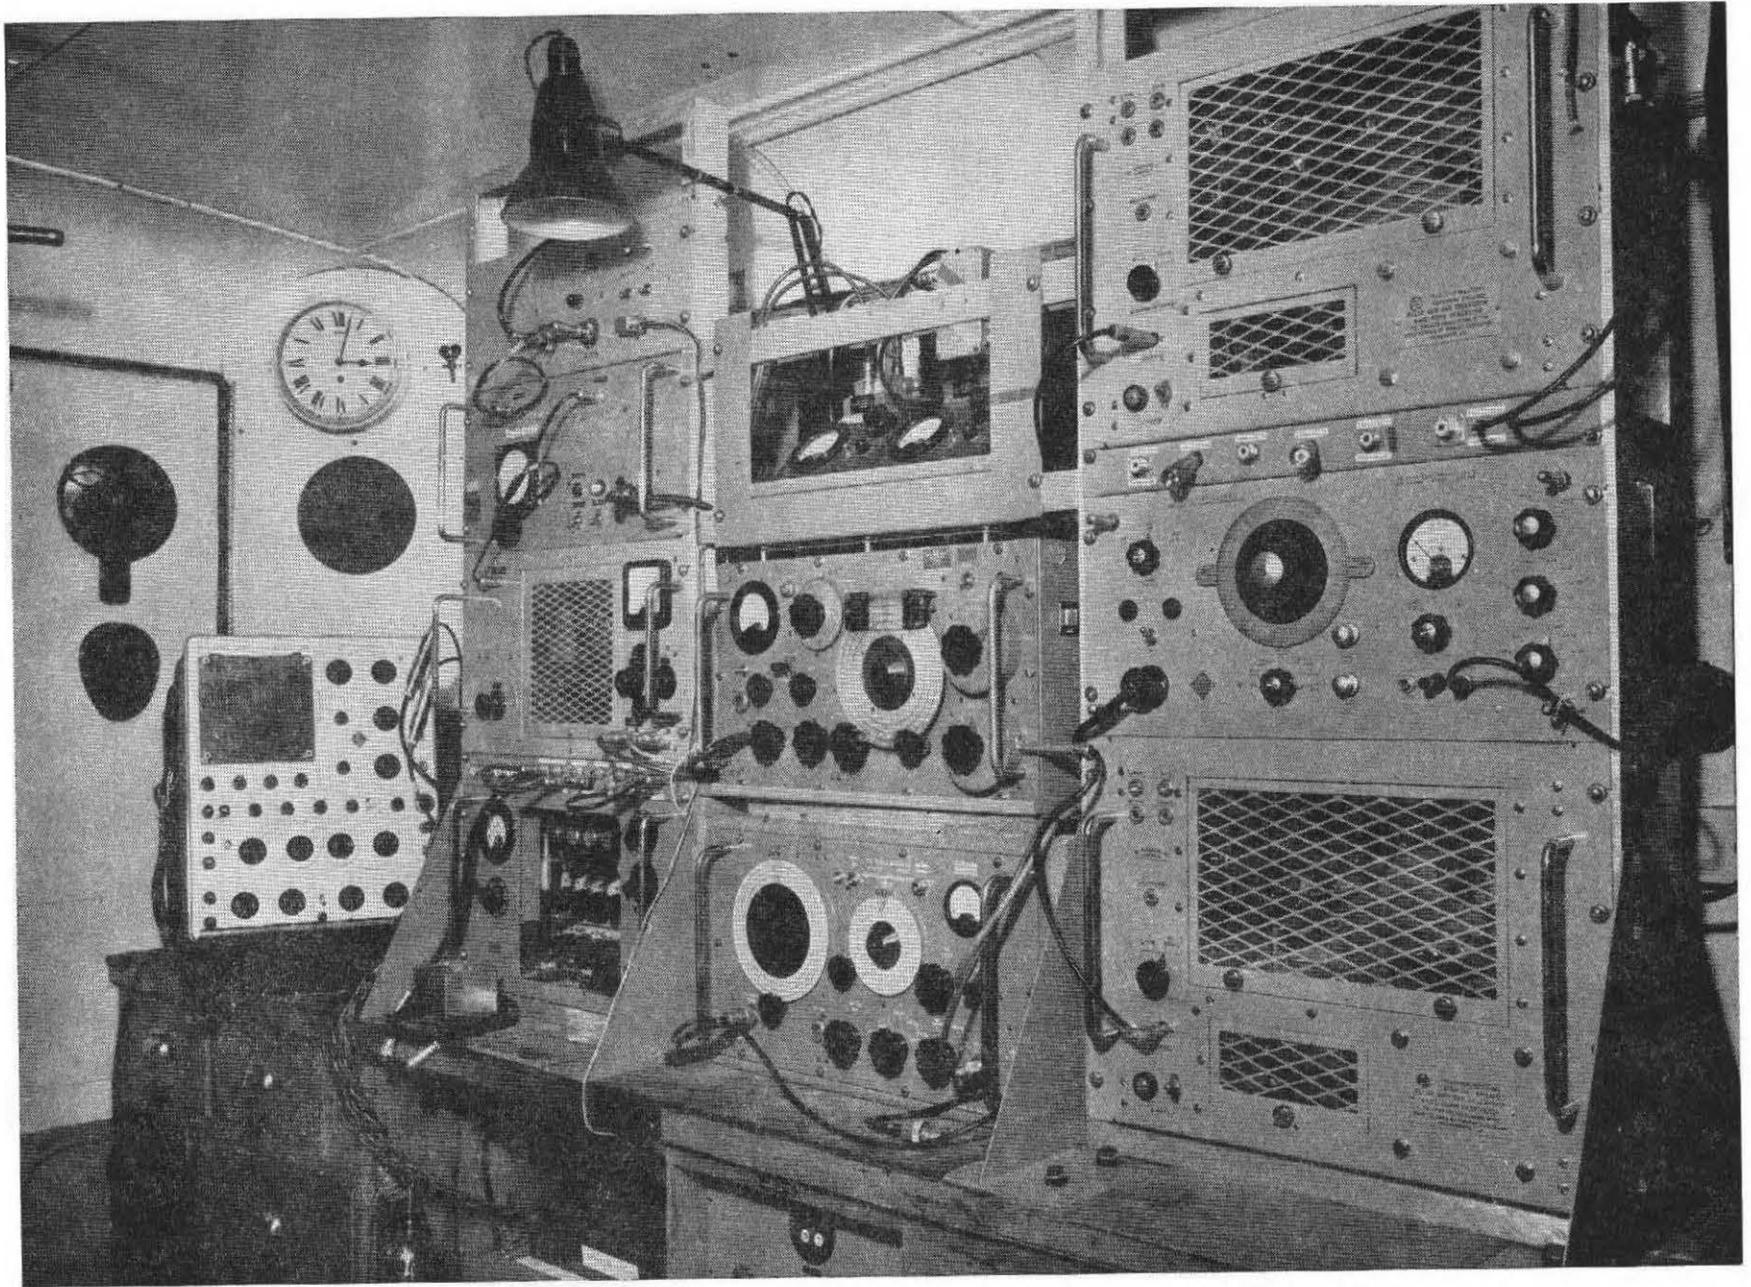
Fig. 12 — Mobile laboratory—view of receiving and test equipment as arranged for Series B tests

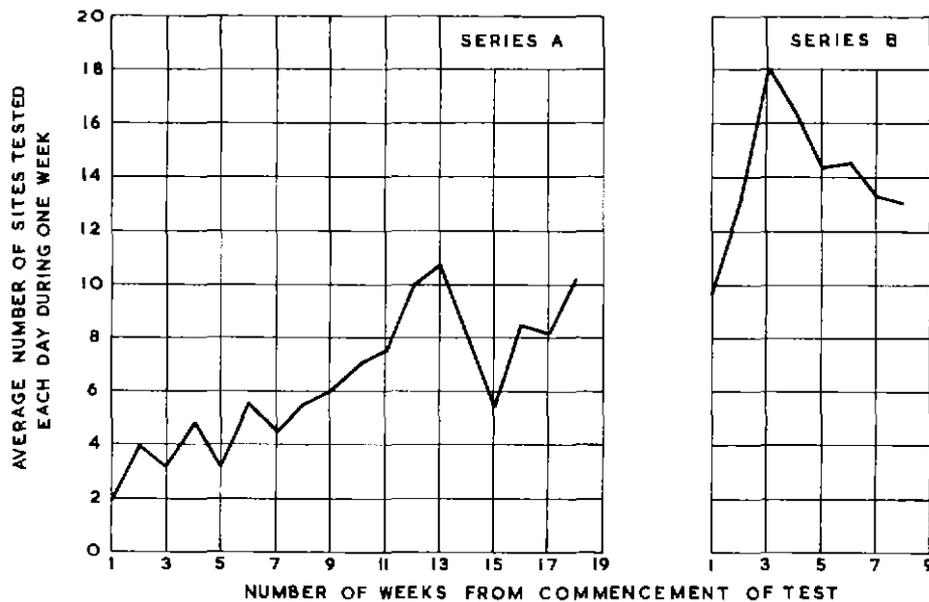
Fig. 13 — Average number of sites tested per day during each week

Series A	Series B
Average number of sites tested per day during the last six weeks of each test	8.6	15.0

Fig. 13 shows the average number of sites tested per day during each week of the survey. The steady increase during the Series A tests as operational experience was gained can be clearly seen: the increase during the Series B tests is also apparent and the steps taken to increase the speed therefore appear to have been justified. Comments from the subjective observers confirmed that their work was on the whole made much easier by the arrangements adopted for the Series B tests, but that the provision of two display monitors (as in the Series A tests) would have made the comparison of the two pictures easier, particularly in the presence of intermittent interference. As only one monitor
