Aspects of high-quality monitoring loudspeakers

A NEW TWO-UNIT HIGH-QUALITY LOUDSPEAKER

MONITORING-LOUDSPEAKER QUALITY IN TELEVISION
SOUND-CONTROL ROOMS

No. 78

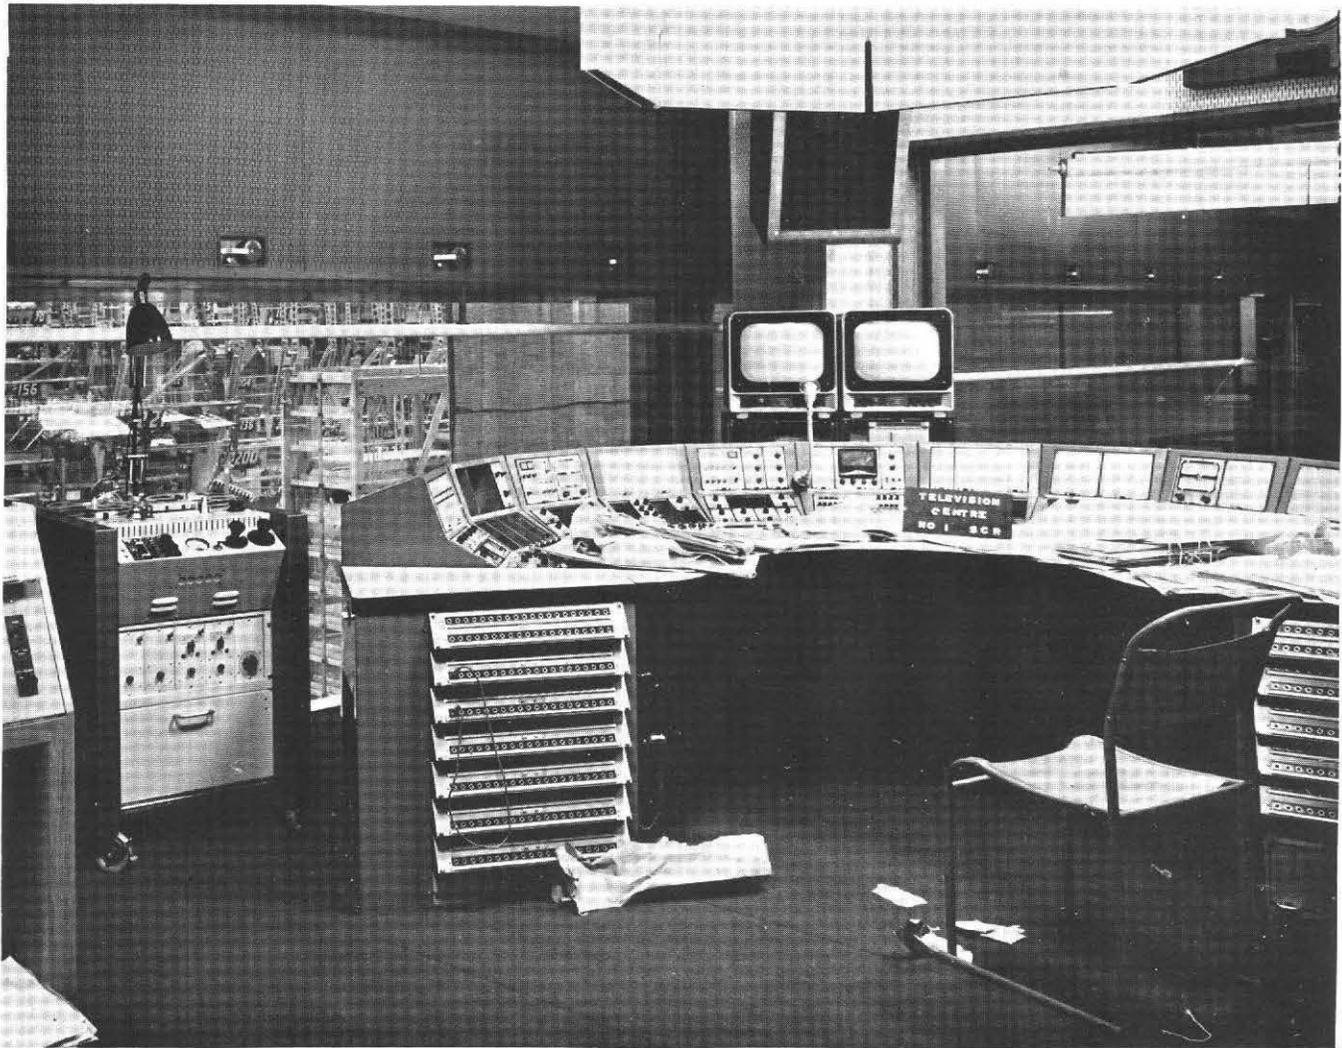
Fig. 17 — Position of the LS5/2 loudspeaker in Television Centre Studio 1 sound-control room
