# PRACTICAL TELEVISION

APRIL  
1969

## THE PTV VIDEOSCOPE

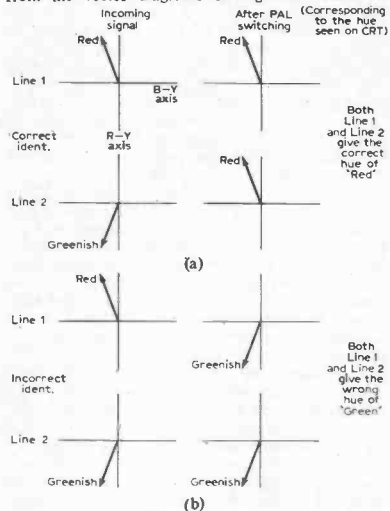
Fig. 22 : Vector diagrams showing why incorrect ident results in a hue which is the mirror image of the correct one. (a) Vectors under correct ident conditions. (b) Vectors under incorrect ident conditions. There are no blinds present on the picture when the fault is incorrect ident.

The reasons for the hue changes can be seen from the vector diagrams of Fig. 22. Since the

signal in the R-Y channel is being switched 180° (inverted) from line to line in sympathy with the transmission, the R-Y component of any particular hue being displayed will either be correct or inverted. The B-Y signal is not switched and so it stays the same regardless. Thus if the ident is incorrect a vector corresponding to a particular hue will be rotated about the B-Y axis to form the mirror image of the correct one.

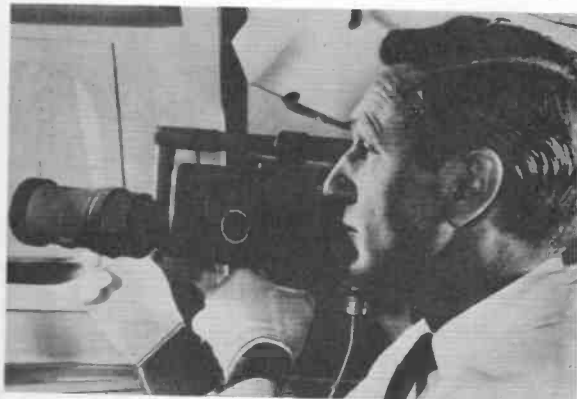
Here can be seen one of the technicians testing the tiny TV camera prior to the Apollo mission.

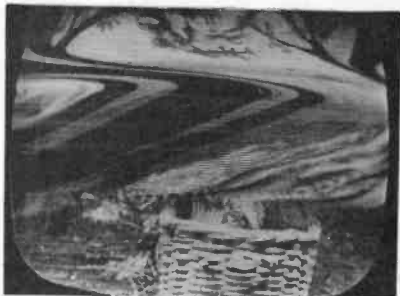
Fig. 10: Hum in a flywheel-sync circuit. This is not uncommonly caused by a heater-cathode leak in an associated valve.

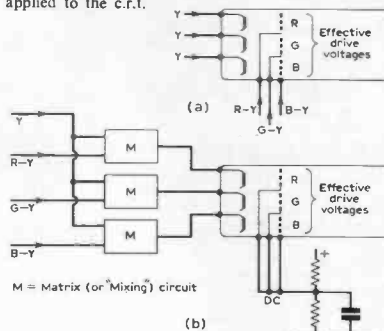
Fig. 21: Adding luminance (Y) and chrominance (R-Y, G-Y and B-Y) information to obtain a colour picture. (a) Colour-difference drive, (b) R, G, B drive.

and this is why it is impossible to get correct colour unless the monochrome picture is correct also. Figure 21 illustrates how the signals are applied to the c.r.t.
